# Project Plan Water System Improvements

Village of  
Downers Grove, Illinois  
April 2015

## Project Plan Water System Improvements

STRAND ASSOCIATES, INC.®  
IDFPR No. 184-001273  
1170 South Houbolt Road  
Joliet, IL 60431  
www.strand.com  
April 2015

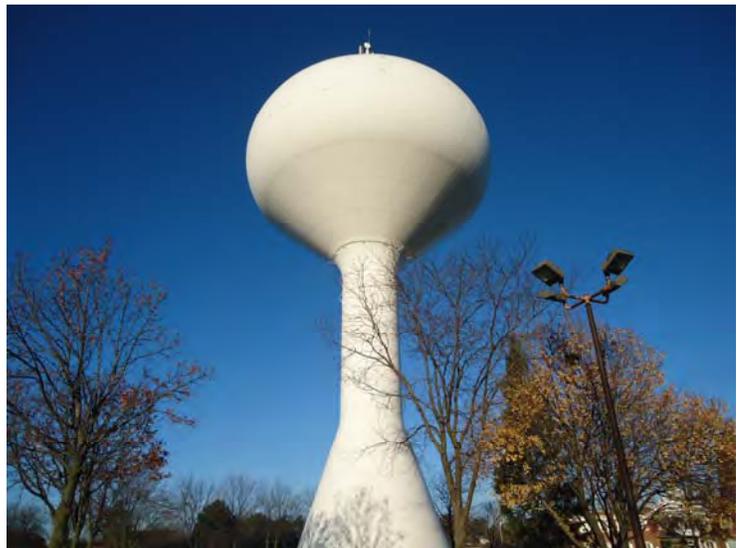
3. The coating on the base cone exterior is in good condition.

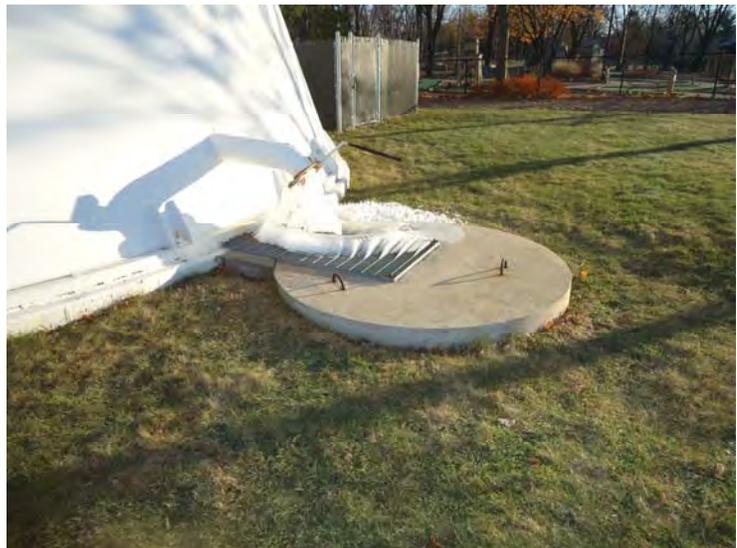
6. The base cone door is in good condition and operated properly during the inspection.

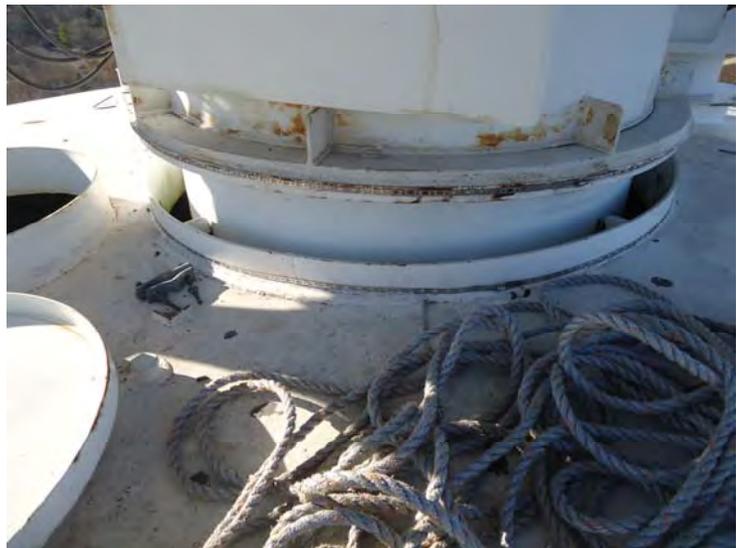
14. The access tube air gap is not screened.

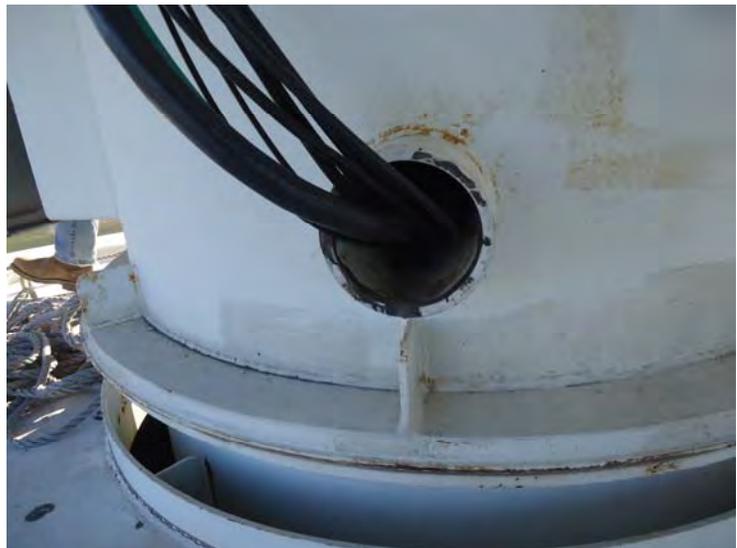
17. The cable penetrations in the pod are not sealed.

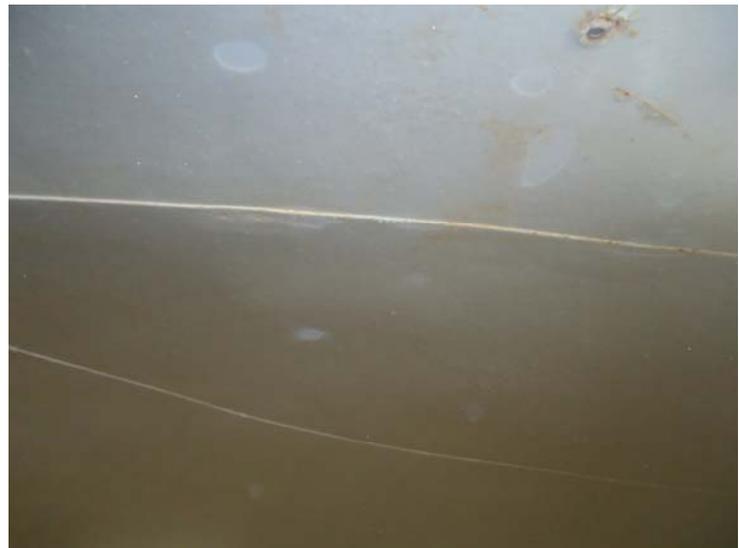
32. A small amount of coating failures and rust bleed through were found on the roof.

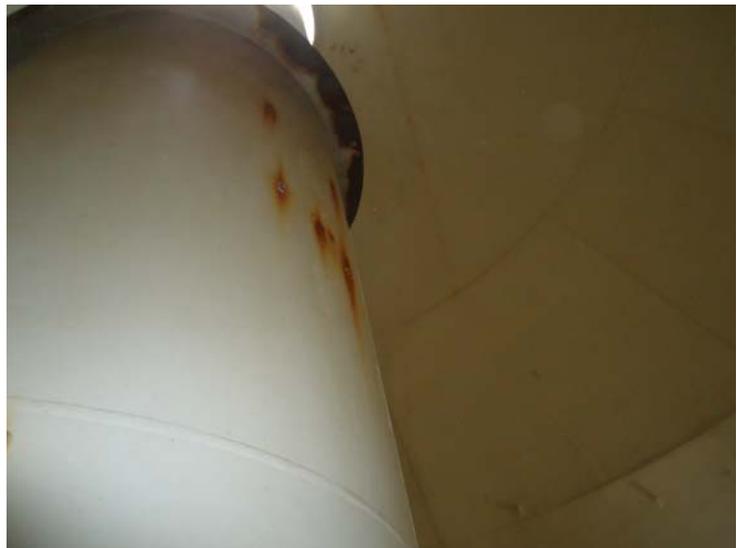
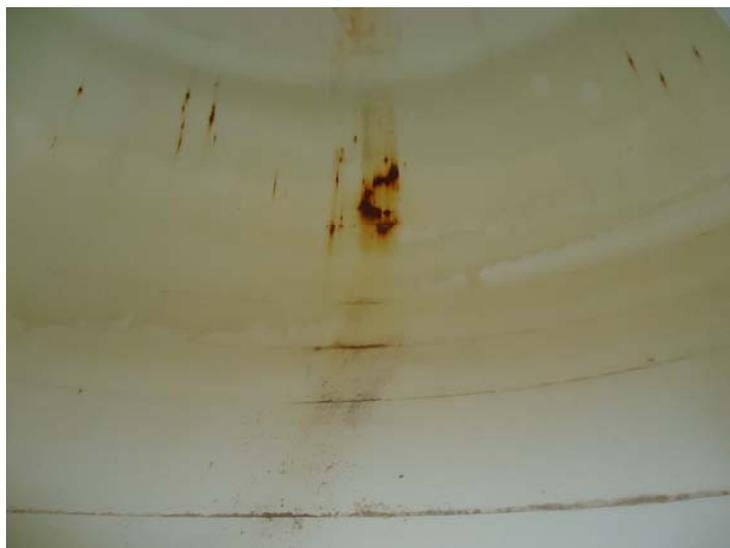
35. Spot coating failures are rusting at the top of the access tube.

36. A large area of coating failure is allowing rust to form on the sidewalls.

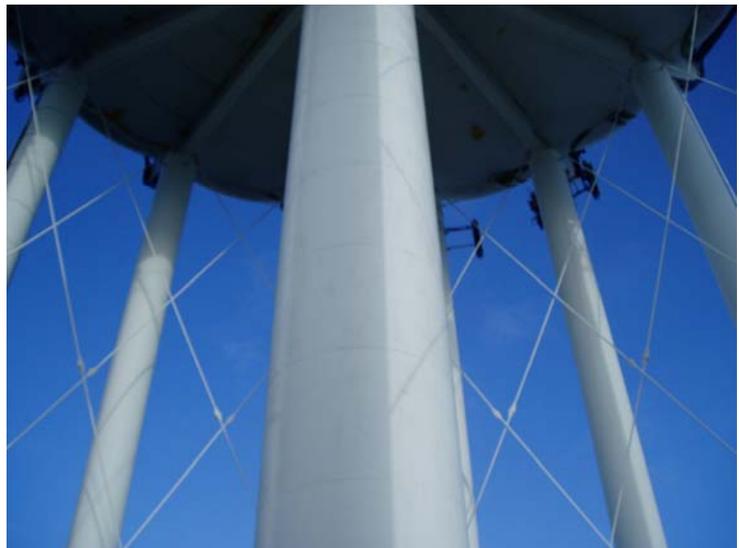
9. The exterior riser coating is in poor condition. The coating is chalking, fading, and eroding.

10. There are spot coating breaks to the substrate with rust undercutting.

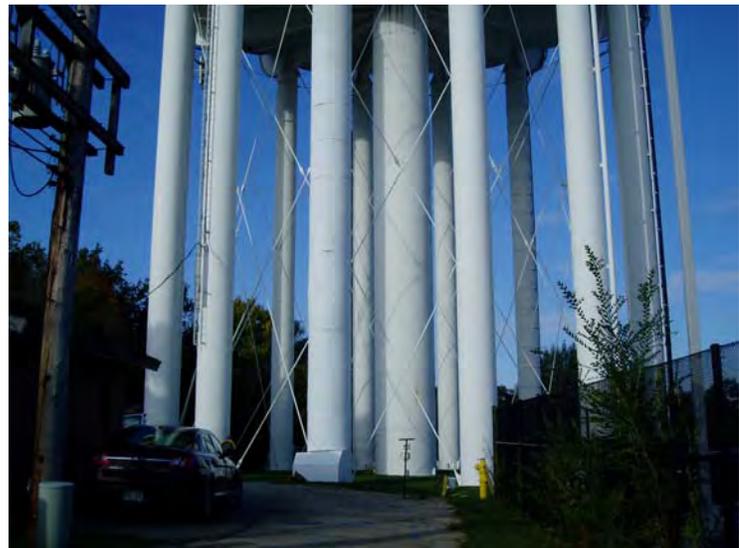
21. The exterior leg coating is in poor condition. The coating is chalking, fading, and eroding. There is rust bleed through.

22. There are spot coating breaks to the substrate with rust undercutting.

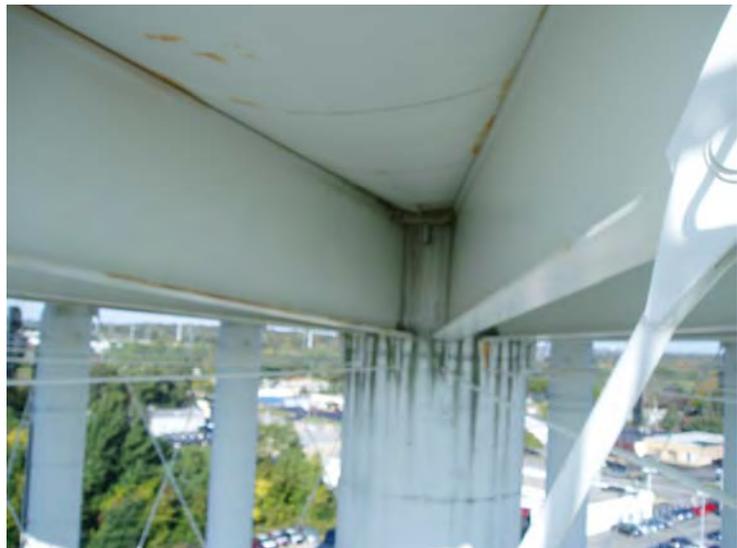
24. There are spot coating breaks to the substrate with rust undercutting.

25. There is rust bleed through.

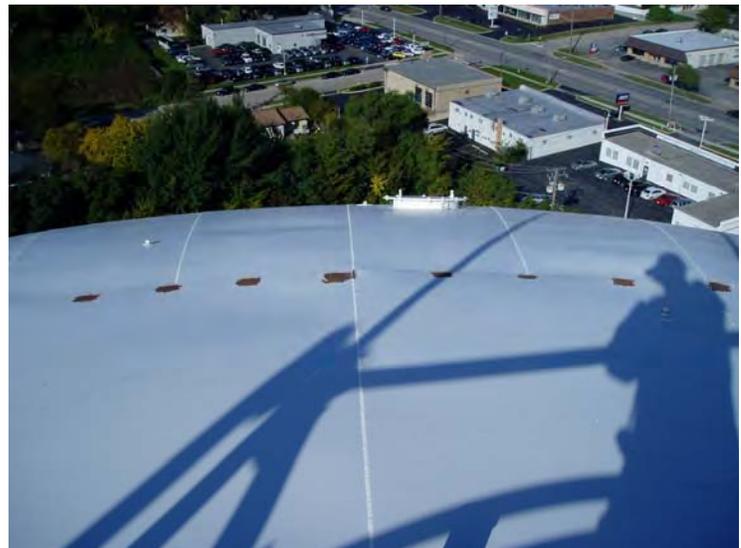
36. The exterior roof coating is in poor condition. The coating is chalking, fading, and eroding.

37. There is delamination and spot coating breaks to the substrate with rust undercutting.

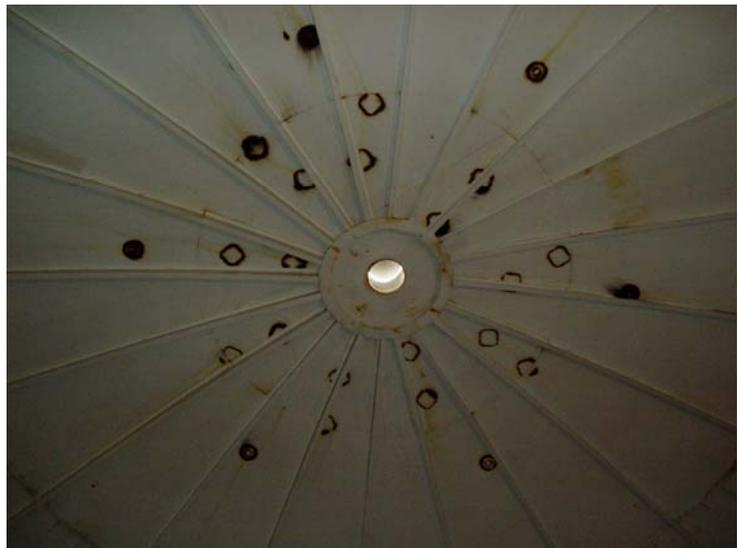
39. The wet interior roof coating is in fair condition overall. There is rust bleed through and weld burns.

40. The wet interior sidewall beam is in poor condition. Sections of the beam are torn loose and scratching the sidewall and bowl coating. The beam coating is in fair condition.

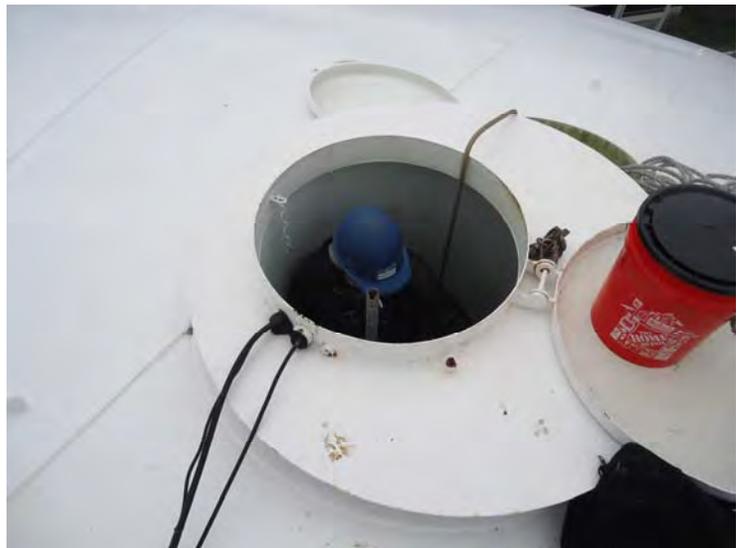
13. The access tube air gap cover does not seal the air gap properly.

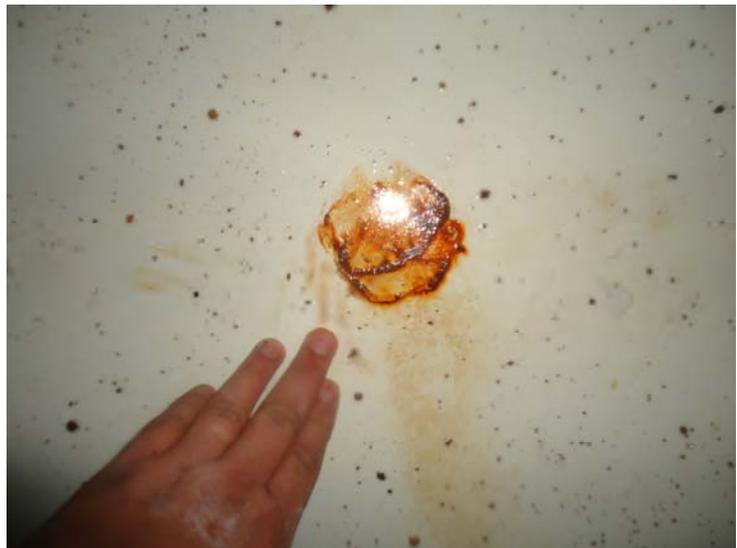
33. Spot coating break on the wet interior floor.

34. The fill pipe has old cathodic deposits around the neck.

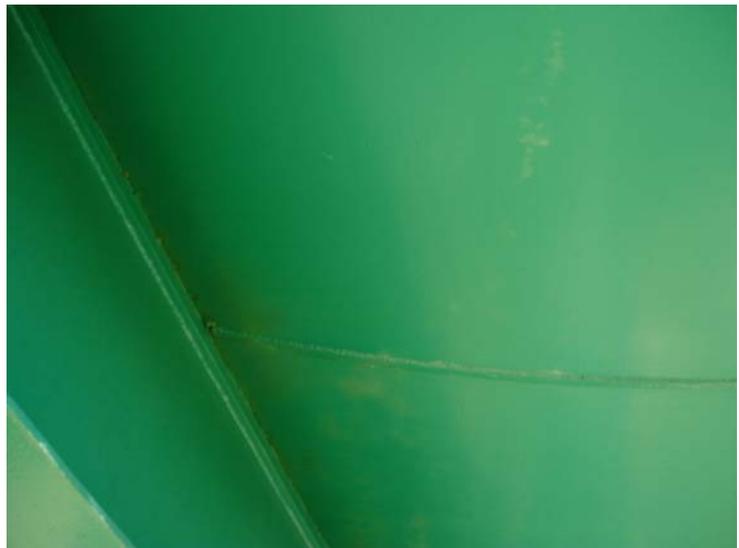
21. There is topcoat delamination.

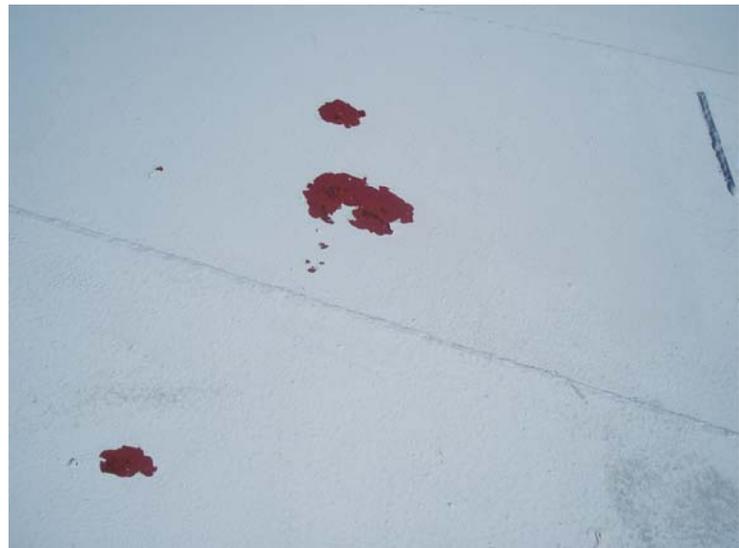
36. There is topcoat delamination.

37. There are areas of rust bleed through and spot coating breaks to the substrate with rust undercutting.

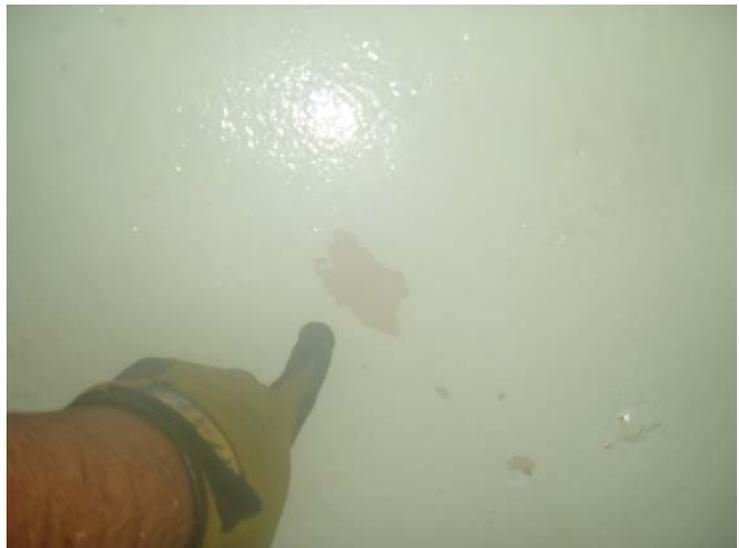
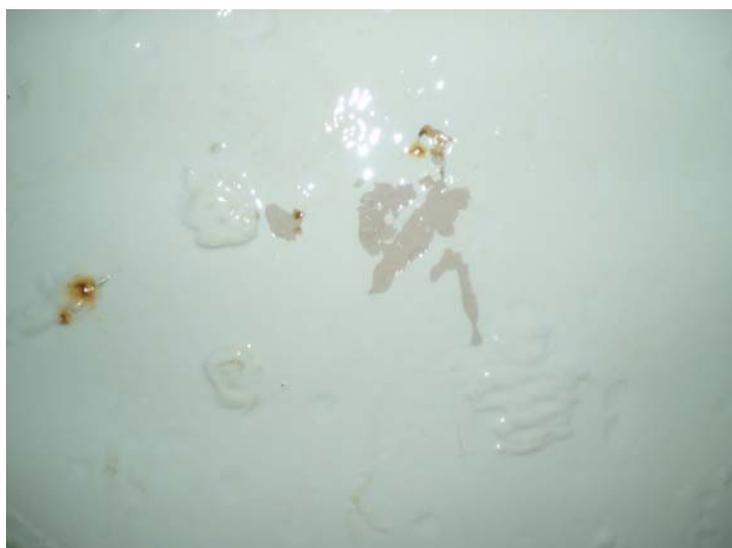
48. There is topcoat delamination.

49. There are spot coating breaks to the substrate with rust undercutting.
