# St. Joseph Creek Streambank Study

Village of Downers Grove, Illinois

CBBEL Project No. 150068

July 2015

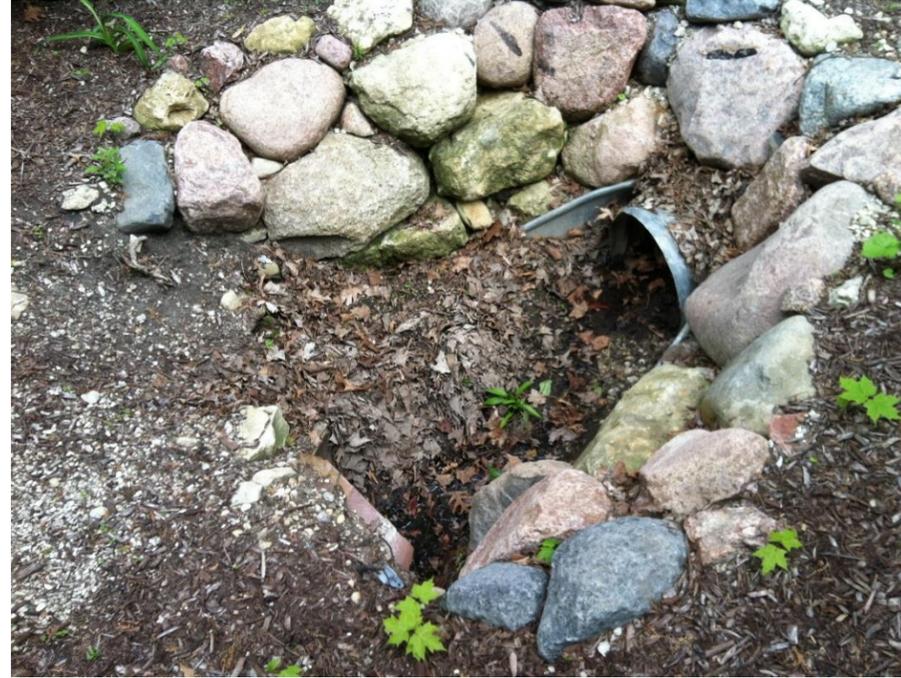
208M

Sheet 12 shows the southwest tributary to St. Joseph Creek (1801+00 to 1817+00) from Sheet 11. This headwater tributary originates at a pond on private residential property. Representative photos are 12A-D. Only one Japanese knotweed location was observed at 209JK. Only one erosional issue was observed at 207S with minimal erosion. Only one maintenance issue was observed at 208M. Access to this tributary is through residential property.
