**Staff Report: April 18, 2013 Flood Event
Prepared July 1, 2013**

I. Executive Summary

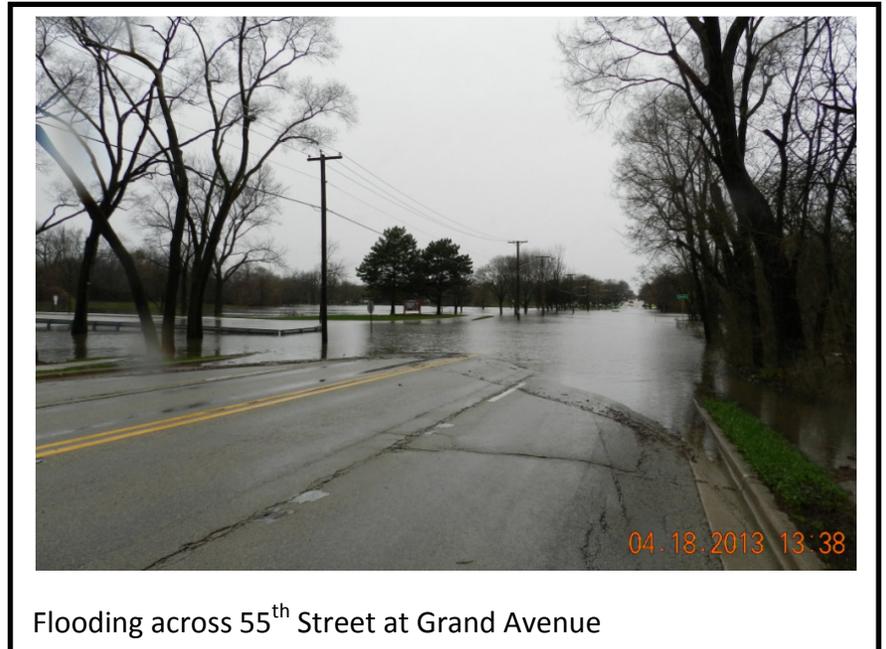
Flooding across 55th Street at Grand Avenue

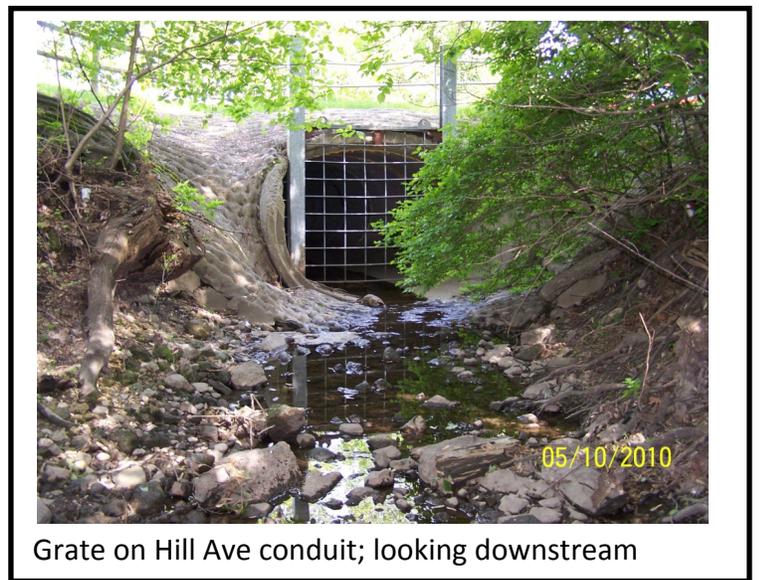
The photo of the grate on Hill Avenue shows that it is a vertical grate at the face of the culvert. It is recommended to revise the grate design to be at a slope, rather than vertical, to allow for debris to be easily pushed up the grate by flowing water. This design also aids in quicker debris removal by Public Works crews during storms.

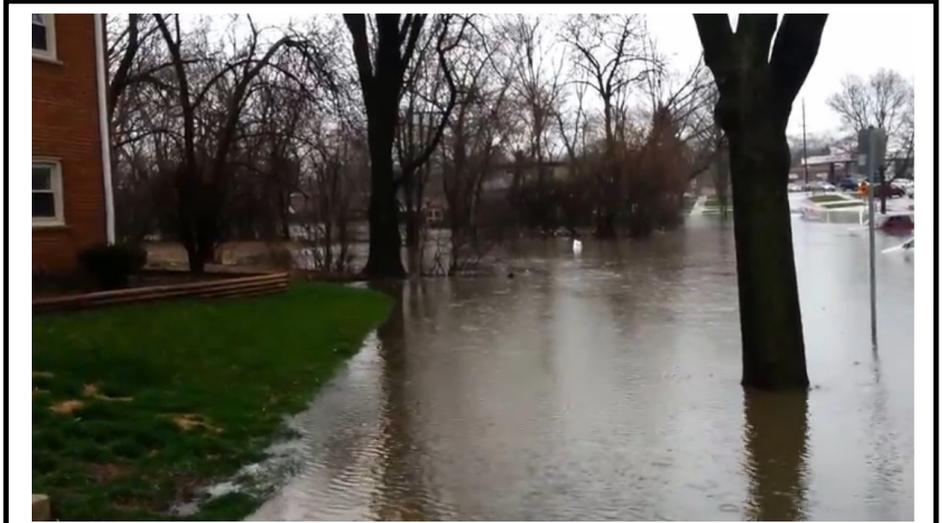
Rogers Street at creek, flood elevation approximately 721.4'

the flood waters encompass the commercial properties south of Rogers Street. The road overtopped during the April 2013 storm event. Surveyed watermarks at the southwest corner of Maple Avenue and Rogers Street indicate that the elevation of flooding was approximately 721.4-ft. The FEQ 100-yr flood plain elevation for this area is at approximately 721.53-ft, indicating that the inundation of flood waters south of Rogers Street during the April 2013 storm event is directly related to the flood plain of the northeast tributary of St. Joseph Creek.

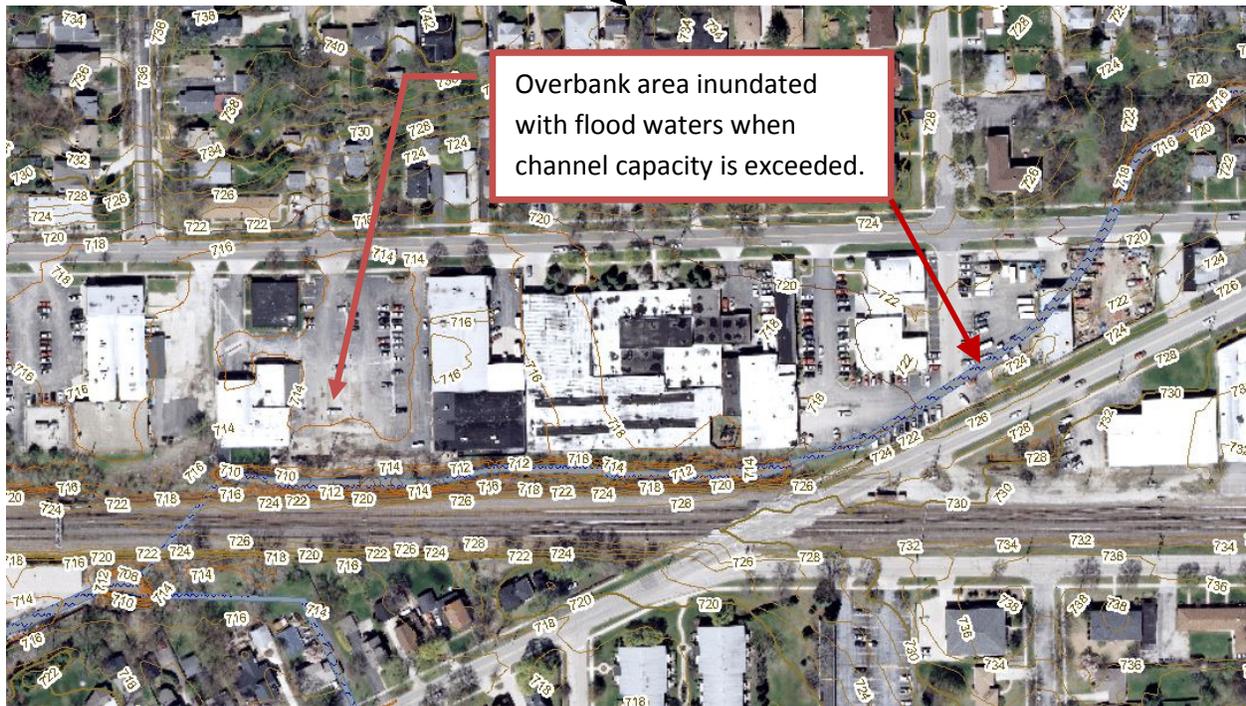
At the downstream outlet to the Rogers Street conduit it discharges into a narrow channel that runs along the north side of the railroad tracks. Once the capacity of this open channel is exceeded, the flood waters come out of the channel banks and into the overbank area which includes parking lots and buildings along the north side of the tracks.

Overbank Flooding Area: Upstream of BNSF Culvert

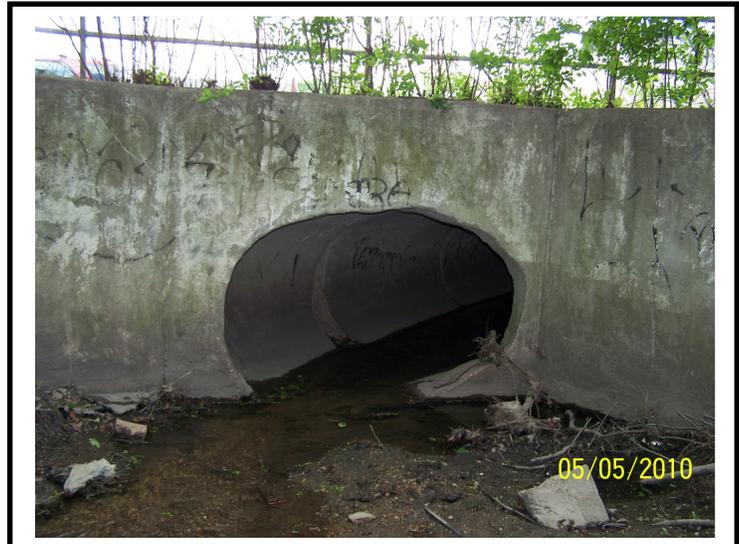
The concrete conduit at Rogers Street is an elliptical pipe with a 6' span and 4' rise. The pipe has the capacity to convey approximately 86-cfs. During the 100-year storm event there is approximately 638-cfs of flow at this location. The conduit does not have the capacity to convey this flow and therefore will overtop Rogers Street and flow southwest through the parking lots until it joins with the open channel at the outlet of the conduit. The conduit has the design capacity for the 2-yr recurrence interval, which is approximately 100-cfs in flow before it is no longer operating on gravity flow and is at risk of overtopping Rogers Street.

Rch7: just u/s Roger Road, view d/s

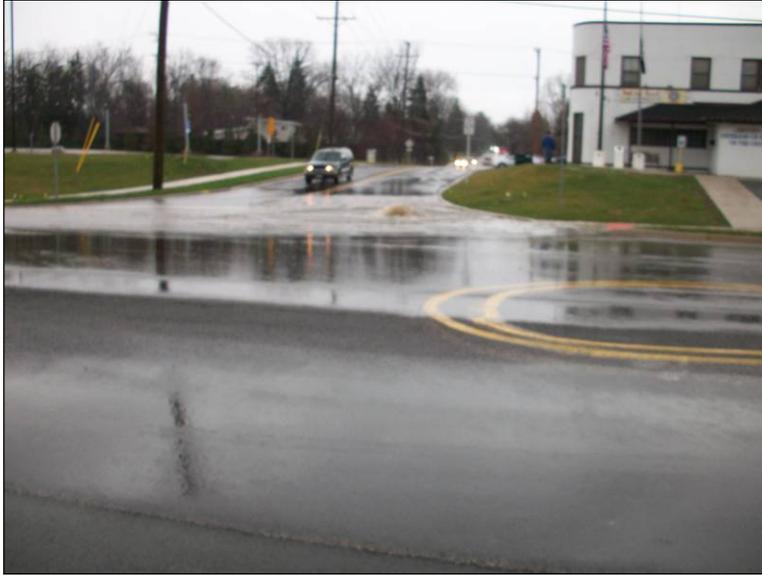
Photo 1 – Manhole “A” at the corner of Belmont Road and Hitchcock Avenue (looking east)

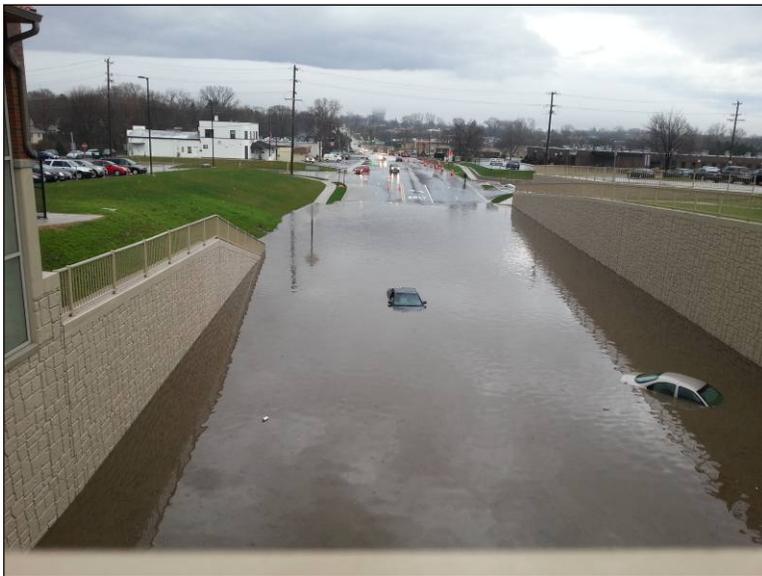
Photo 2 – Belmont Road underpass with approximately 3.5' of water

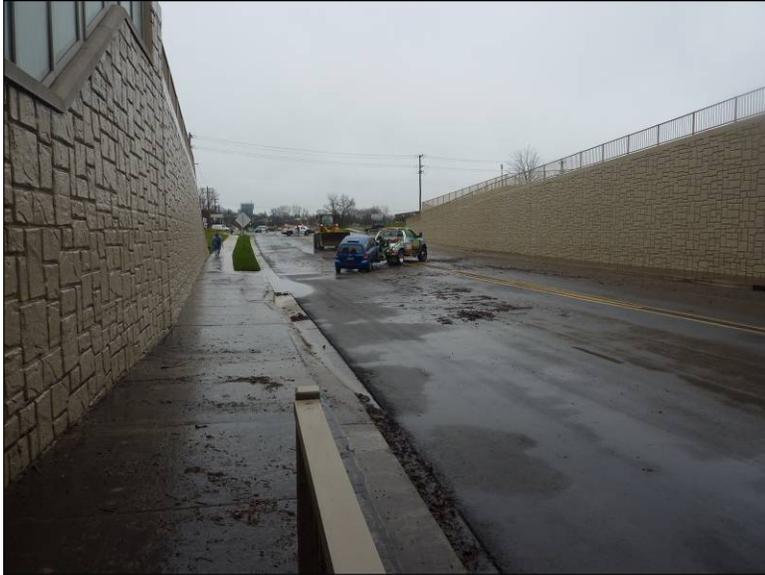
Photo 3 – Belmont Road underpass fully drained

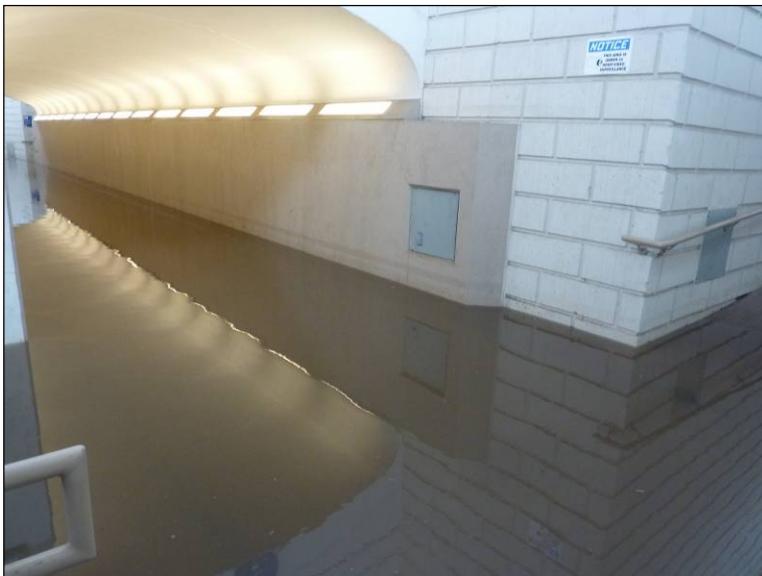
Photo 4 – Pedestrian tunnel with approximately 6" of water

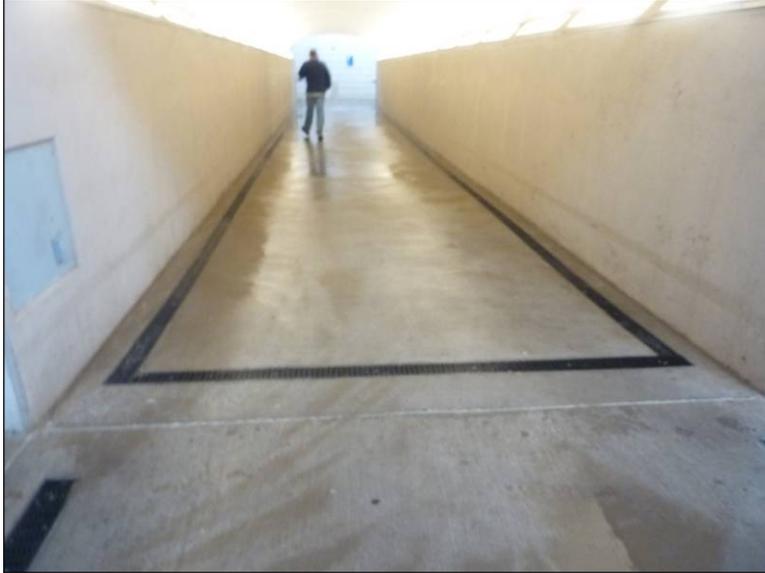
Photo 5 – Pedestrian tunnel fully drained
