# **Prentiss Creek Watershed**

## **Appendix 4A: Detailed Problem Areas**

**STORMWATER INFRASTRUCTURE IMPROVEMENT PLAN  
VILLAGE OF DOWNERS GROVE**

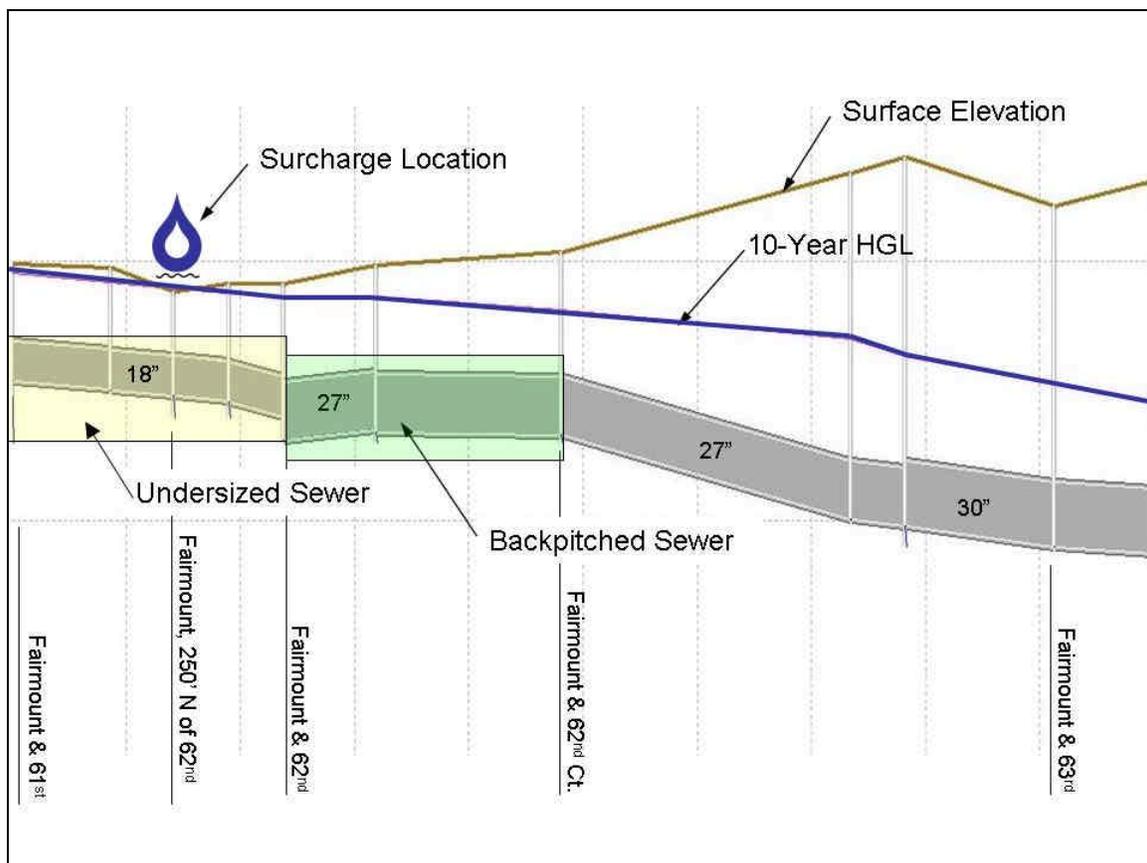
Figure 600-2  
Storm Sewer Profile and 10-Year Hydraulic Grade Line, Fairmount Avenue

Flooding occurs in this area because the storm sewer is increasing in elevation (is backpitched) at a location where the ground elevation is at its lowest. When the sewer was modeled assuming no restrictions downstream of 63<sup>rd</sup> Street, the hydraulic grade line was above the crown of the storm sewer for the segment along Fairmount from 61<sup>st</sup> Street to 62<sup>nd</sup> Street, but was still under the pavement. The portion of sewer from 61<sup>st</sup> Street to 62<sup>nd</sup> Street, which is 18-inch diameter, is undersized. Figure 600-2 illustrates the existing storm sewer profile along Fairmount Avenue.

Improvements should first be made to Problem Area 614. Even if the storm sewer along Fairmount through Problem Area 600 is upsized, there is still a restriction downstream that will cause flooding in the area. Problem Area 614 should be addressed first, which will then provide relief upstream.

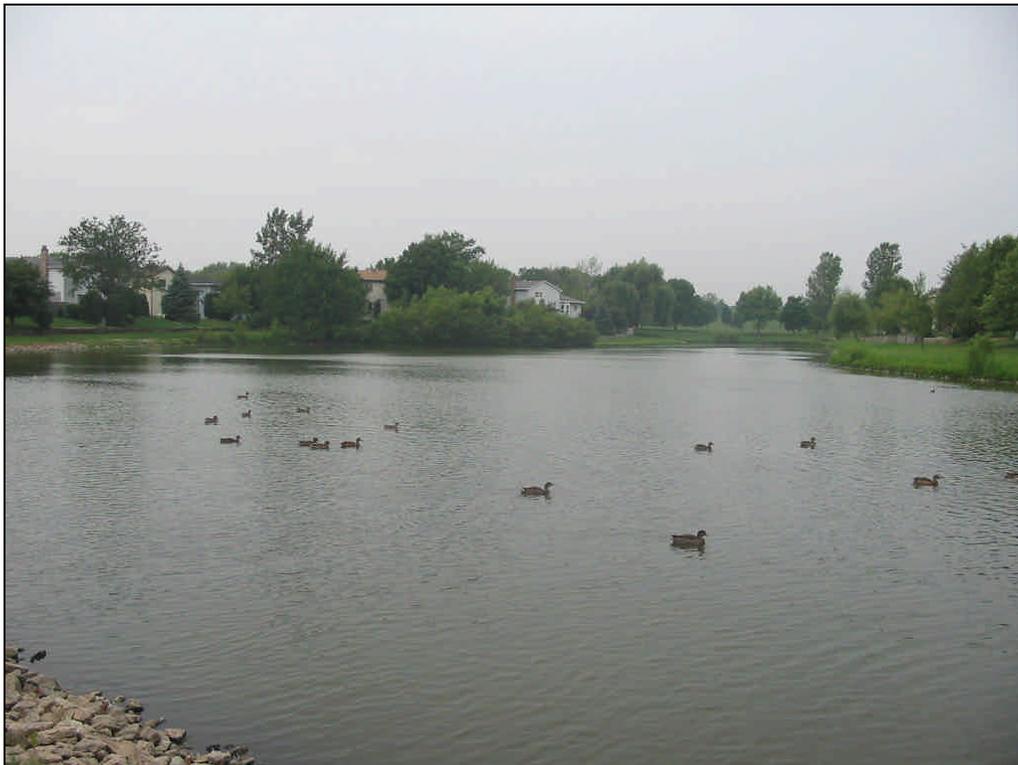
Figure 601-2  
View Looking West, O'Brien Park Pond

In most locations around the pond perimeter, there are no natural banks. It is common for lawns to end at the banks, which consist only of a rocky shoreline. Waterfowl will congregate along unvegetated banks, since the lack of vegetation equates to a lack of cover in which their predators can hide. The pond banks are thus welcoming to the waterfowl, which residents find to be a nuisance.

- 1.1. Add a Sediment Forebay. A forebay should be provided at the east inlet to filter out sediment prior to discharge to the main pond. Typical design standards recommend sizing the forebay to hold 0.1 inches of runoff per impervious acre of contributing drainage, and should be 4 to 6 feet deep. The forebay should be a separate cell with a barrier, such as an earthen berm, dividing the forebay from the pond. This keeps the nutrient-laden sediment contained and easier to remove during pond maintenance.

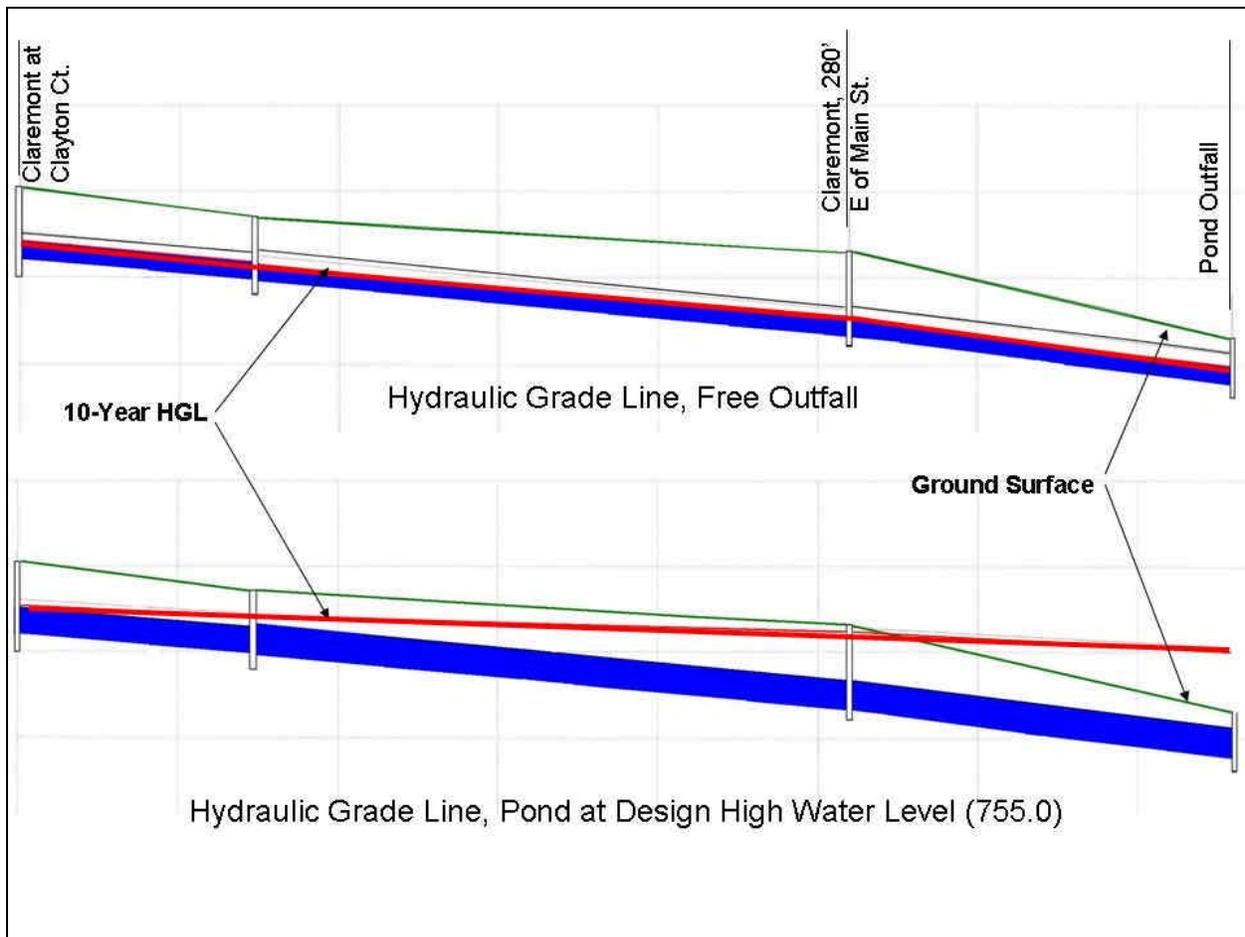
Figure 602-3  
10-Year Hydraulic Grade Line, Claremont Drive to Pond Outfall

The 100-year design high water level of the Spring Green Village detention pond is 755.0; the rim elevation of the structure on Claremont Drive upstream of the pond (first structure east of Main Street) is 756.65. Thus, when the pond is full the hydraulic grade line of the 21-inch storm sewer into the pond is above the crown of the pipe, and there is no capacity left in the pipe. This would potentially cause flooding at this location. Figure 602-3 illustrates the 10-year hydraulic grade line in the system based on whether the Spring Green Village detention area is dry or at the design high water level.

The structure located on Claremont Drive (280 feet east of Main Street) is at the low spot along the Claremont Drive street profile. Any overland flow which is not intercepted by an upstream inlet would collect at this spot. Additionally, residents have complained about debris collecting at the grates, decreasing their inlet capacity.

- 1.3. Inspect detention pond outlet structures to verify the ponds have a proper outlet. Partially clogged (or damaged) outlet structures may result in high water levels above the intended design, which impacts the sewer performance at Claremont Drive. This inspection may need to include a portion of the receiving 54-inch trunk storm sewer downstream of the Spring Green Village detention pond.

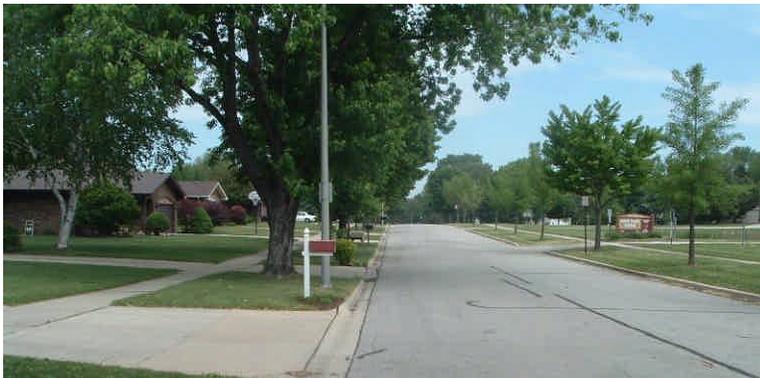
Figure 603-2  
Area of Flooding, 6700 Block  
Saratoga Avenue

Additional inlet structures need to be installed to intercept the overland flow. A site visit confirmed that only one inlet structure exists on Saratoga Avenue to intercept all the flow from the east. This inlet is overwhelmed during heavy storm events, leading to adjacent street flooding. Additional inlets should be placed in the yards and streets in the overland flow path.

To remedy the flooding in this area, overland flow should be attenuated and intercepted upstream of Saratoga Avenue. The following methods are recommended:

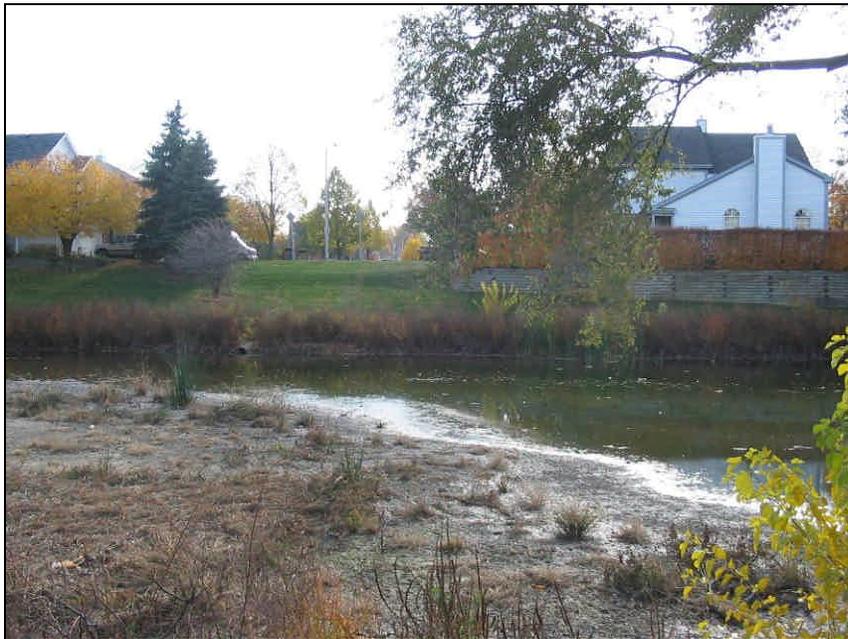
Figure 604-2  
Sedimentation in In-Line Retention Pond

The in-line retention pond along Prentiss Creek, located downstream of the Prentiss Drive crossing, accumulates sediment. When water drops to the level of the weir under Woodward Avenue, the deposited sediment can be seen at the surface, which leads to increased odors and an unsightly view for the neighboring residences. Also, the water in Prentiss Creek flowing into the retention pond is stagnant during baseflow conditions.

To better use the retention area downstream (north) of Prentiss Drive, it is recommended that it be converted from an in-line pond to an off-line pond.

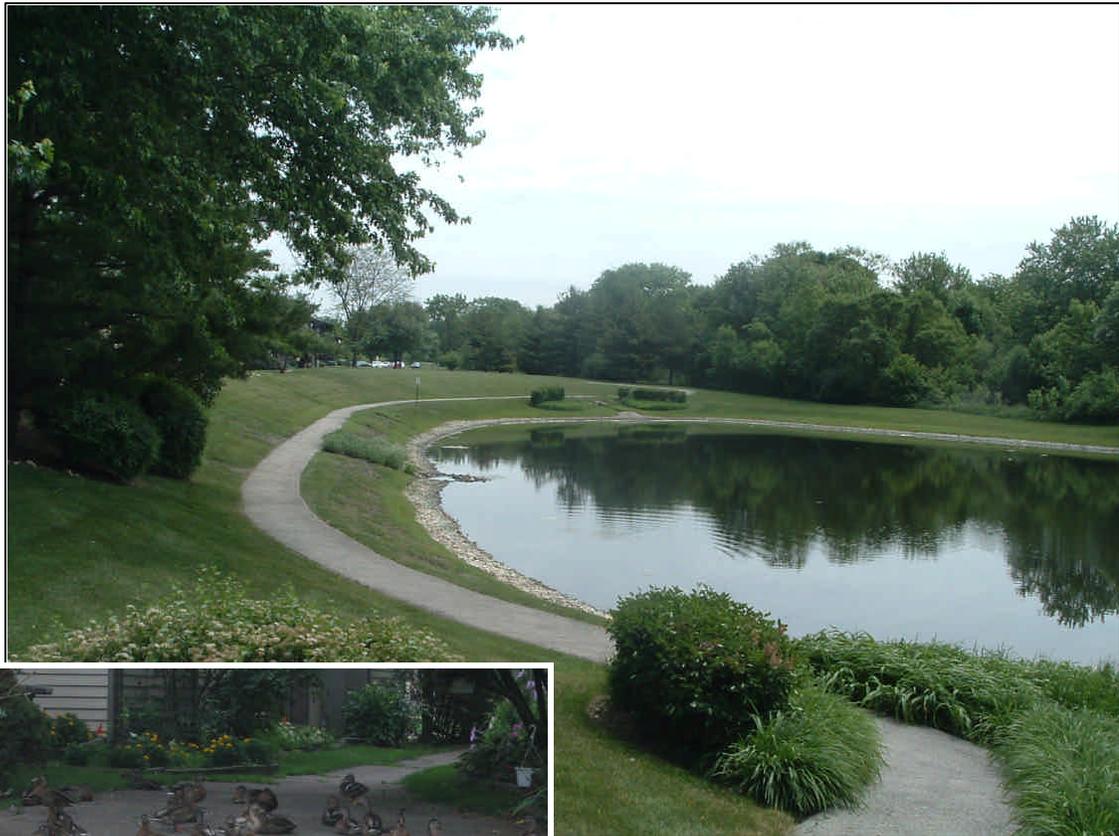
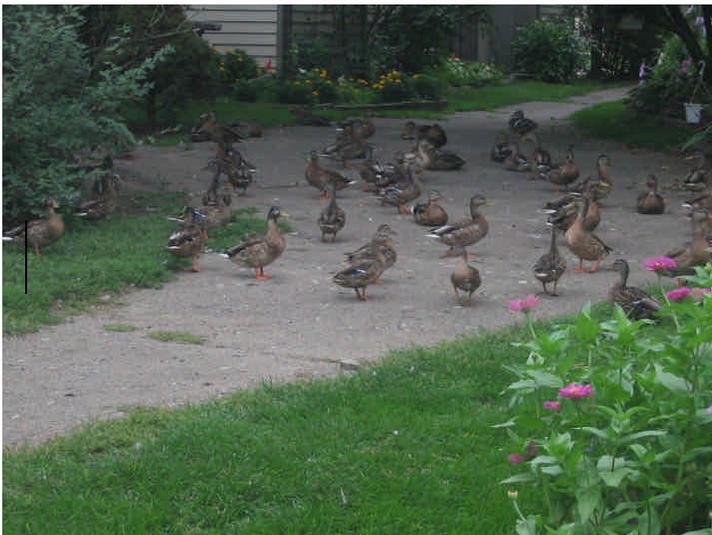
Figure 604-3  
Retention Pond with Unvegetated Banks

The banks of the retention ponds in the subbasin, although stable, are steep (roughly 4:1 side slopes). A buffer zone is located around the retention areas, and is typically mowed. A common complaint from residents bordering the retention areas is the excess of goose droppings. The banks of the ponds are a favorable habitat for waterfowl, because they tend to frequent areas with a lack of bank vegetation to hide their predators.

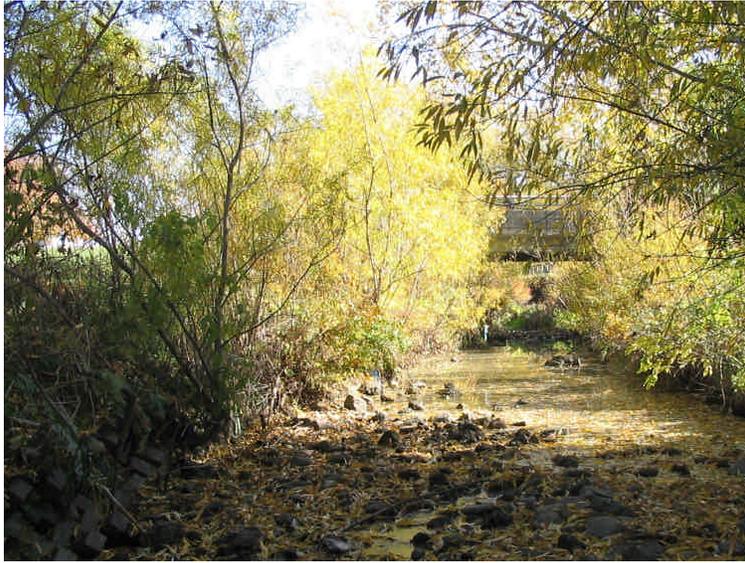
Figure 604-4  
Overgrown Willow Stalks along Banks of Prentiss Creek

Prentiss Creek was stabilized using lunkers, coir rolls and ajax approximately 10 years ago, and the stabilization appears to be holding up in most locations. There is little erosion along the banks, with a few exceptions. During the stabilization work, willow stakes were planted to provide root structure, which stabilizes the banks. Typically, the willows need maintenance over the years, and are supposed to be trimmed so that they do not overwhelm the banks and shade the creek. The willow stakes along Prentiss Creek have become overgrown, and need to be cut back.

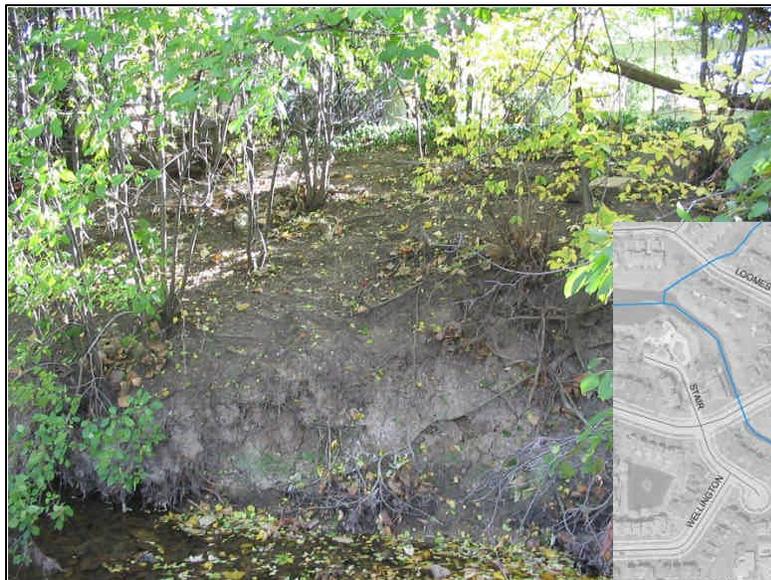
Figure 604-5  
Bank Erosion along Prentiss Creek

One area along Prentiss Creek, that was not previously stabilized, does have some bank erosion. The eroded bank is located at the inside of a meander, where velocities are relatively high and scour occurs. This section of erosion does not warrant immediate attention, because there is a large buffer between the creek and any residences, but still provides a safety hazard and water quality concern, and may become a future problem.

For these locations, toe protection is recommended to prevent further erosion and subsidence of the bank. Willow stakes can be planted to help establish vegetation.

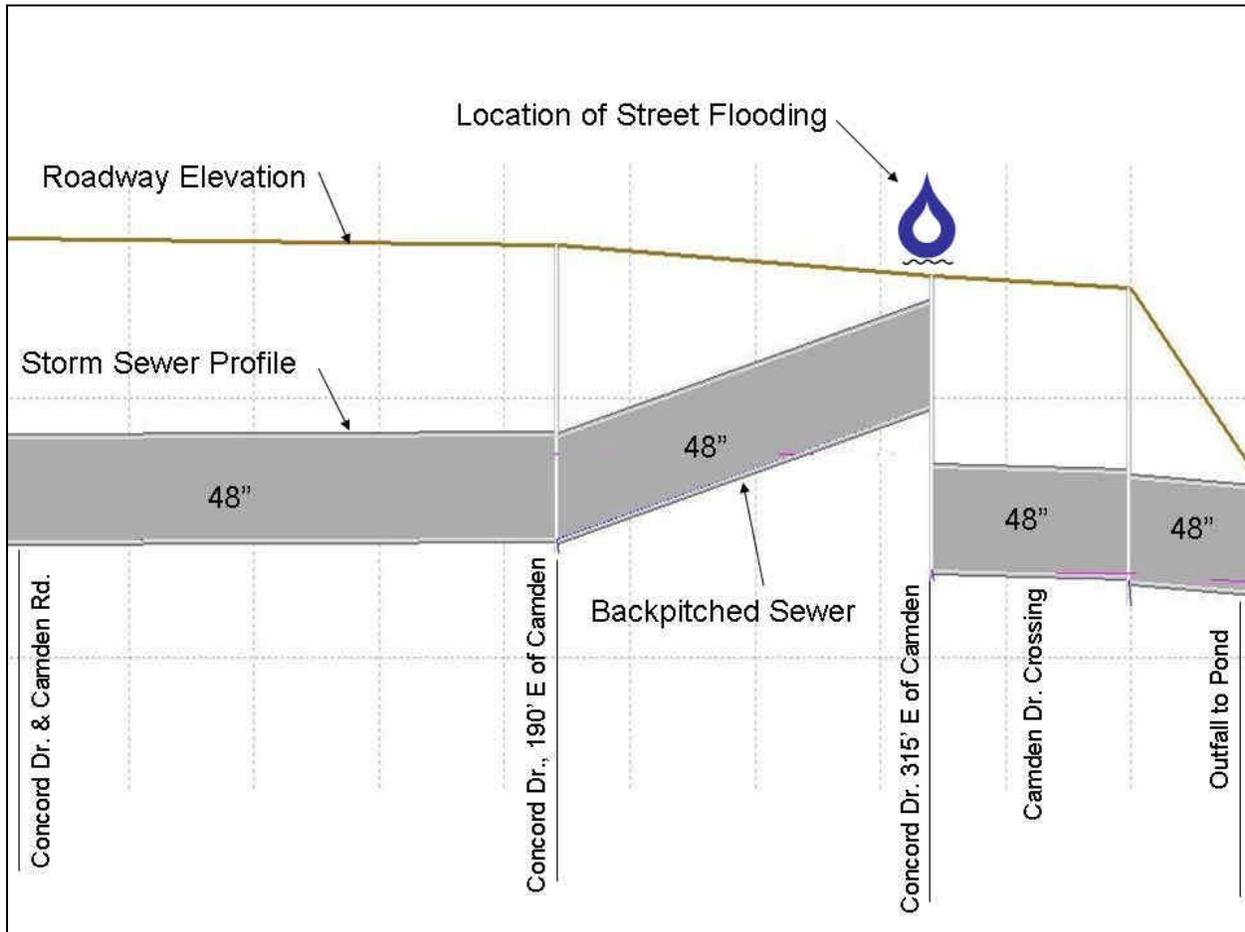
A survey was completed of the major storm sewer in the area. It was found that there is a severely backpitched pipe just east of the intersection of Camden Road and Concord Drive. This is for the likely cause of the flooding at this intersection. Figure 605-2 illustrates the storm sewer profile along Concord Drive.

Figure 605-2

Storm Sewer Profile along Concord Drive from Camden Road to Pond Outfall

The 48-inch storm sewer on Concord Drive is severely backpitched and causing flooding; this segment of sewer should be replaced. Prior to this project, the Village should verify whether a utility conflict would prevent such an improvement. *It may be possible that a major utility conflict during construction of this sewer resulted in the current backpitched scenario.*

If the storm sewer is truly backpitched as the survey suggests, this is likely to have caused sedimentation in the line. It is recommended that the storm sewer be cleaned to remove sediment.

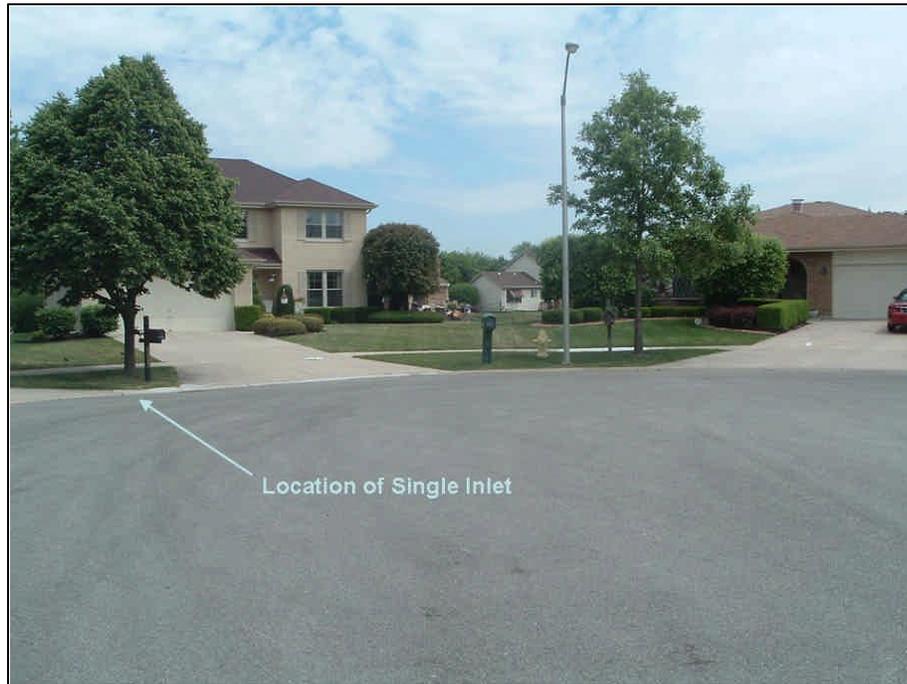
Figure 605-3  
Looking Northeast  
along Penner Place

This problem area has relatively steep slopes and many overland flow paths which flow through residents' yards. Bushes, fences, and other similar obstructions impede the flow of water through the properties, contributing to yard flooding. Also, there are some small depressional areas throughout the yards which collect the stormwater, which takes a long time to infiltrate due to high groundwater levels.

property, and potentially affect residential structures. Figure 605-3 shows the Penner Place cul-de-sac.

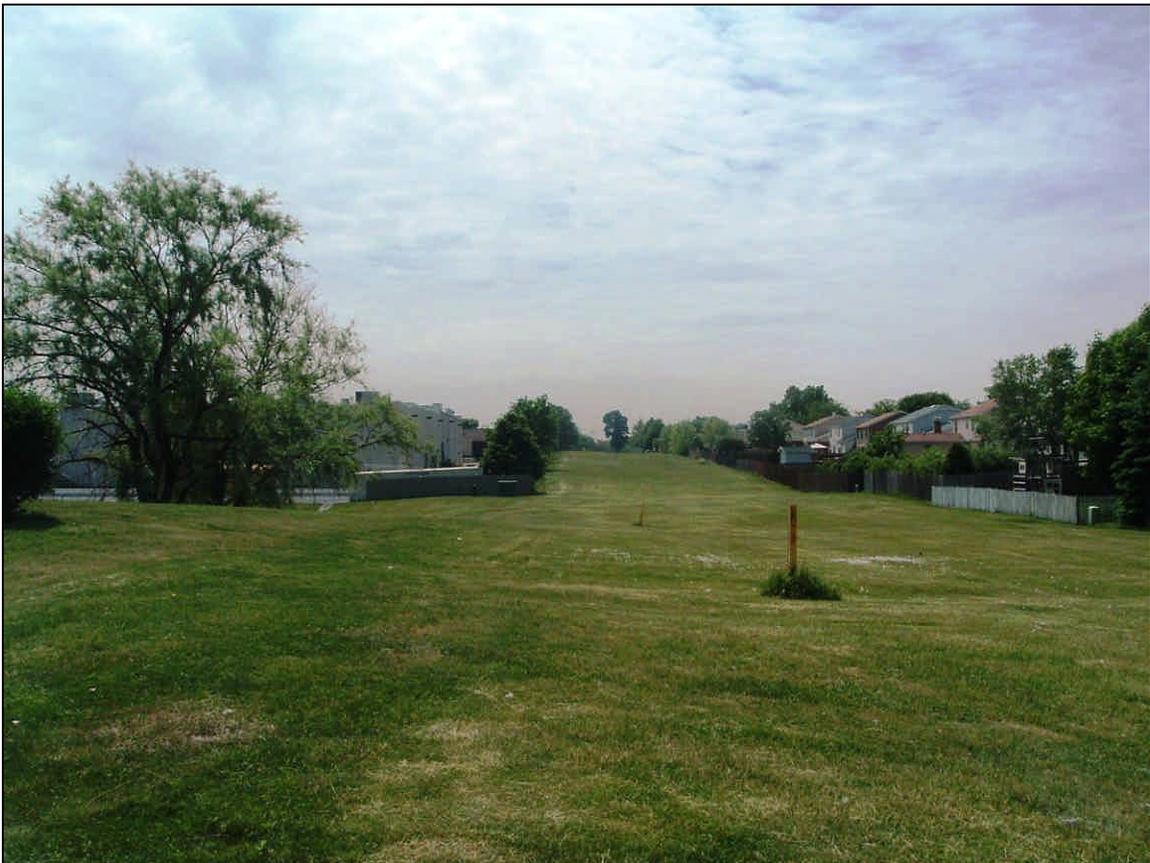
Figure 606-2  
Nicor Gas Utility Easement located west of Springside Avenue

The Nicor easement drains northerly with an average slope of 0.8%. The land generally slopes towards the Dunham Place detention pond; however, the land does slope slightly east in some areas, towards the homes along Springside Avenue. There appear to be electrical boxes along the property lines of each residence; some of these boxes would be in the overland flow path. The land is fairly undulating in this easement, so there are occasional small depressional areas. There is also a high water table in this area, which prevents stormwater infiltration and promotes ponding in areas without direct access to storm sewers.

A maintenance program is recommended to clean out clogged grates. It is likely that the main source of street flooding is debris over the grates; the locations with reported flooding are at the far upstream end of the sewer system, so the problem is not likely to be sewer capacity.

The addition of extra inlet structures with non-clog grates is recommended at the intersection of Springside and Richards Avenues. According to preliminary calculations, the existing sewer has adequate hydraulic capacity to convey the higher flow rates resulting from additional inlets.

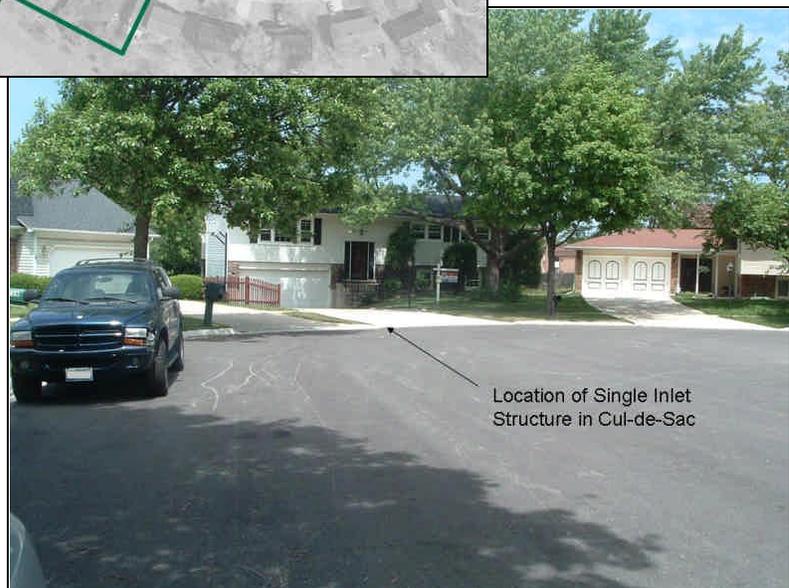
Figure 607-3  
Location of Street Flooding

Residents have reported street, house, garage and yard flooding on Oxnard Drive. Interior house damage and associated property damage was reported after the October 2, 2006 storm event. Residents have indicated that water ponded and overtopped the curve in the cul-de-sac.

The natural overland flow path in this area flows towards northern end of Oxnard Drive. If the inlets at the intersection of Midhurst Road and Oxnard Drive are at capacity, the flow would continue along Oxnard Avenue. The end of Oxnard Drive, which is on the northern end of the subdivision and ends in a cul-de-sac, has only one inlet. If this inlet is at capacity, water would overflow directly towards the property at 2222 Oxnard Drive. Figure 607-2 illustrates the overland flow paths in the area; Figure 607-3 depicts the area of flooding.

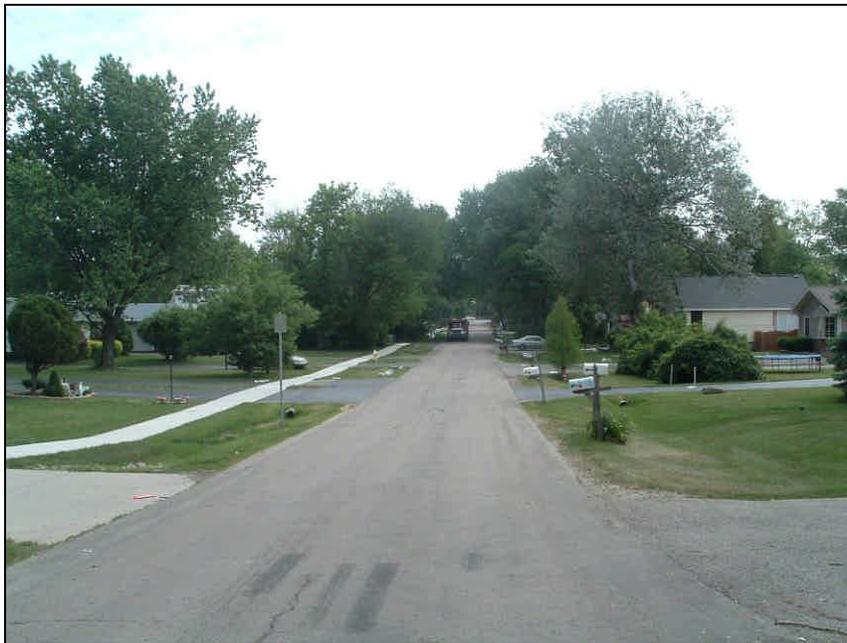
Figure 608-2  
Typical Roadway Cross Section (taken along Saylor Street)

This area does not have an effective stormwater conveyance system. The portion of the area in Subwatershed B generally flows east, but the ditch system is inadequate, particularly along Saylor Street, where numerous homes report yard and structure flooding. The portion of the area in Subwatershed C has some storm sewer along Carol Street, but a survey of this sewer system found that there is a backpitched section of sewer on the western end of Carol Street, in the vicinity of the low point along Carol Street.

Because of the proximity to storm sewers in this neighborhood and the severity of complaints, installation of curb and gutter with storm sewers is recommended along Saylor Street. A storm sewer would run easterly along Saylor Street, tapping into the storm sewer at Main Street and Saylor Street, which ultimately ties into the 66-inch storm sewer system along 67<sup>th</sup> Street.

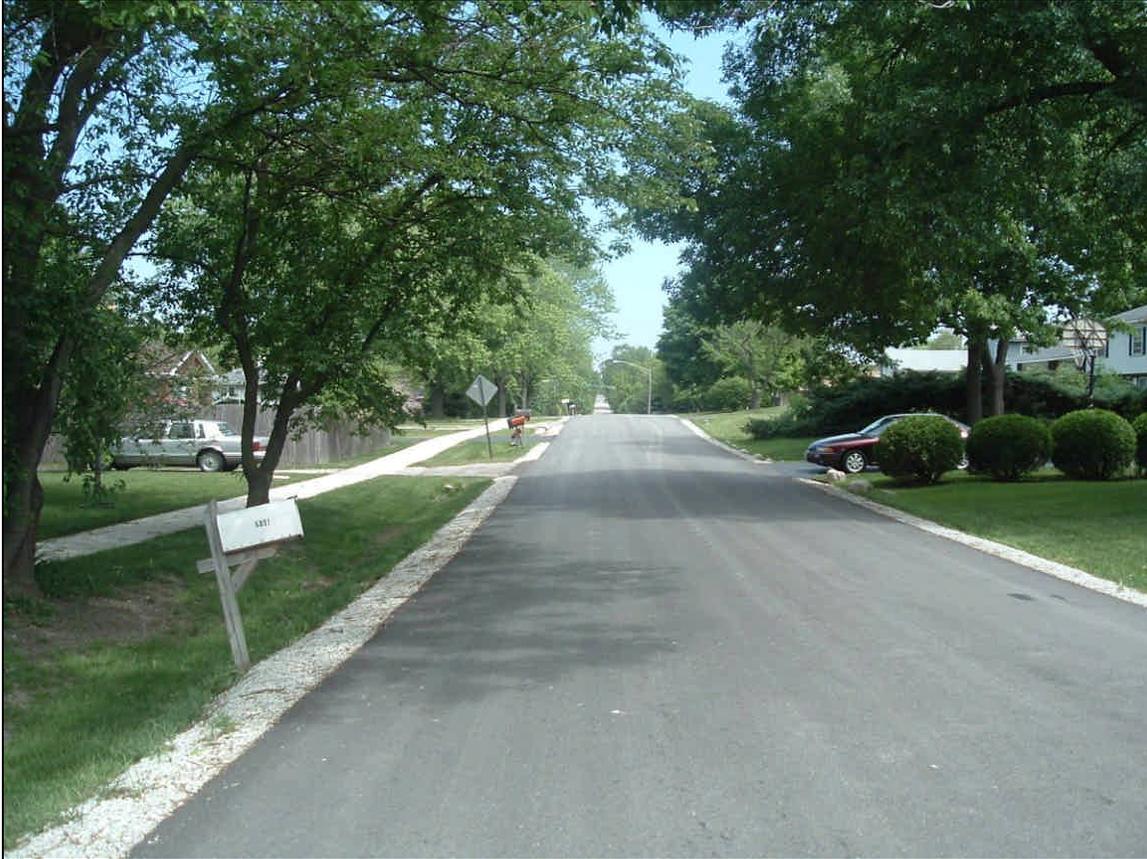
Figure 610-2  
Typical Existing Roadway Cross Section in Hobson Triangle

The roads in this neighborhood have a rural cross-section which, while contributing to a more rural feel, does not adequately convey stormwater flows. Additionally, this area contains septic fields. Water which ponds in the backyards of homes inundates these fields, adversely impacting private septic systems.

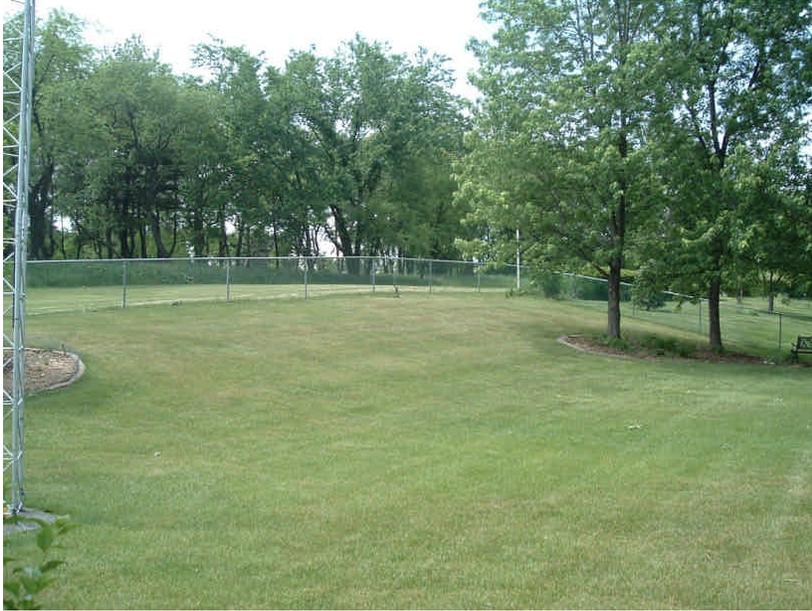
Figure 611-2  
Steep rear yard slopes drain towards residential structures

The main cause of flooding in this area is due to overland flow. Because of the steep slopes, stormwater runoff travels at a high velocity both through yards and along streets, making it difficult for existing sewer inlets to intercept a significant portion of the runoff. The homes on Oxnard Drive which have reported structure flooding are located in the natural flow path.

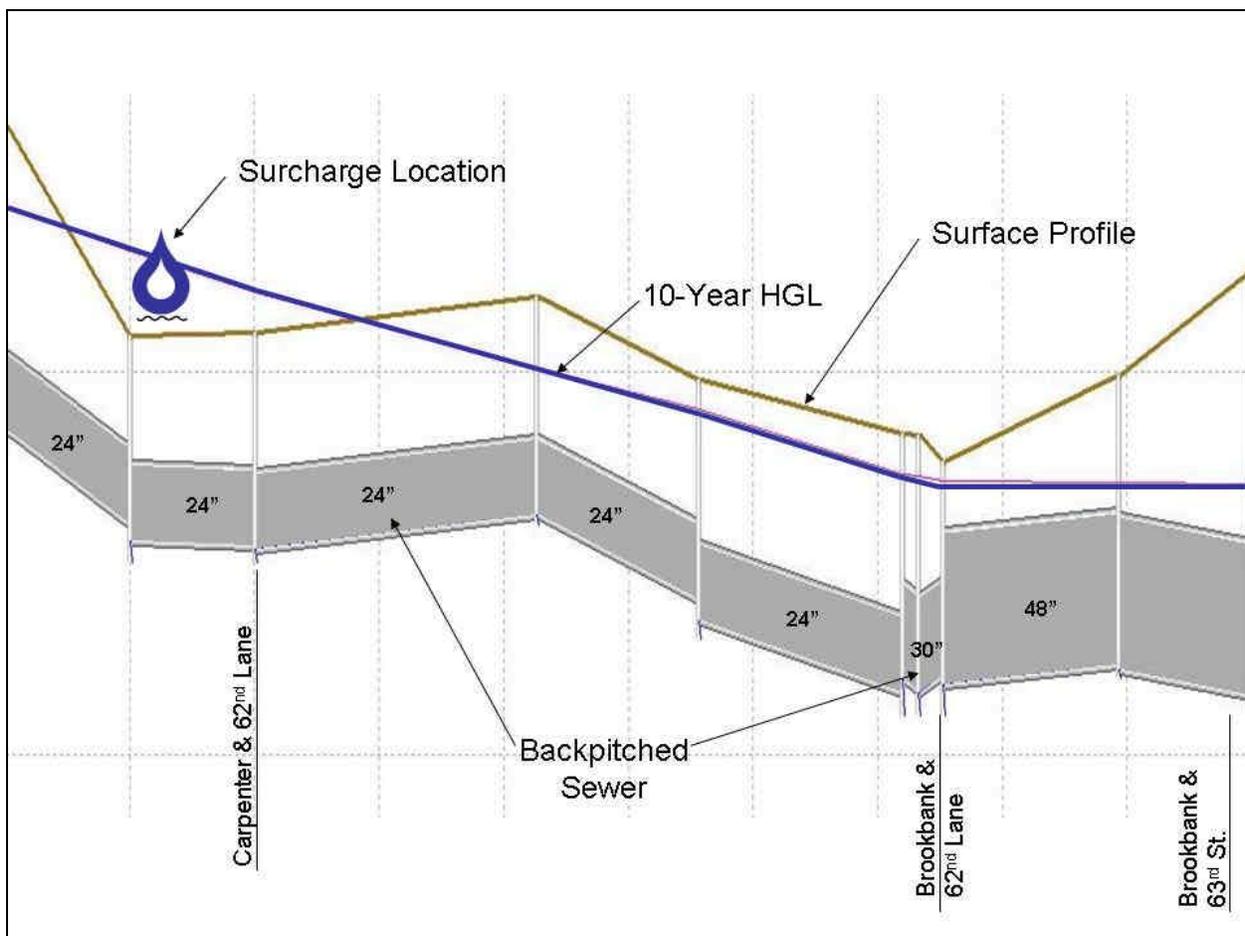
A survey of a portion of the storm sewer system showed that the sewer is backpitched near the intersection of 62<sup>nd</sup> Lane and Carpenter Street; this also happens to be the local low spot along 62<sup>nd</sup> Lane. Figure 613-2 depicts the storm sewer profile and 10-year hydraulic grade line of the storm sewer along 62<sup>nd</sup> Lane.

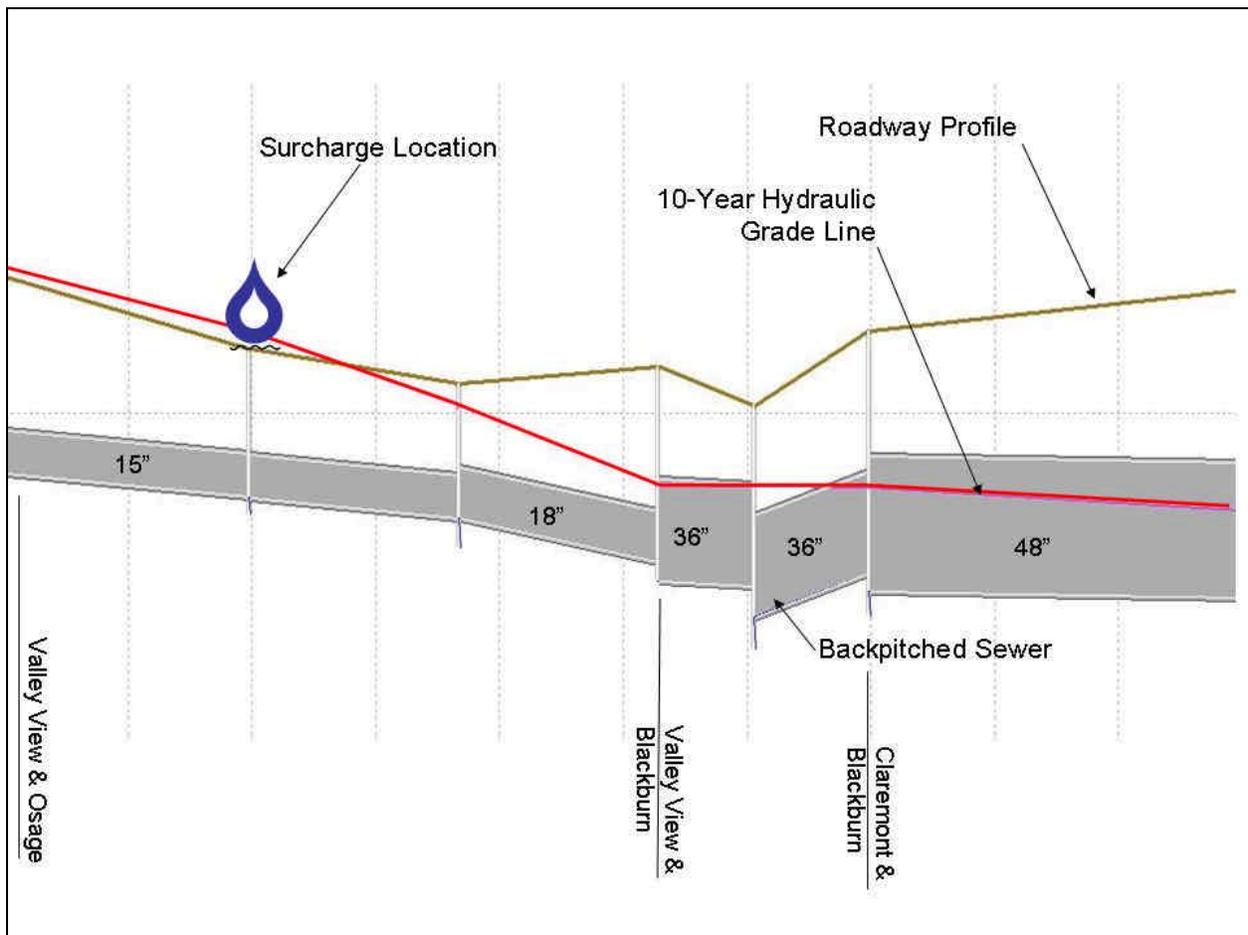
Figure 615-2  
Storm Sewer Profile with 10-Year HGL, Valley View Dr. to Claremont Dr.

Survey of the trunk line indicates that the storm sewer is backpitched just downstream of the flooding area at the intersection of Blackburn Avenue and Valley View Drive. Stormwater draining to Valley View Drive, a local low spot, will pond there until the sewer has capacity to drain the excess runoff. Figure 615-2 illustrates the storm sewer profile along Valley View Drive and Blackburn Avenue.

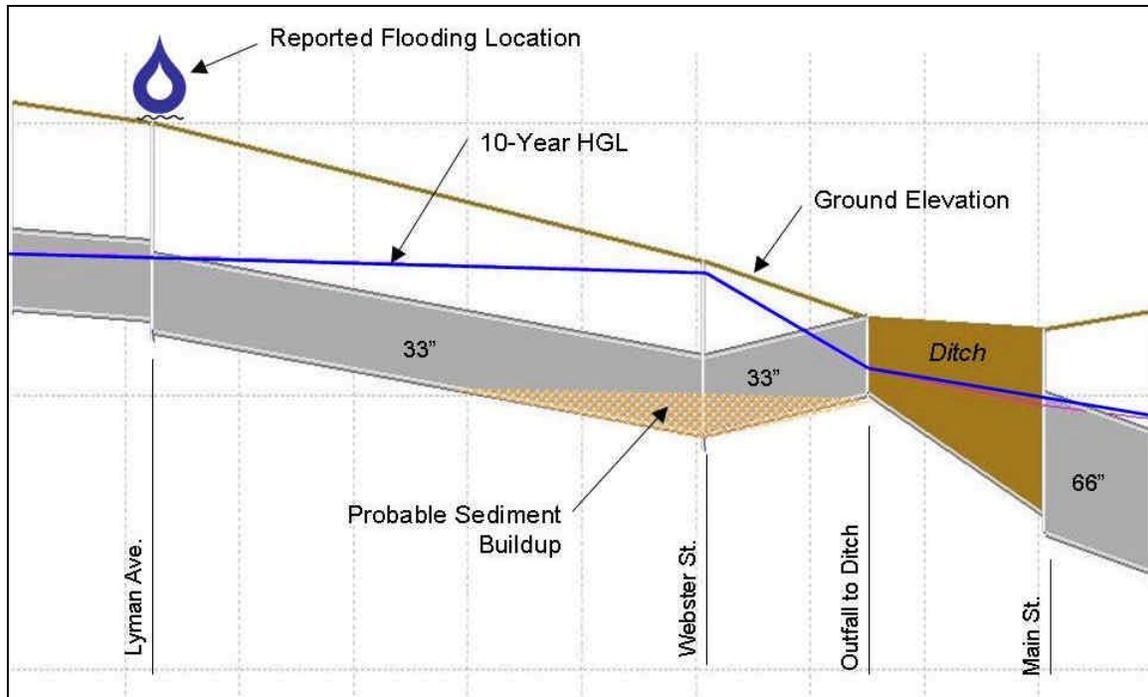
Figure 616-2

3 feet of standing water in the manhole on Webster Street immediately upstream of the end section. It is likely that this hydraulic restriction is causing a decrease in capacity in the upstream portion of the system. Additionally, the sedimentation is likely to have occurred due to the backpitched sewer, leading to a further decrease of capacity.
