# St. Joseph Creek Streambank Study

Village of Downers Grove, Illinois

CBBEL Project No. 150068

July 2015

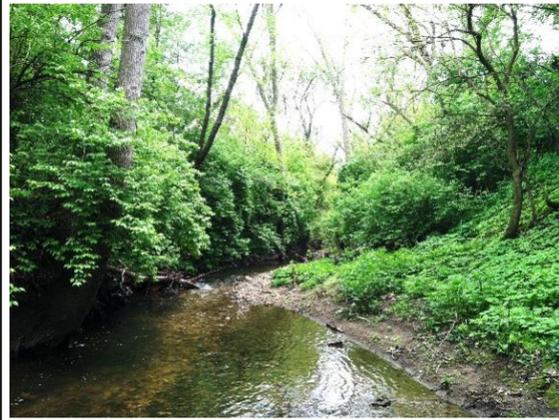
2A

This section contains the main stem of St. Joseph Creek (26+00 to 35+00) and was overall similar to Sheet 1. The conditions are similar, however there are more mature maple and cottonwood trees present on the banks (Representative Stream views 2A-2B). The riparian zone also

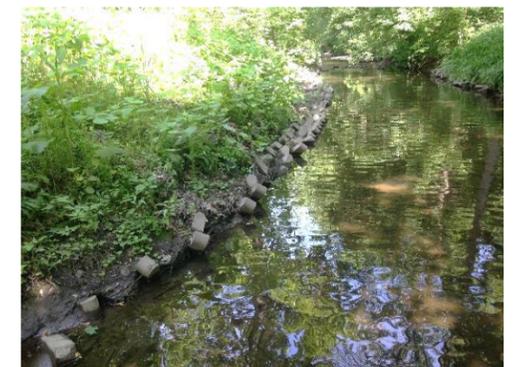
10B – View of Ajax

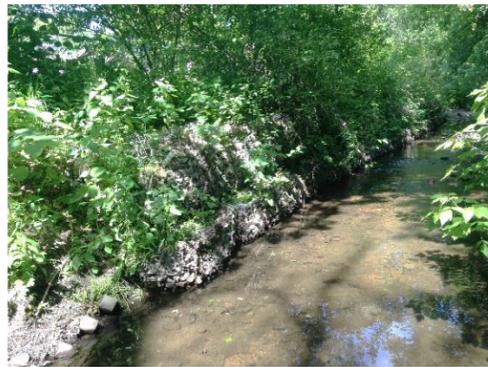
10B – View of Gabion Baskets

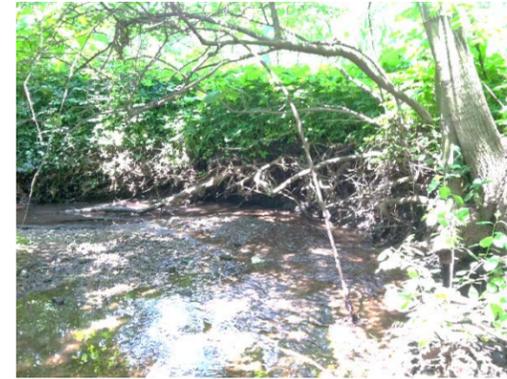
180S / 181S

13	180S	1903+30 - 1903+70	Mod	Stone Toe (2 Feet)	40	Linear Feet	\$250	\$10,000
13	181S	1903+50 - 1903+90	Mod	Stone Toe (2 Feet)	40	Linear Feet	\$250	\$10,000
13	182M	2000+40	Mod	Pipe Repair (Rock apron)	2	Cubic Yards	\$300	\$600
13	183S	2000+90 - 2001+60	Min	Stone Toe (2 Feet)	70	Linear Feet	\$250	\$17,500
13	184S	2002+30 - 2002+80	MIn	Stone Toe (2 Feet)	50	Linear Feet	\$250	\$12,500
13	185S	2003+90 - 2004+20	Min	Stone Toe (2 Feet)	30	Linear Feet	\$250	\$7,500
13	186M	2005+40	Min	Pipe Repair (Block Wall)	1	Lump Sum	\$500	\$500
13	187S	1906+50 - 1907+30	Mod	Stone Toe (2 Feet)	80	Linear Feet	\$250	\$20,000
13	188S	1906+70 - 1907+00	Mod	Stone Toe (2 Feet)	30	Linear Feet	\$250	\$7,500
13	189S	1907+30 - 1907+70	Mod	Stone Toe (2 Feet)	40	Linear Feet	\$250	\$10,000
13	190S	1907+70 - 1908+00	Min	Re-grade Slope	30	Linear Feet	\$75	\$2,250
13	191S	1909+60 - 1910+10	Min	Re-grade Slope	50	Linear Feet	\$100	\$5,000
