**Staff Report: April 18, 2013 Flood Event
Prepared July 1, 2013**

I. Executive Summary

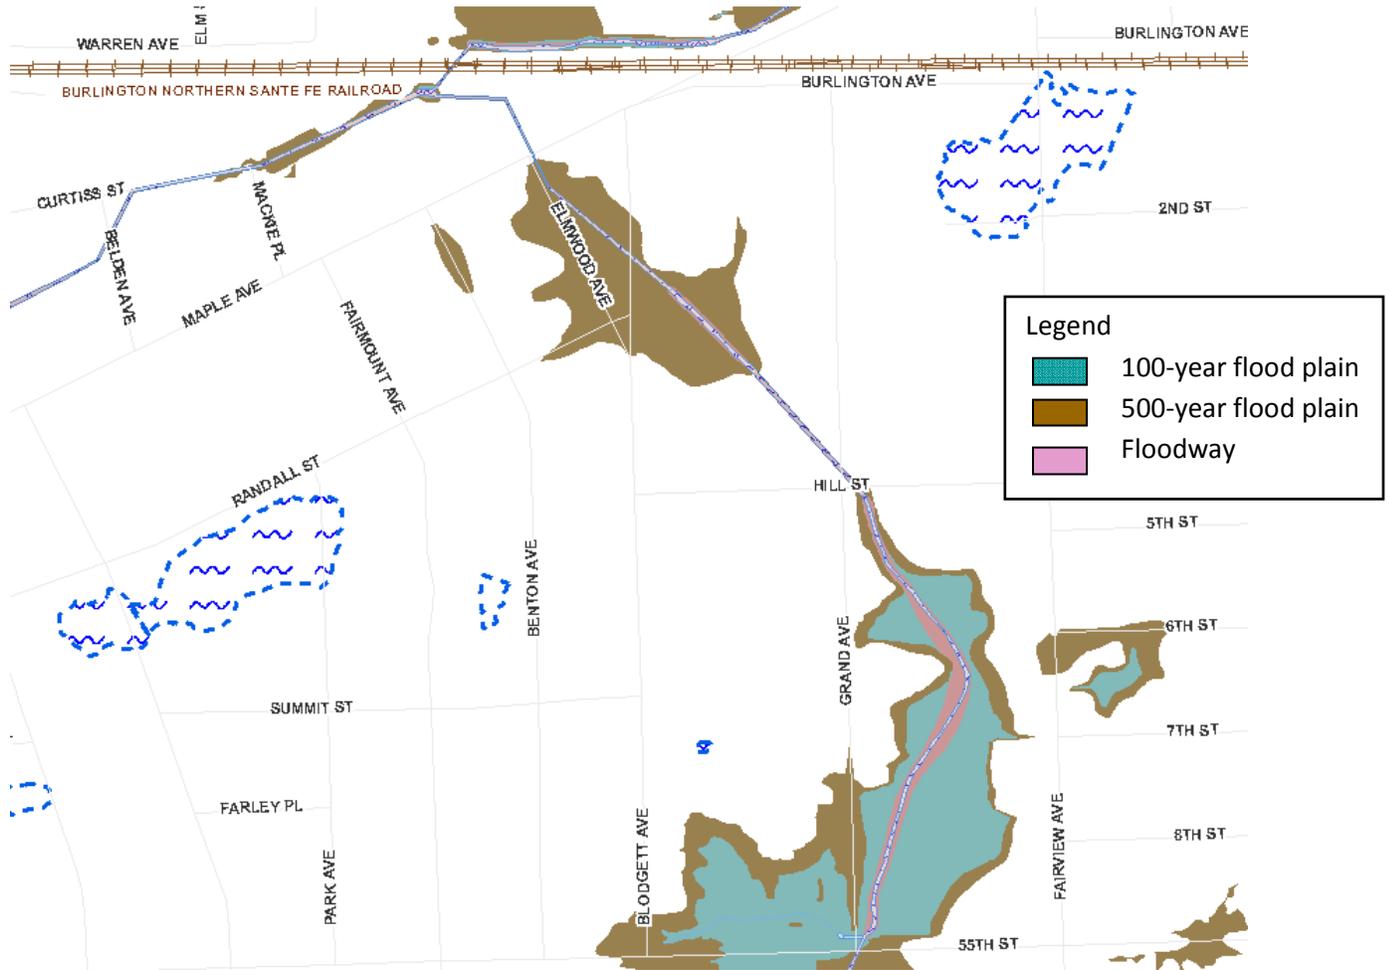
Location of Study Area

During the April 17-18 storm event, structural flooding was reported within the neighborhood between Park Avenue and Fairview Avenue, south of Maple Avenue and north of 55th Street. The streets in this area including Elmwood Avenue, Grand Avenue, Hill Street, 55th Street, 6th Street, Fairview Avenue, Randall Street and Benton Avenue were closed or reported flooded. Approximately 50 residential homes reported flooding through the Individual Assistance Damage Assessment survey. Location of flood damage occurred in back yards, detached

garages, basements and first floor living areas. Some damage was caused by sanitary sewer back up and others by overland flow routes, overbank flooding and depressional areas.

The Village's current CIP includes a project to replace the existing grate at Hill & Grand, which is confirmed by the consultant's report. The consultant report also recommends establishing overflow routes to convey the stormwater in the floodplain, as well as encouraging homeowners to use barrier flood proofing to protect basements and window wells.

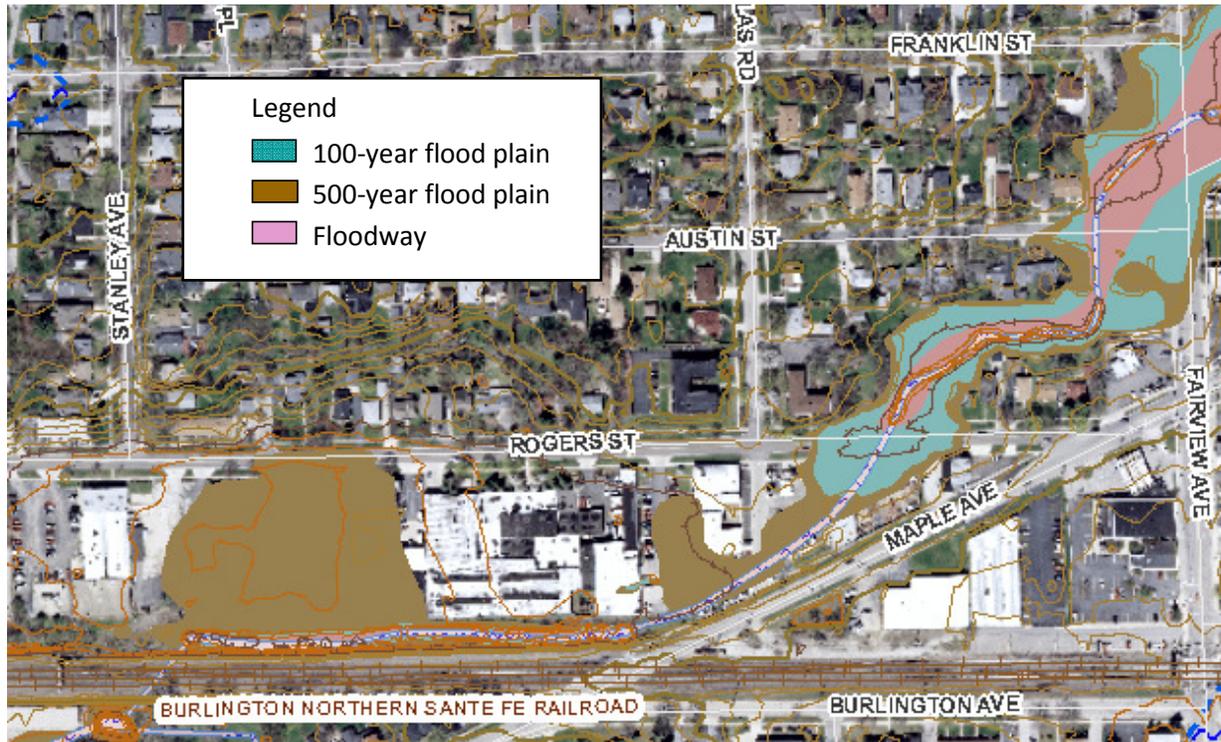
Location of Study Area

Flood damage along The Northeast Tributary of St. Joseph Creek - Reach 7 was reported by at least seven businesses located along Roger Street between Prospect Avenue and Maple Avenue through the Individual Assistance Damage Assessment survey. This stretch along St. Joseph Creek is open channel, just upstream of the railroad before it goes under the tracks and converges with the main reach (Reach 1) of St. Joseph Creek, behind Village Hall. During the April 17-18 storm event, Rogers Street, Prospect Avenue and Stanley Avenue were closed due to flooding. Various businesses and residential homes reported flooding in their basement or first floor from sanitary sewer back up and flood waters from overland flow.

For this area, the consultant recommends considering the cost/benefit of replacing the structures at Rogers, Austin and Fairview, possibly building a flood control berm along the south side of the commercial properties, and encouraging flood proofing or flood mitigation measures. Some mitigation measures include constructing barriers or floodwalls around a home, elevating homes above the 100-year flood level, flood proofing non-residential buildings and flood insurance.

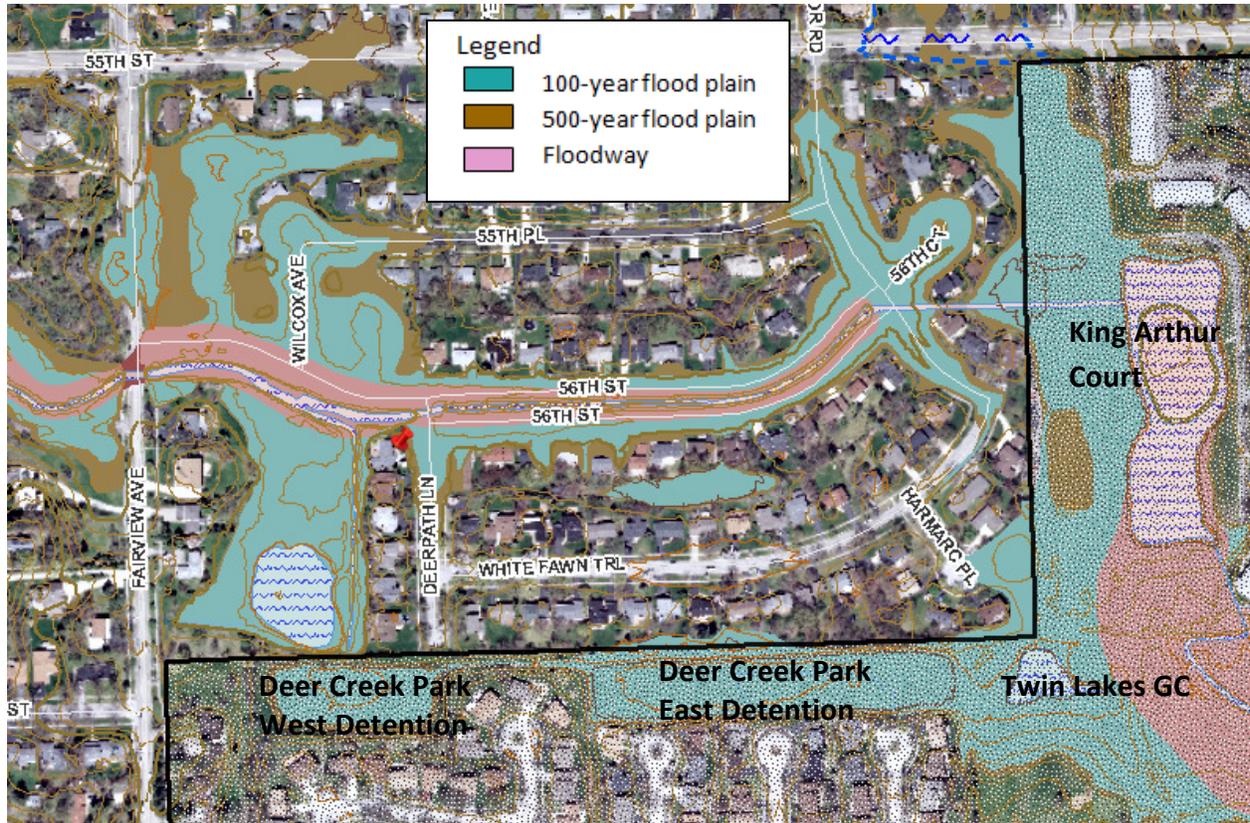
Location of Study Area

During the April 17-18 storm event, structural flooding was reported in the Deer Creek neighborhood, located on the eastern edge of the Village, south of 55th Street and east of Fairview Avenue. The entire area was inaccessible as the main entrances to the subdivision were inundated with flood waters and closed. These included the entrances at Fairview and 56th Street and the entrance at Cumnor Road and 55th Place.

- 3 homes with sanitary backups
- 5 homes with crawlspace flooding, depths between 1 and 4 feet
- 10 homes had basement flooding with depths between 1 and 8 feet
- 3 homes experienced flooding on two levels. The first had twelve feet of water. The other two had 6 feet on their lowest basement level and between 2 and 3 ft on their next level
- 2 homes reported no flooding

Recommendations for this area include moving the overflow points to a safe location and better defining the overland flow paths throughout the Deer Creek subdivision. Additional improvements should be considered in Westmont for establishing a defined overland flow path from the King Arthur Court Development to the east and raising the berms along the south portion of the Deer Creek subdivision.

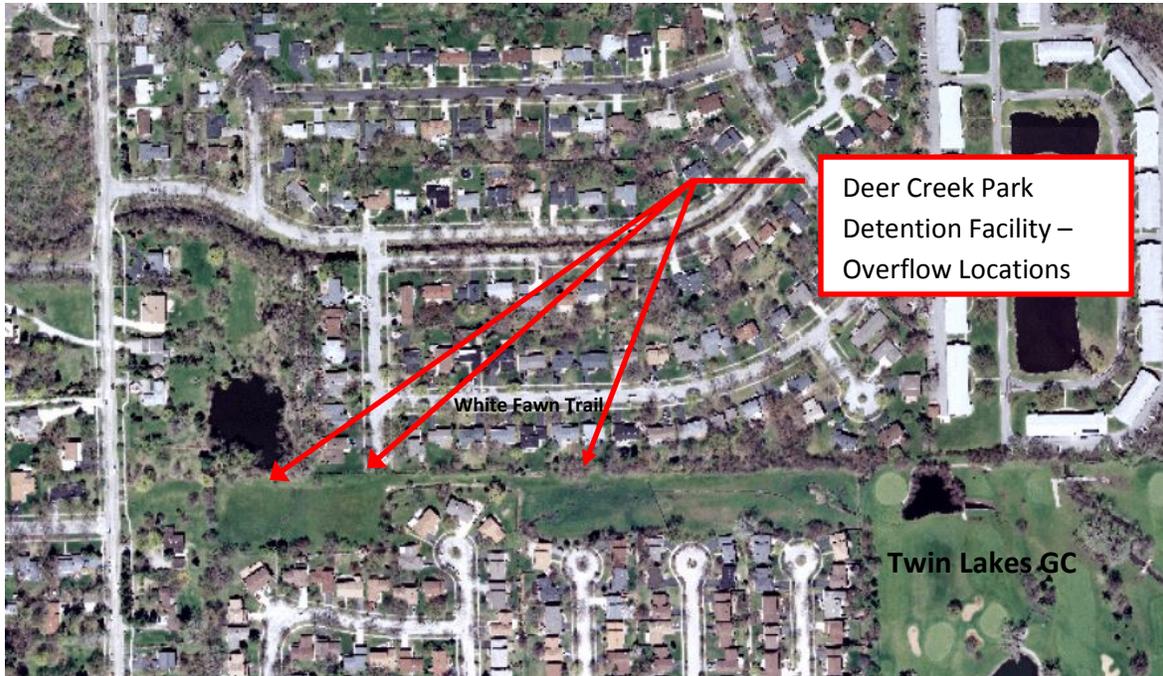
Topography (Detention Facilities and Overland Flow Routes)

Flooding occurred along White Fawn Trail and Deerpath Lane. The flooding appears to be caused by the overtopping of two detention facilities just south of the subdivision in Deer Creek Park. Deer Creek Park's detention facility's overflow location is designed at the north side of the west detention facility to discharge into the open channel located behind the backyards of the properties on Deerpath Lane. There is a secondary overflow weir on the west basin at the right-of-way to Deerpath Lane. In addition, the eastern detention facility was overtopped during the April 2013 which caused flood waters to overflow onto residential properties located on White Fawn Trail. This was likely due to settling of the detention basin berm and/or insufficient overflow weir capacity at the west basin. Water was reported to have flowed towards the homes and exit through their side yards. One homeowner reported water breaking the glass block in their window wells and flooding their crawlspace.

Deer Creek Park's detention facilities are hydraulically connected to St. Joseph Creek's flood plain. Therefore during large storm events, like the one seen on April 2013, the detention facilities (both east and west basins) fill up due to flood waters from St. Joseph Creek which reaches the basins after inundating the Twin Lakes Golf course in Westmont. Overtopping of the detention basins caused by St. Joseph creek overbank flooding is more severe than when this occurs from direct tributary runoff (storm sewer from Westmont and Downers Grove into the Deer Creek Park basins) because overbank flooding brings higher water surface elevations, higher flow rates over and more volume of water to the area.

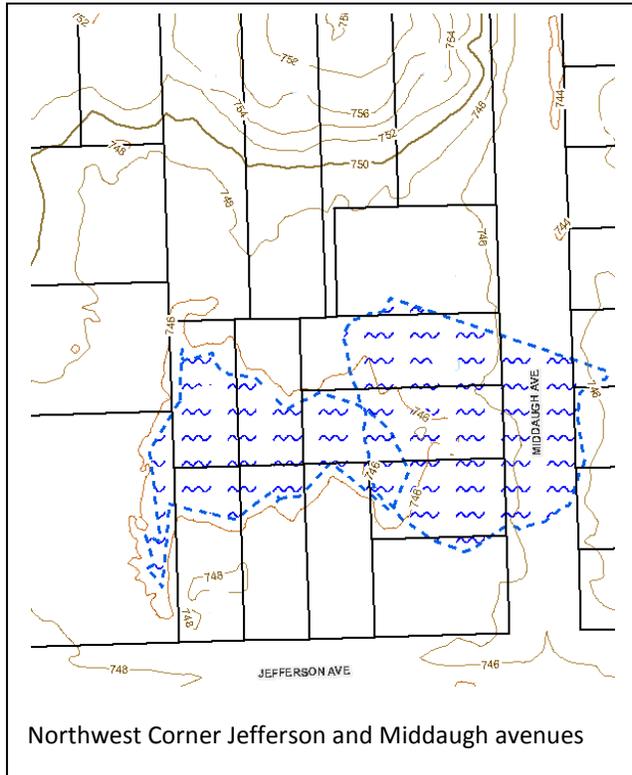
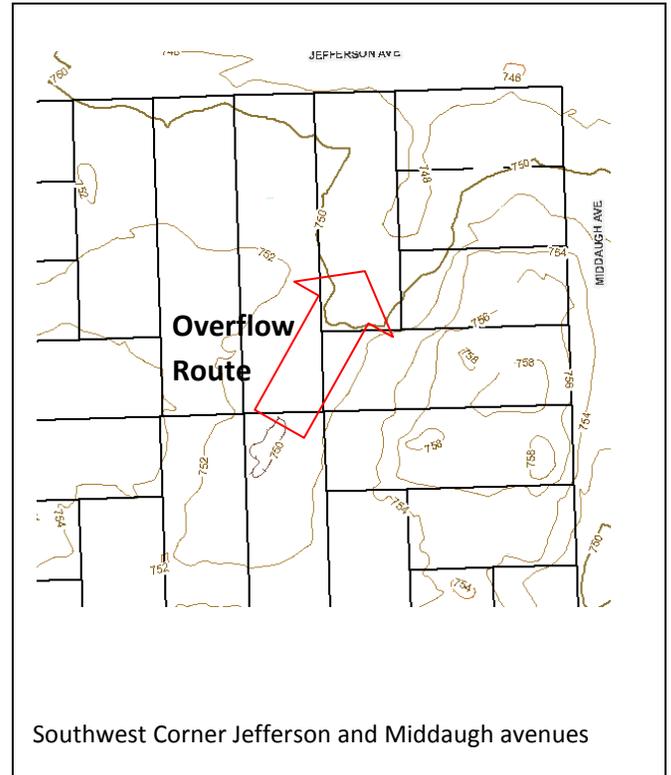
Location of Study Area

During the April 17-18 storm event, flooding was reported at the northwest and southwest corners of Middaugh and Jefferson avenues. These areas, shown above, are not located within the regulatory flood plain. Flooding in the area was reported to be basement, garage, and yard flooding. The Village topography shows a LPDA at the northwest corner and an overflow path for local drainage at the southwest corner.

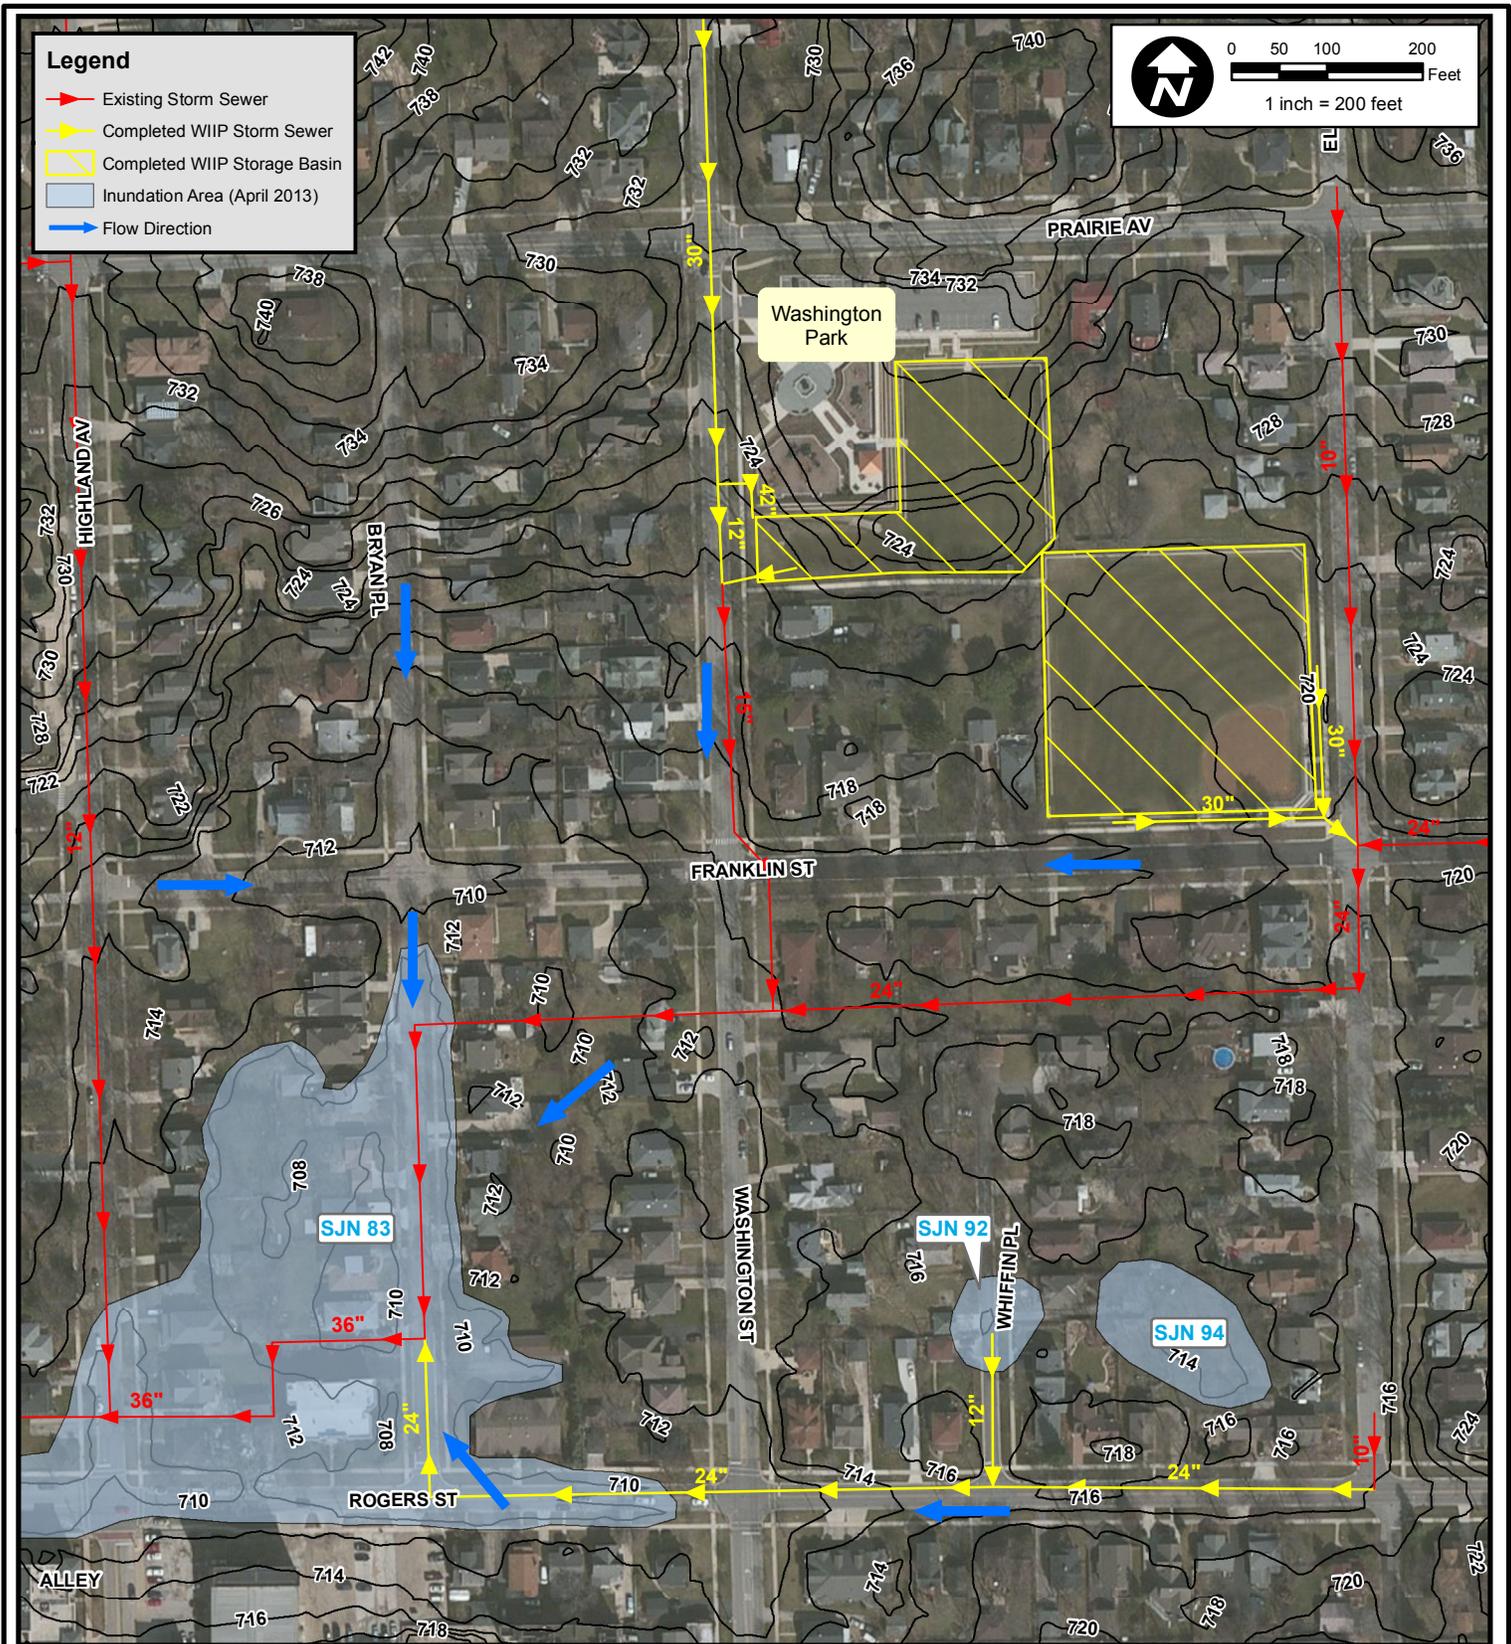
DSGN.	DEV	CHKD.	
JOB#		13-0260	
TITLE			DATE
ROGERS STREET AT BRYAN PLACE STUDY AREA			06/19/13
			EXHIBIT 2

Rogers Street at Bryan Place and Whiffin Place - There was street and yard flooding in this area, caused by runoff that exceeded the capacity of the storm sewer. The storm sewer has capacity for drainage of 33 cubic feet per second (cfs); the April 18 storm event generated runoff of 129 cubic feet per second. However, the nearby improvements at Washington Park and the increased Rogers Street sewer capacity reduced the flooding that would have occurred without the improvements.

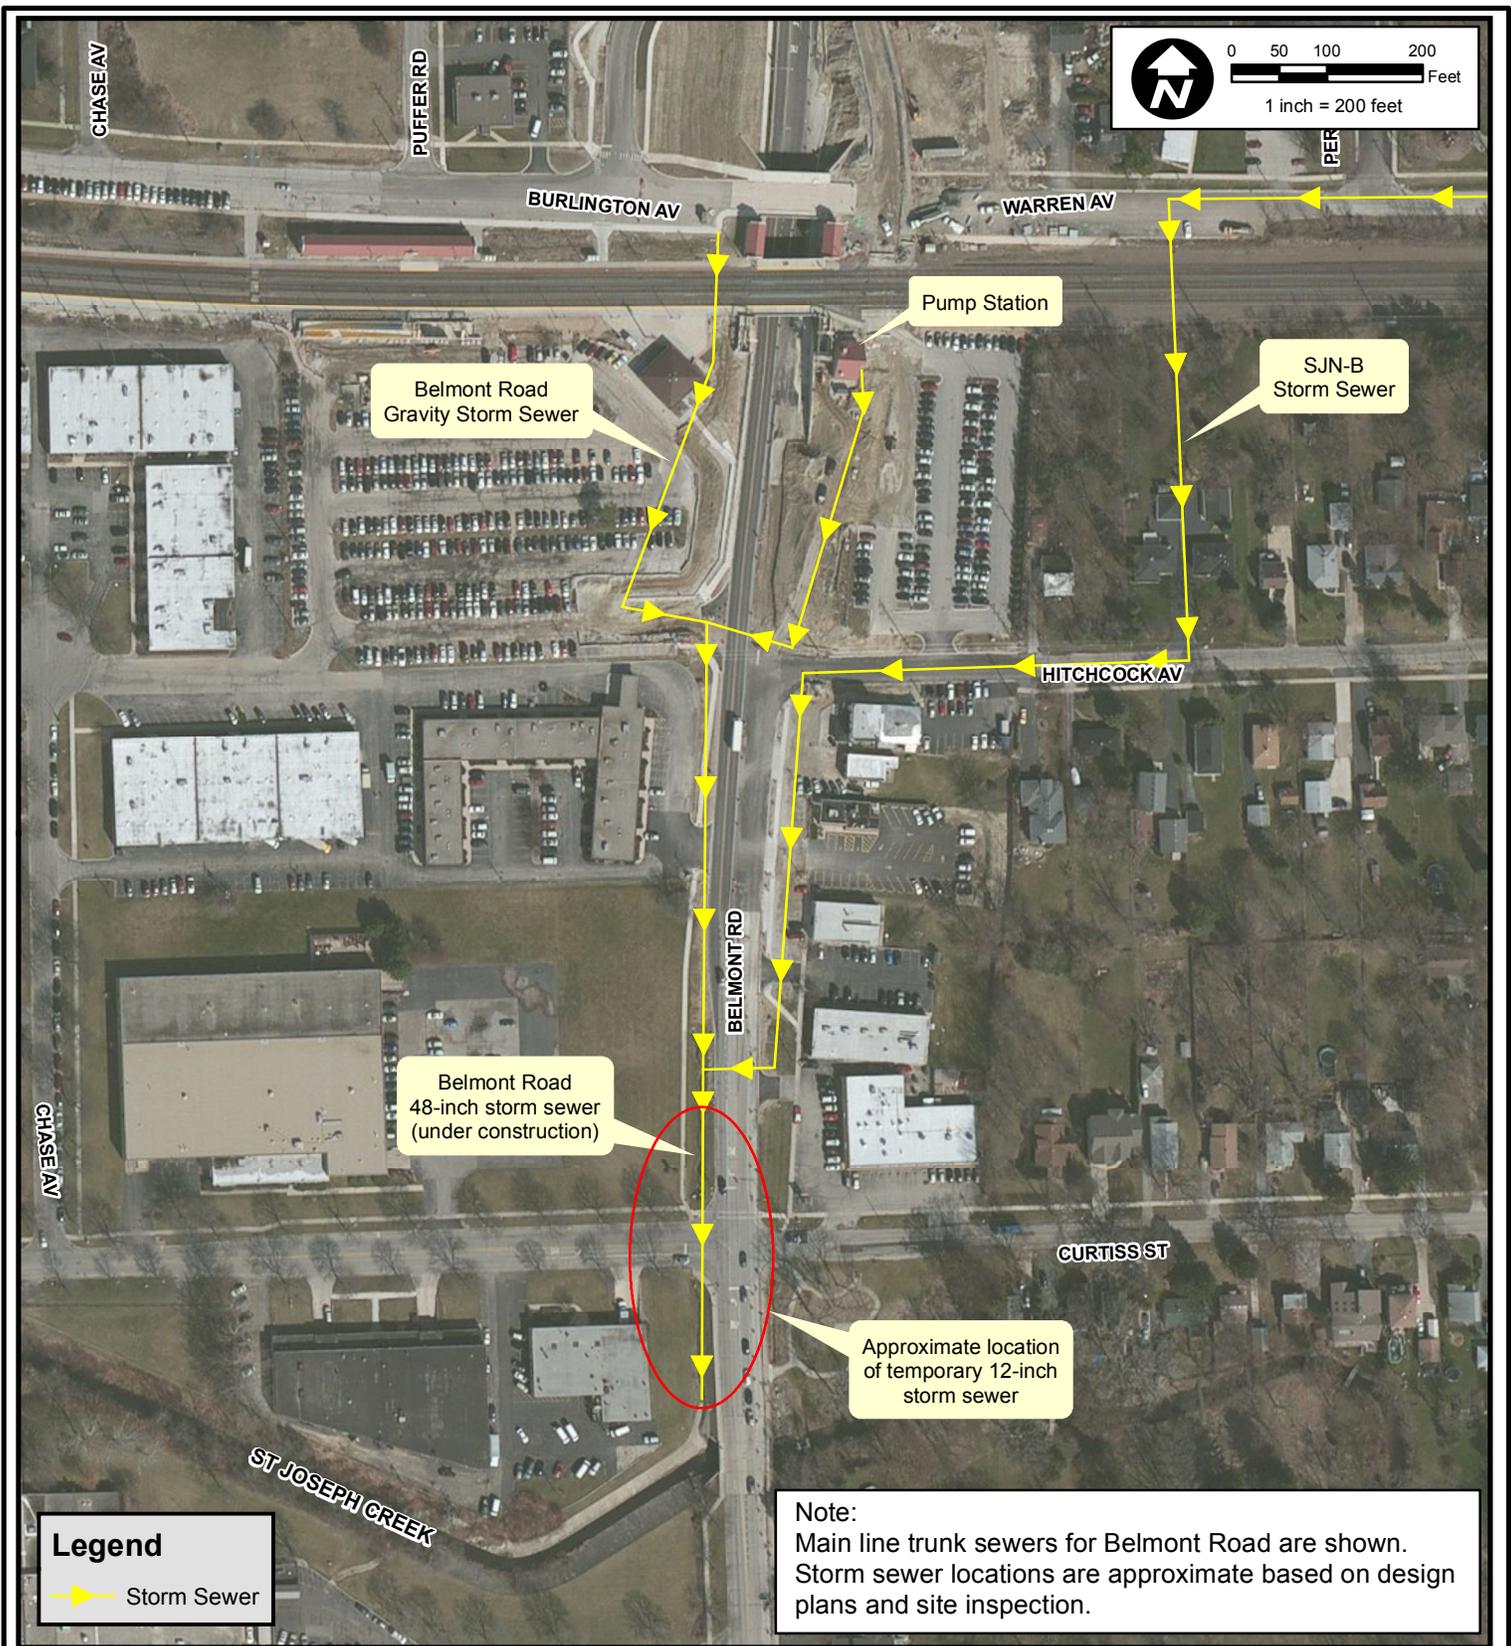
Note:
Main line trunk sewers for Belmont Road are shown.
Storm sewer locations are approximate based on design plans and site inspection.

On the morning of April 18, 2013, Metra contacted URS regarding flooding of the Belmont Road Grade Separation highway underpass and the pedestrian tunnel. URS visited the site that morning and observed these conditions with representatives of the DuPage County Division of Highways, Metra's Construction Department, the Metra's resident engineer for the grade separation project, and the County's Phase III consultant for its Curtiss Street / Belmont Road Intersection improvement. Based on our site inspection and follow-up correspondence with several of the others who visited the site, following is URS' understanding of the root cause of the problem:

conflict. This temporary 12-inch pipe was scheduled to be replaced with the permanent 48-inch pipe within the next several weeks once the conflicting utility was relocated. This 12-inch pipe greatly restricts how much flow can be handled as the receiver of the above noted storm sewer systems. It did not have the capacity to accommodate the heavy rainfall event that began on April 17th and lasted into the morning of the 18th and resulted in pressurized water backing up in the storm sewer systems feeding it. This was evidenced by water flowing out of the top of several manholes including the one for Manhole "A" at the corner of Hitchcock Avenue and Belmont Road that handles flow that comes from east of the grade separation project (see Photo 1). As seen in the photo, that outflowing water in-turn flowed north along Belmont Road into the depressed roadway of the grade separation.

Once the temporary 12-inch pipe is replaced with the intended properly-sized 48" pipe at Curtiss

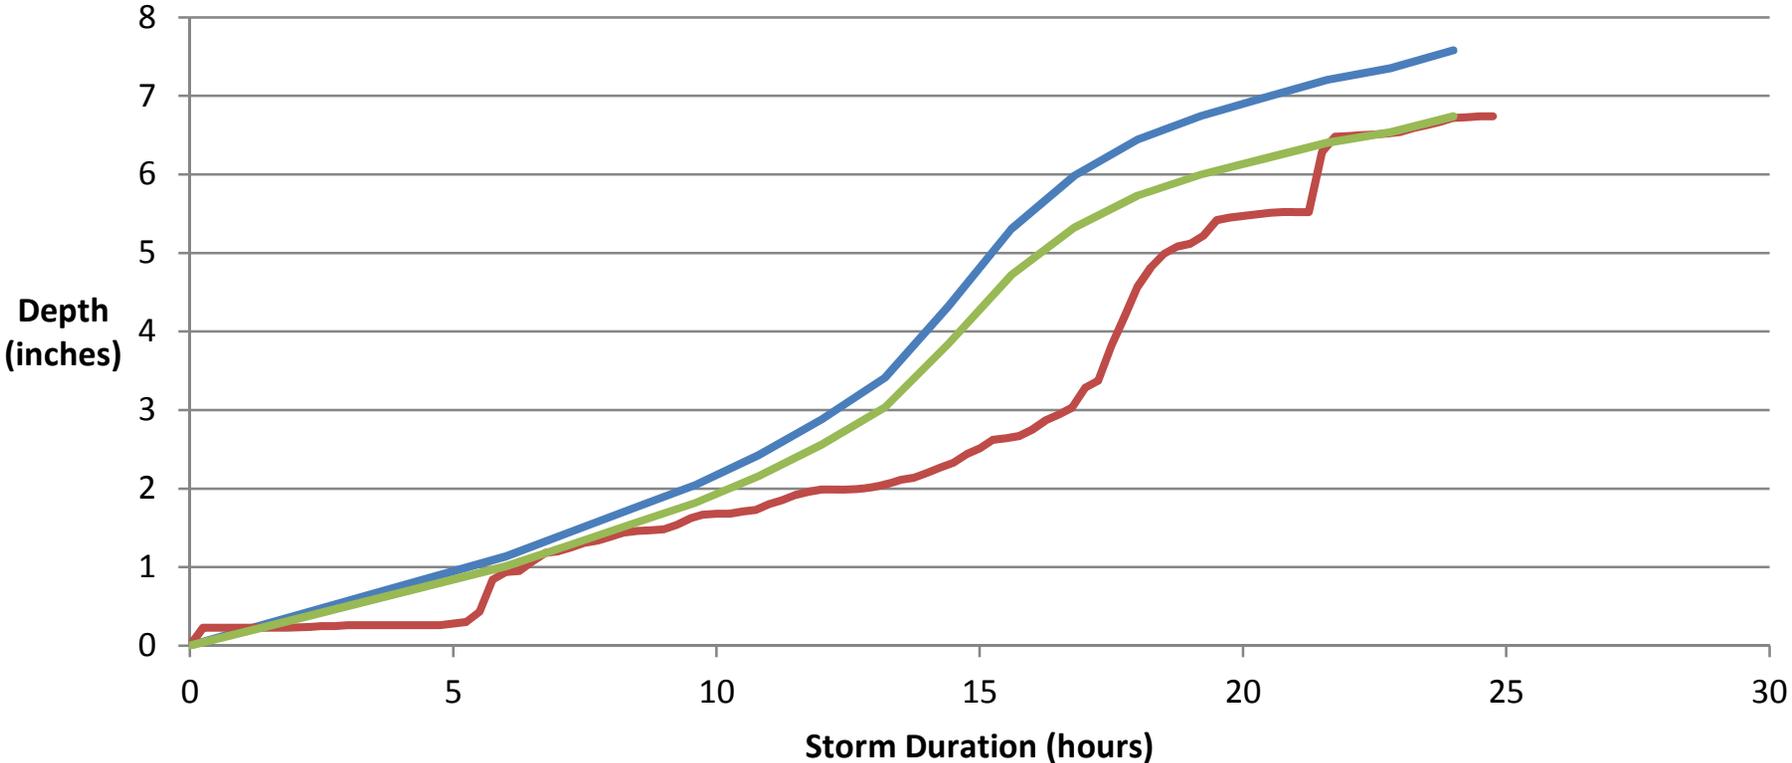
Hydrograph Comparison

The hydrologic results suggest that the 6.73 inches of rainfall from the April 2013 storm event produced slightly more runoff volume than what is expected from a typical 7.58 inch design storm. Intuitively this makes sense given the saturated ground condition due to the wet spring weather. The increased peak discharges are the result of the storm's natural distribution and although the peak discharge rates likely lasted for only short durations, they may have contributed to localized / isolated flood damages in situations where runoff conveyance is critical due to the lack of available storage. For example, a side yard swale may have enough capacity to convey the peak flow from a 100-year, 24-hour storm without overtopping into adjacent window wells but the peak flow from a shorter, more intense storm (or portion of storm) may result in overtopping. The extent of flood damage typically depends on how long the peak elevation remains above the elevation that results in flood damages.

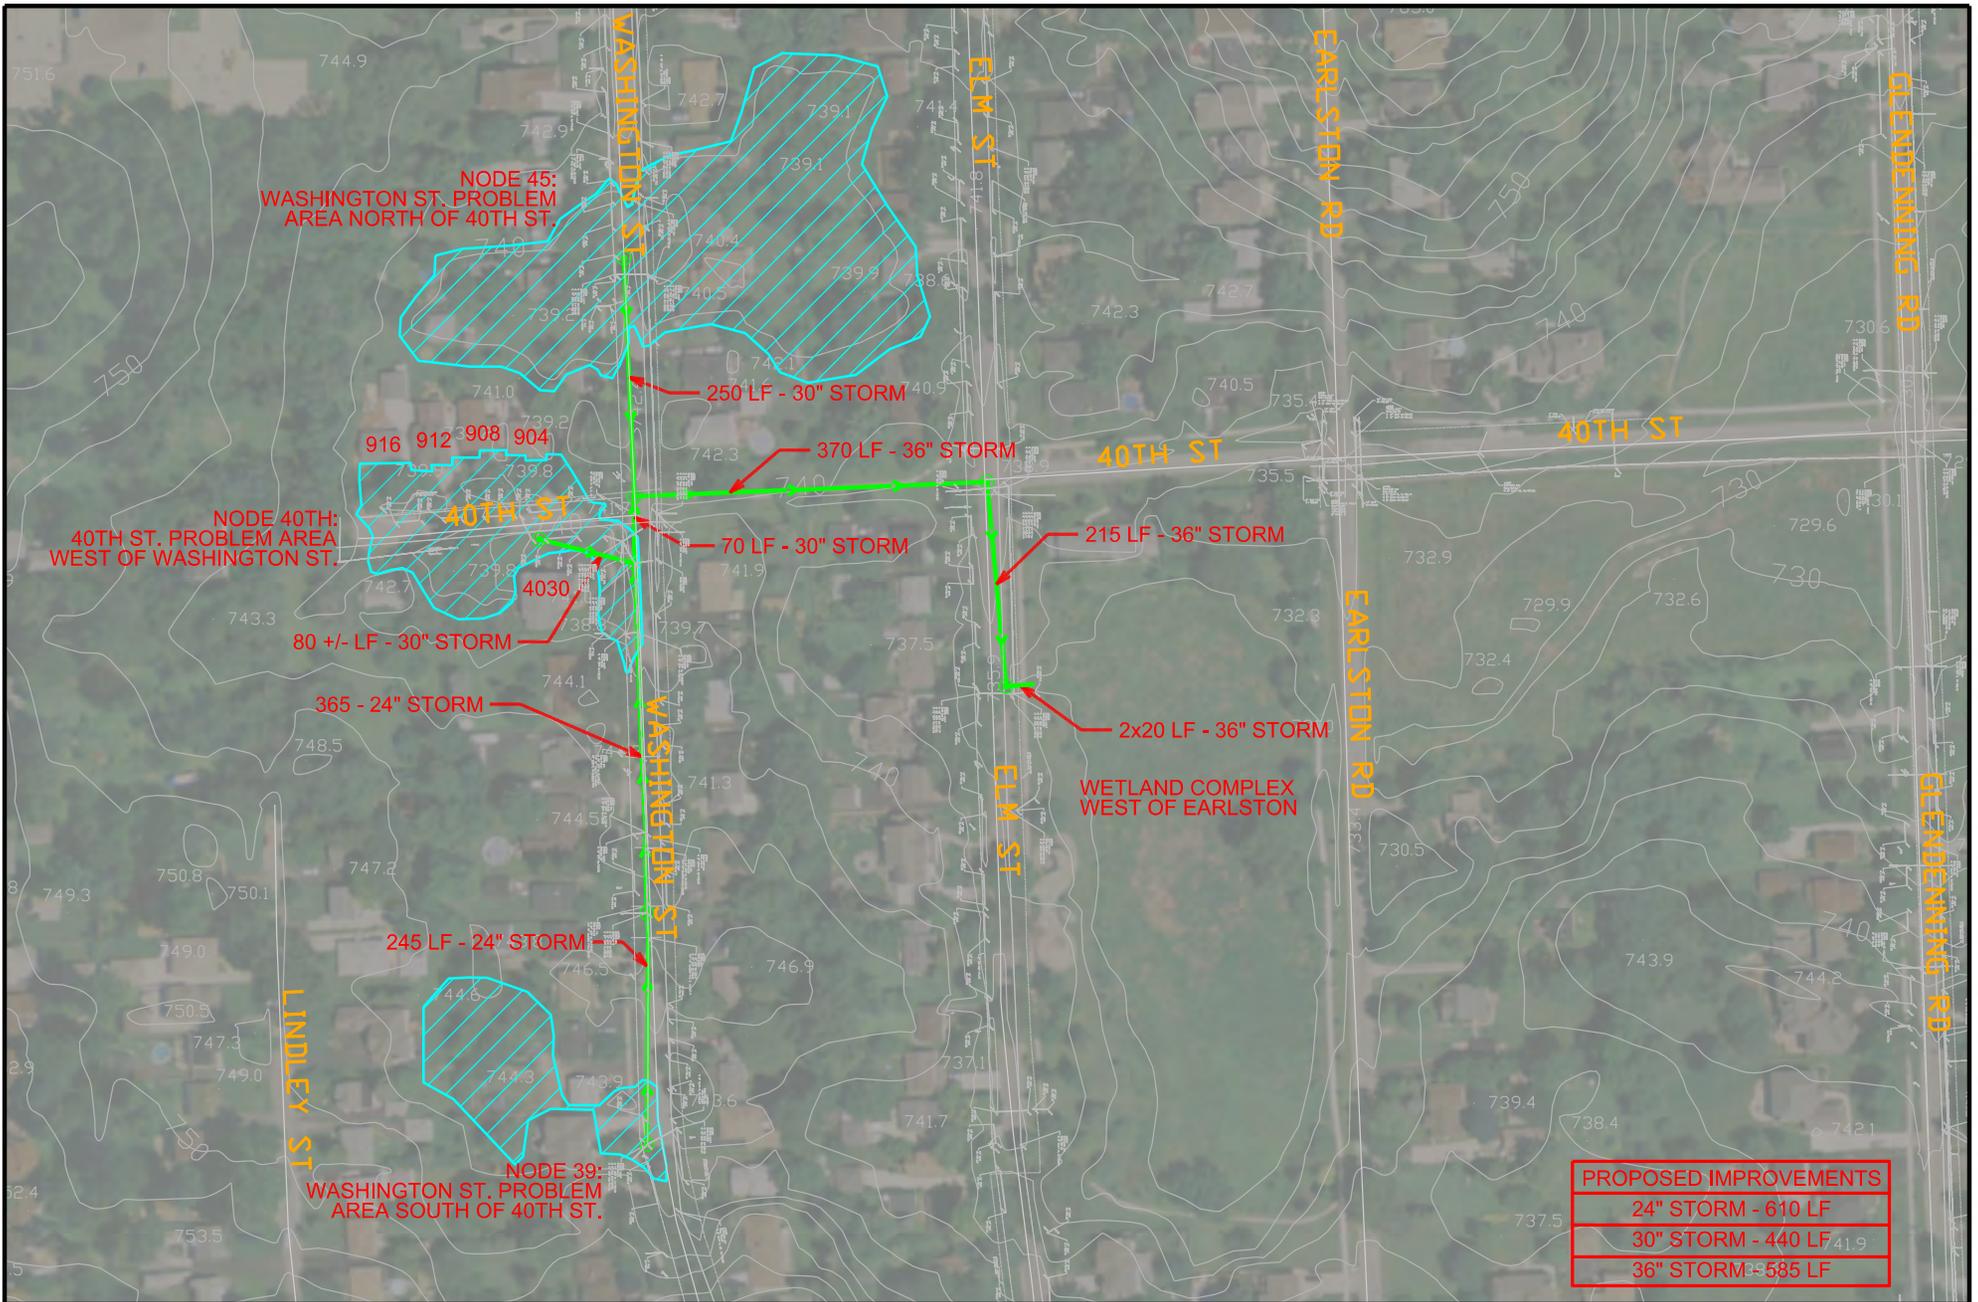
REVISED ALTERNATIVE C STORM SEWER REPLACEMENT EXHIBIT

The stormwater analysis did include revisions to the XPSWMM model to better define the flood prone areas near the intersection of 40th Street and Washington Street. The XPSWMM hydrologic results showed the same tendencies as described above. Based on available topographic information and flooding photographic information, it is appears the XPSWMM hydraulic results demonstrate a reasonable match between modeled flood elevations and actual observed flood elevations. The XPSWMM analysis also confirmed that improving stormwater conveyance from the Washington and 40th Streets area to the Wetland Bank area east of Elm Street should provide flood relief to the residents in and adjacent to the flood problem areas. See the attached Revised Alternative C Storm Sewer Replacement Exhibit that shows the general location of the flood problem areas near 40th and Washington Streets (light blue cross hatch areas) as well as the proposed conceptual storm sewer improvements.

PROPOSED IMPROVEMENTS	
24" STORM	- 610 LF
30" STORM	- 440 LF
36" STORM	- 585 LF
