# **Prentiss Creek Watershed**

## **Appendix 4A: Detailed Problem Areas**

**STORMWATER INFRASTRUCTURE IMPROVEMENT PLAN  
VILLAGE OF DOWNERS GROVE**

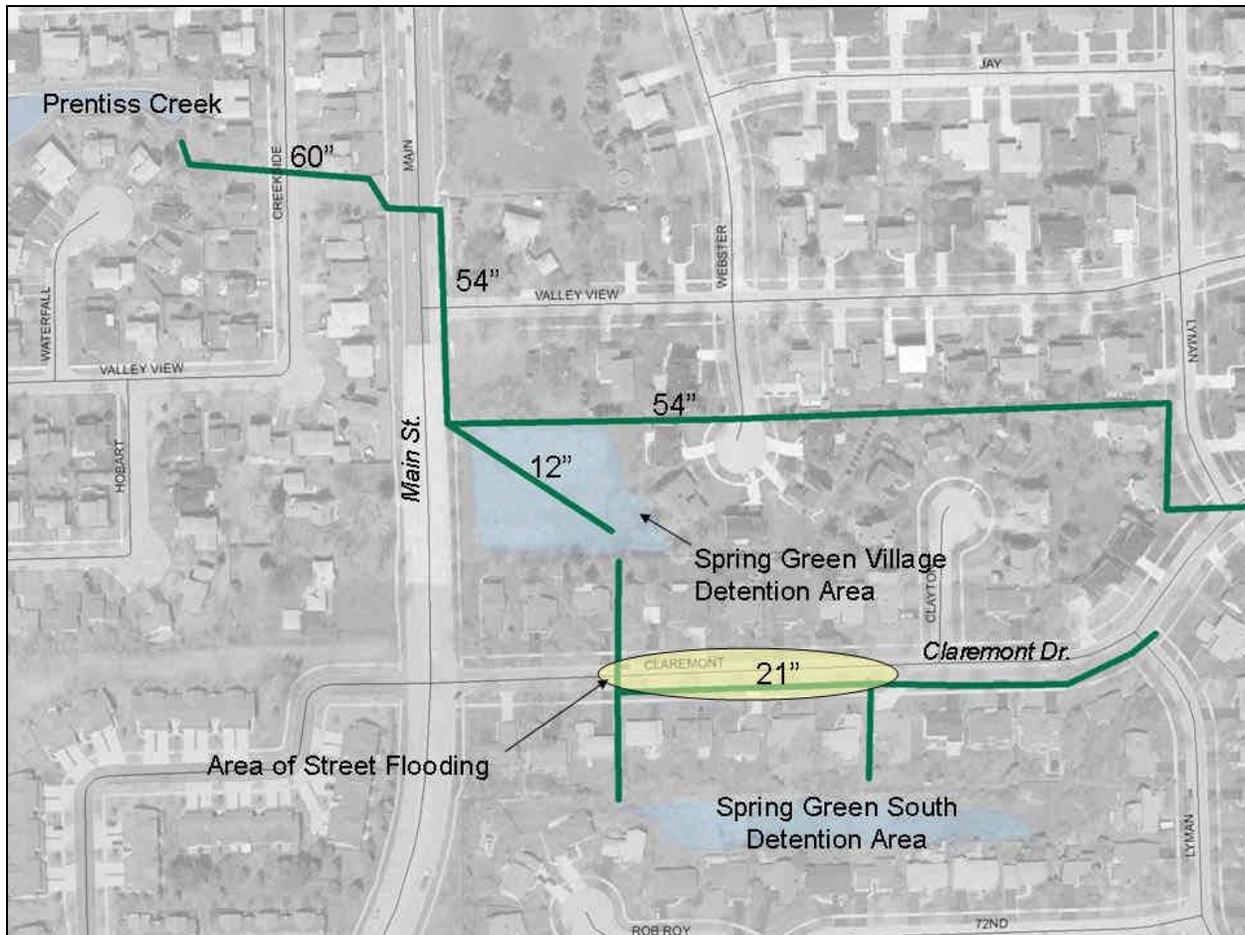
As-built drawings for the Spring Green Village subdivision were used to model the storm sewer along Claremont Drive where the flooding occurs. The results show that the storm sewer along Claremont Drive is adequately sized, but that the flow out of the pipe is greatly influenced by water depth in the detention ponds in the Spring Green Village and Spring Green South subdivisions. Figure 602-2 illustrates the location of the detention ponds as well as the storm sewer network connecting the ponds.

Storm Sewer and Detention Locations, Spring Green Village & Spring Green South Subdivisions

The 100-year design high water level of the Spring Green Village detention pond is 755.0; the rim elevation of the structure on Claremont Drive upstream of the pond (first structure east of Main Street) is 756.65. Thus, when the pond is full the hydraulic grade line of the 21-inch storm sewer into the pond is above the crown of the pipe, and there is no capacity left in the pipe. This would potentially cause flooding at this location. Figure 602-3 illustrates the 10-year hydraulic grade line in the system based on whether the Spring Green Village detention area is dry or at the design high water level.

- 1.3. Inspect detention pond outlet structures to verify the ponds have a proper outlet. Partially clogged (or damaged) outlet structures may result in high water levels above the intended design, which impacts the sewer performance at Claremont Drive. This inspection may need to include a portion of the receiving 54-inch trunk storm sewer downstream of the Spring Green Village detention pond.

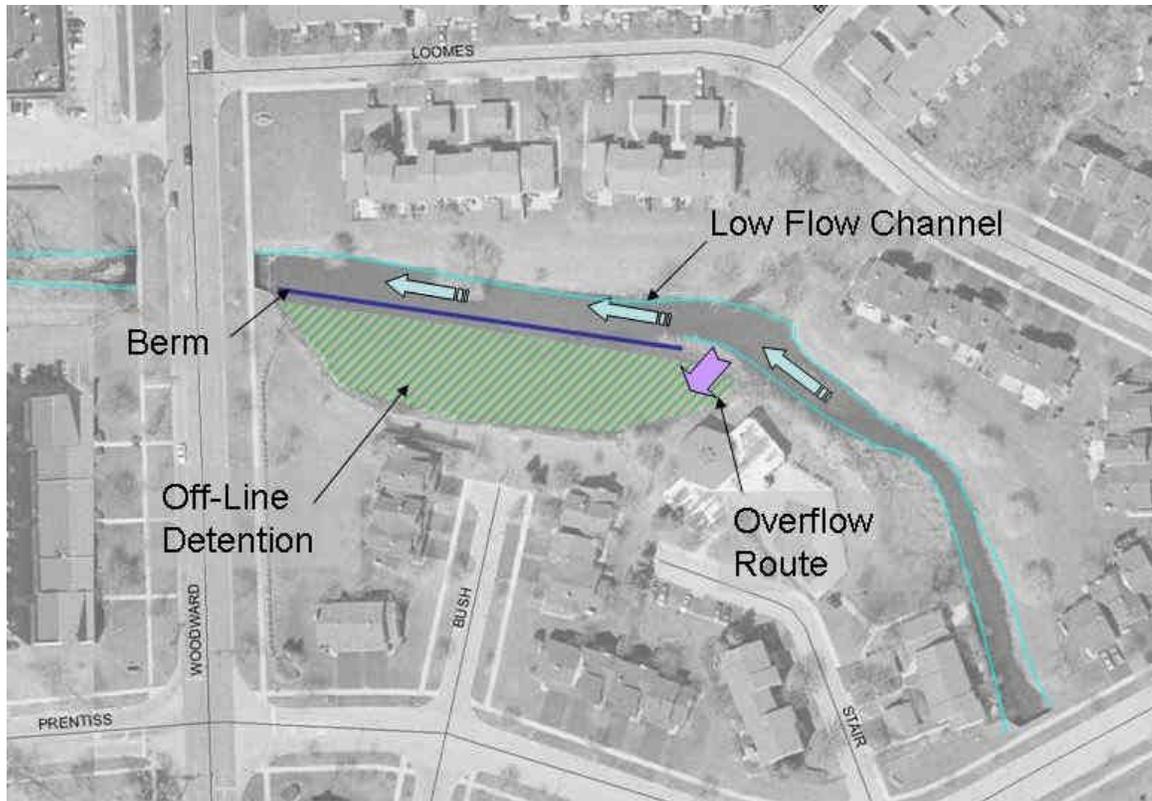
Figure 604-6  
Recommended Pond Reconfiguration

To better use the retention area downstream (north) of Prentiss Drive, it is recommended that it be converted from an in-line pond to an off-line pond.

The new off-line pond component must contain an outlet structure designed to attenuate peak flows from the Kensington Place Subdivision. This outlet structure should be designed to provide adequate detention time for smaller (i.e. 1-year/2-year) storms in order to enhance stormwater quality. Larger storms would require no controls, as Prentiss Creek would overtop the berm and flood the pond area.

It is essential that the converted detention pond have a carefully designed landscaping plan. The water levels should be carefully considered when choosing pond vegetation; improper landscaping will lead to vegetation that cannot thrive, repeating the current problems within the pond.

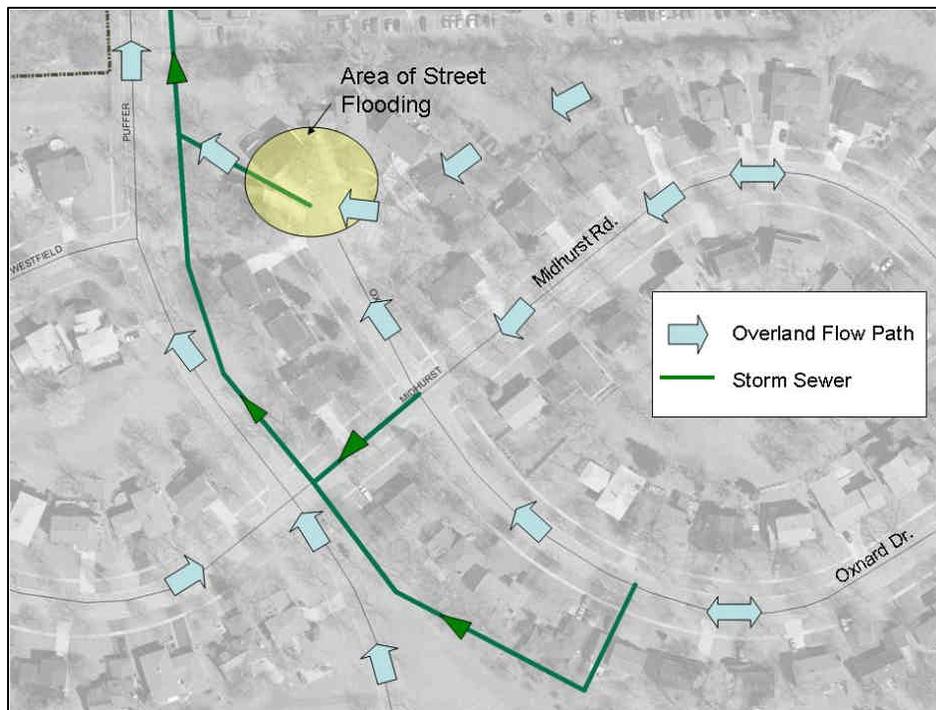
Figure 607-2  
Overland Flow Paths  
near Oxnard Avenue

The natural overland flow path in this area flows towards northern end of Oxnard Drive. If the inlets at the intersection of Midhurst Road and Oxnard Drive are at capacity, the flow would continue along Oxnard Avenue. The end of Oxnard Drive, which is on the northern end of the subdivision and ends in a cul-de-sac, has only one inlet. If this inlet is at capacity, water would overflow directly towards the property at 2222 Oxnard Drive. Figure 607-2 illustrates the overland flow paths in the area; Figure 607-3 depicts the area of flooding.

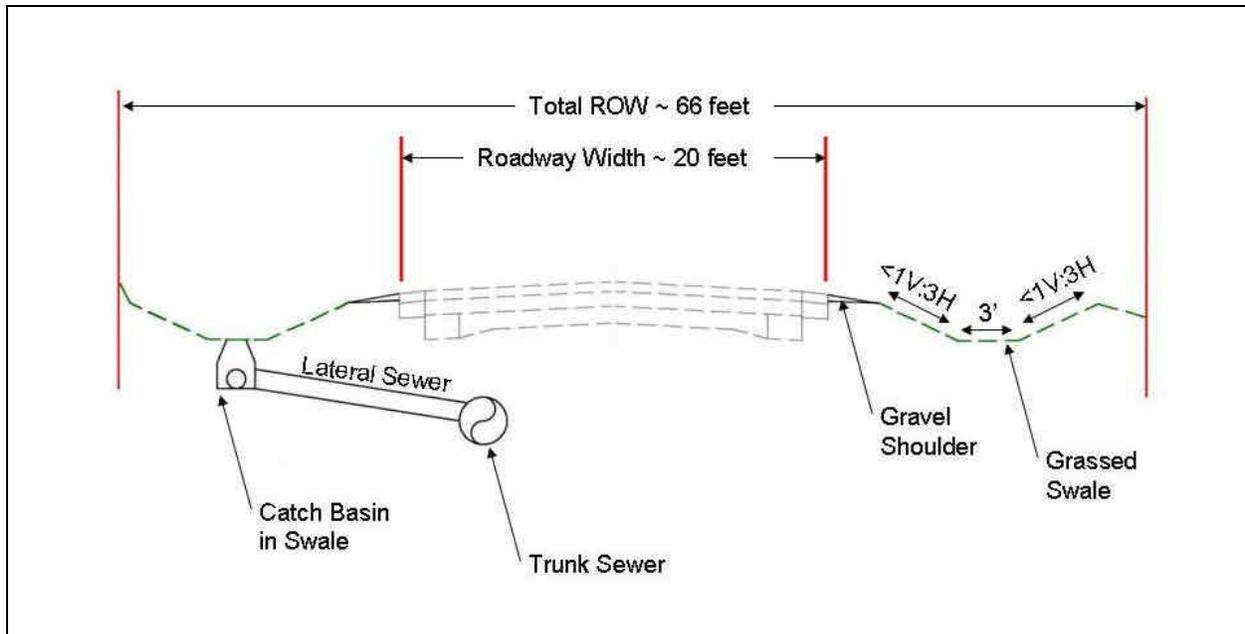
Figure 610-3  
Modified Rural Cross Section

Option 1B, Modified Rural Cross Section, should be implemented in this area. This option maintains the open feel of the rural cross section as well as the infiltration benefits of the ditches, yet also provides for the flexibility (and effective drainage) that a storm sewer system provides. Figure 610-3 illustrates a typical cross section of the combination ditch and sewer system.

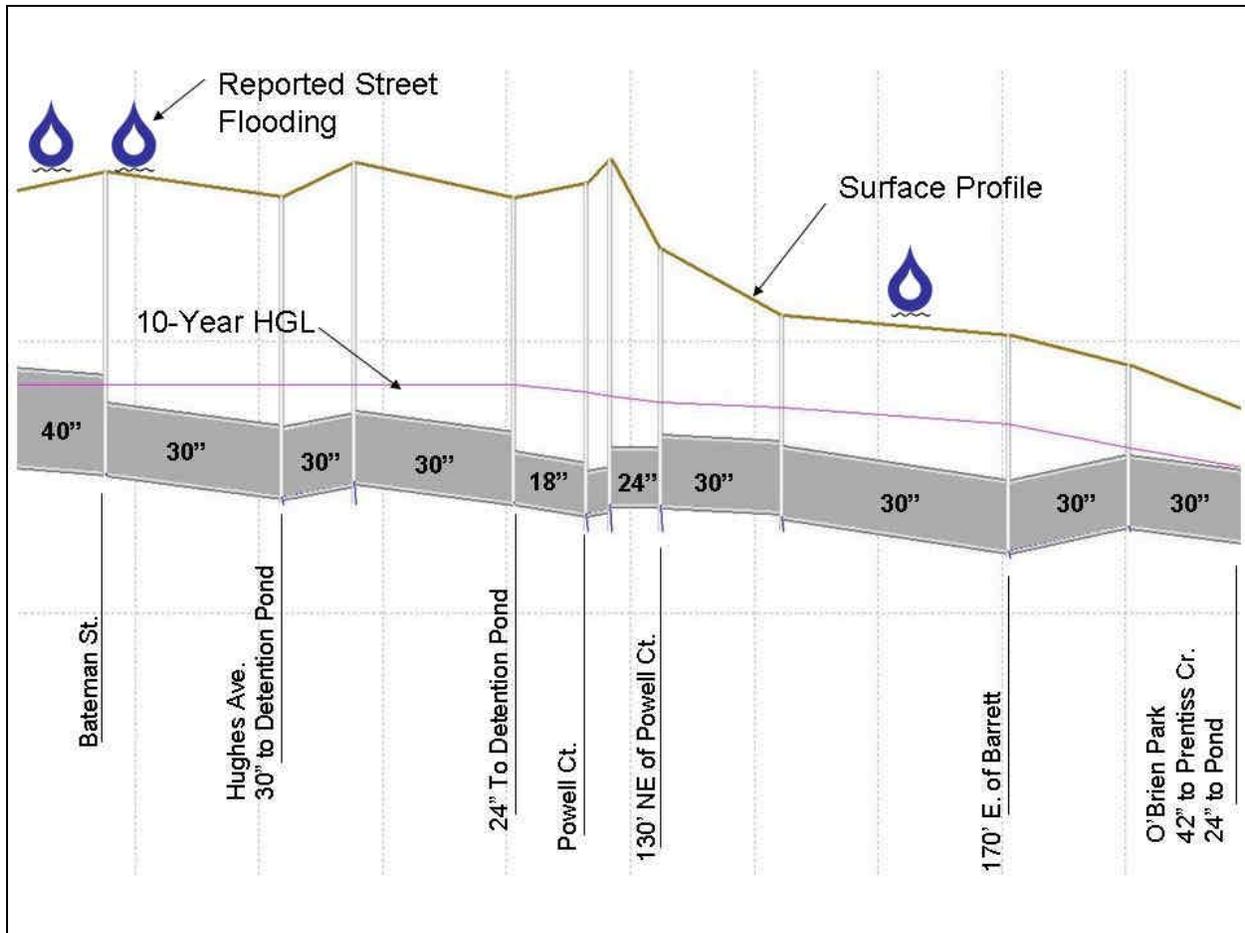
Figure 612-2  
Storm Sewer Profile, Powell St. to O'Brien Park Pond

Hydraulic modeling of the subbasin suggests that the hydraulic grade line during the peak 10-year storm event is slightly above the crown of the pipe but well below the surface elevation. The outflow from the ponds is ultimately controlled by the 18-inch storm sewer at Powell Court. The trunk line along Powell Street decreases in diameter as it goes downstream; the excess flow is expected to back up into the detention ponds.

Due to the complex pond system and the numerous end sections to the pond, it is possible that the ponds may not be performing as designed, and that stormwater may be surcharging the system. However, street flooding is being reported in areas, particularly the section at Powell Street and Bateman Street, where the storm sewer is the deepest. This suggests that the cause of the flooding may be related to a lack of storm sewer inlets (as opposed to undersized storm sewers).

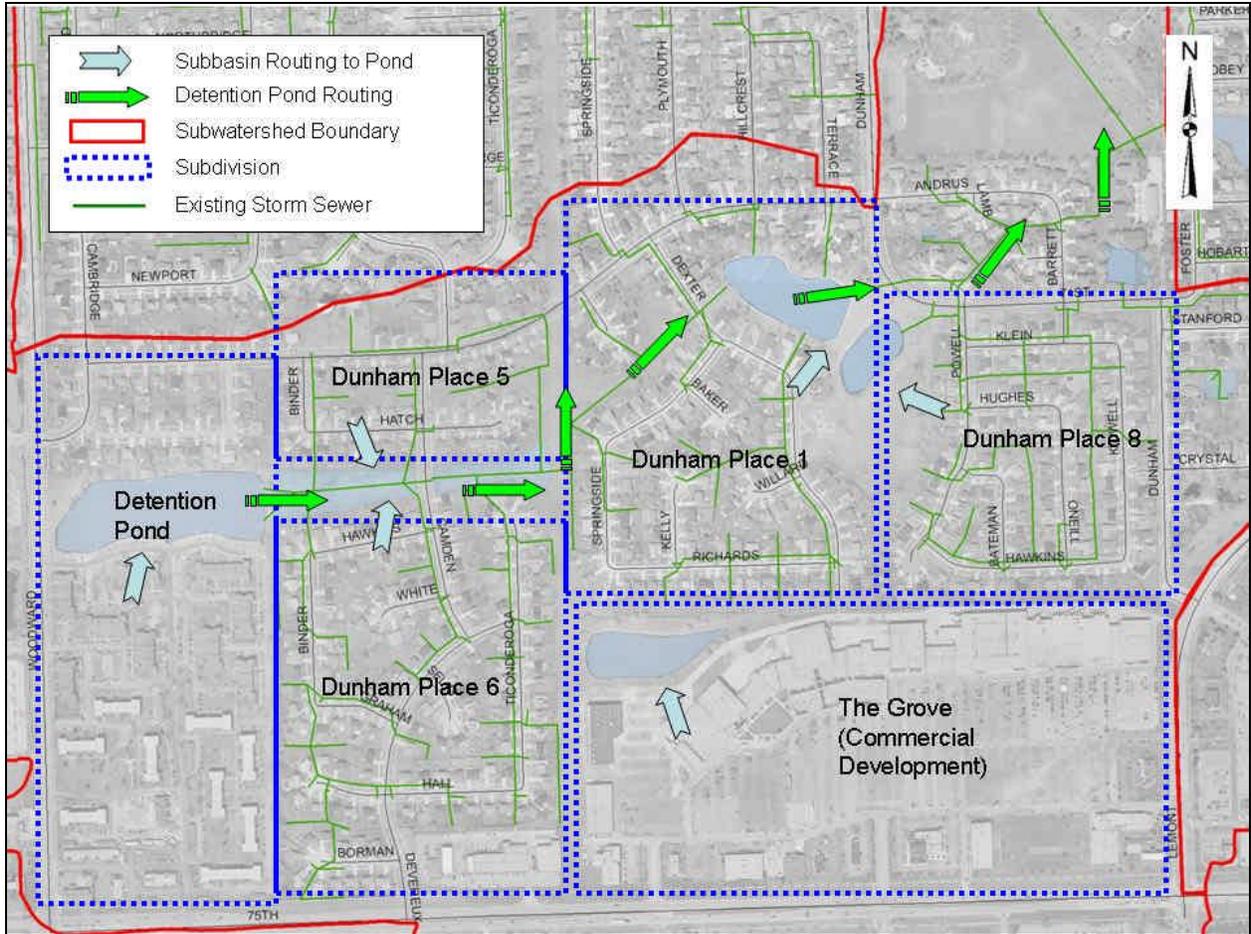
Figure 612-3  
Detention Pond Locations and Routing, Subwatershed D

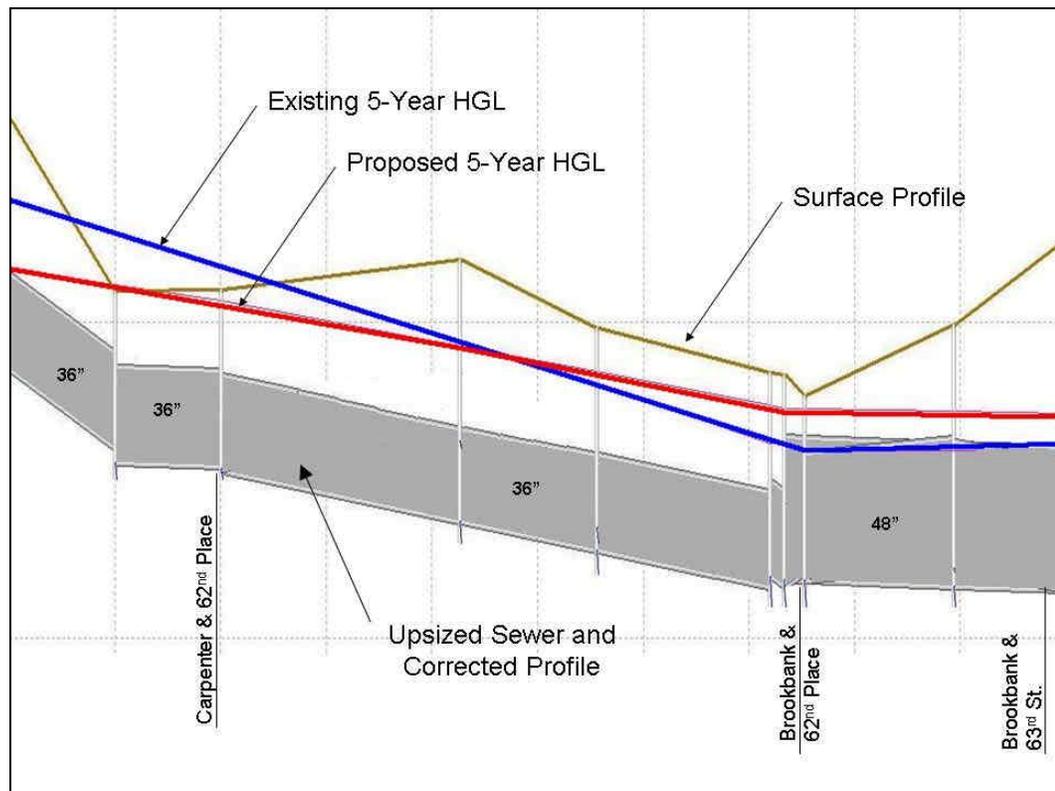
Improving the storm sewer system to convey the 10-year storm event is not feasible. The downstream trunk line was designed to convey the 5-year storm event (per the original 1970s Master Plan), and so designing the system for the 10-year event would require upsizing all pipe to the outfall at Prentiss Creek. However, replacing the backpitched storm sewer segments with larger diameter sewers will provide additional flood protection for the 5-year storm event.

Figure 613-3  
Proposed Storm Sewer Profile along 62<sup>nd</sup> Place

- 1.1. Replace and increase the size of the backpitched storm sewer along 62<sup>nd</sup> Place to provide positive drainage.

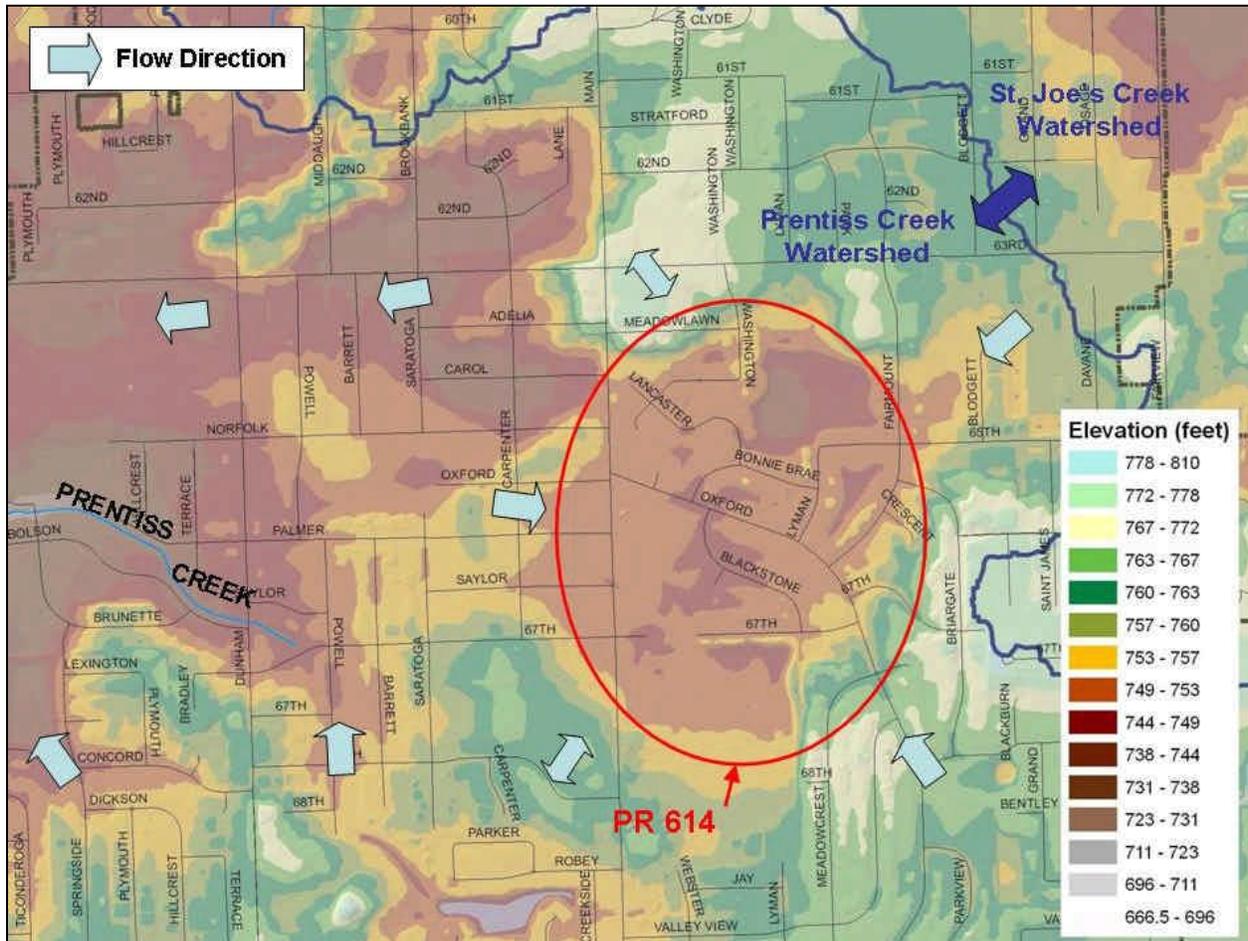
Problem Area 614 is a low spot in the watershed. Overland flow drains towards Oxford Street and Blackstone Drive, and has no natural outlet. Figure 614-2 illustrates the topography of the area.

Figure 614-2  
Topography, Vicinity of PR 614

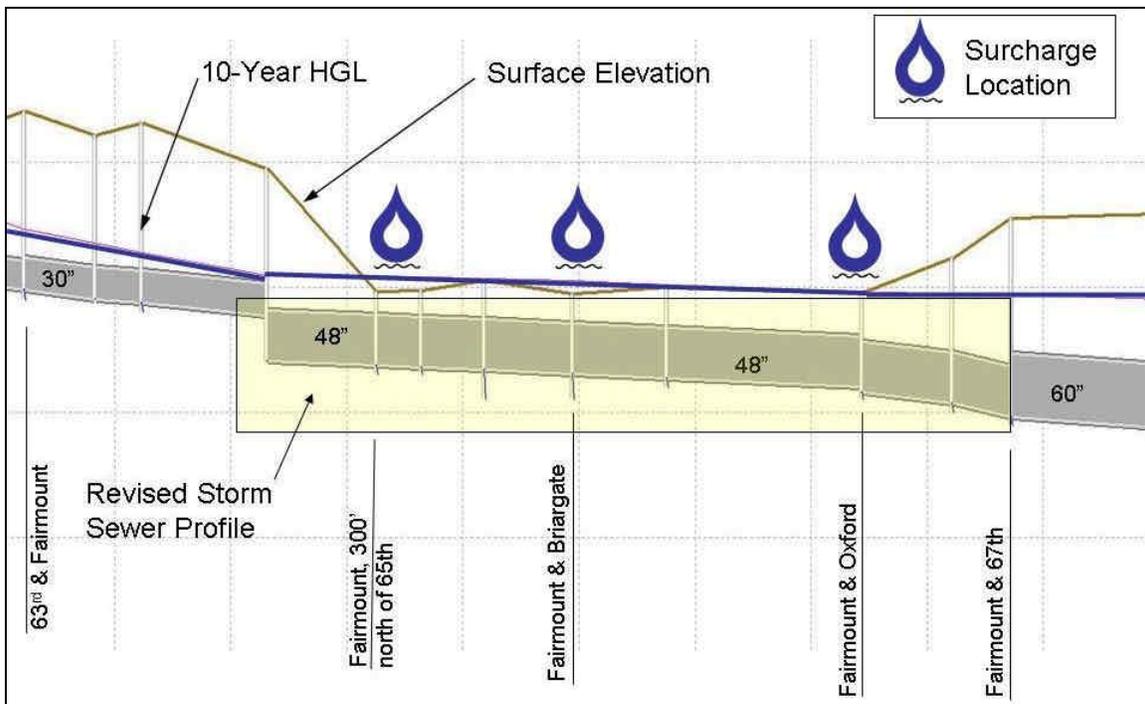
One alternative considered (Option A) was to upsize the storm sewer along Fairmount, and eliminate the backpitched storm sewer. However, XP-SWMM modeling of this alternative showed no improvement, suggesting that, while the backpitched and undersized sewer may be a part of the problem, the main cause is a hydraulic restriction downstream. Figure 614-4 shows the revised (improved) storm sewer profile along Fairmount Avenue with the hydraulic grade

line for the 10-year storm event; comparing Figure 614-3 with Figure 614-4 shows little to no improvement in flooding conditions. Construction of a relief sewer along 67<sup>th</sup> Street was modeled, and results suggest that this will substantially improve conditions upstream. Figure 614-5 shows the hydraulic grade line along Fairmount Avenue after a 48-inch relief sewer with an outlet to Prentiss Creek is constructed and the storm sewer profile is revised.

Figure 614-4  
10-Year HGL, Revised Storm Sewer Profile along Fairmount Avenue

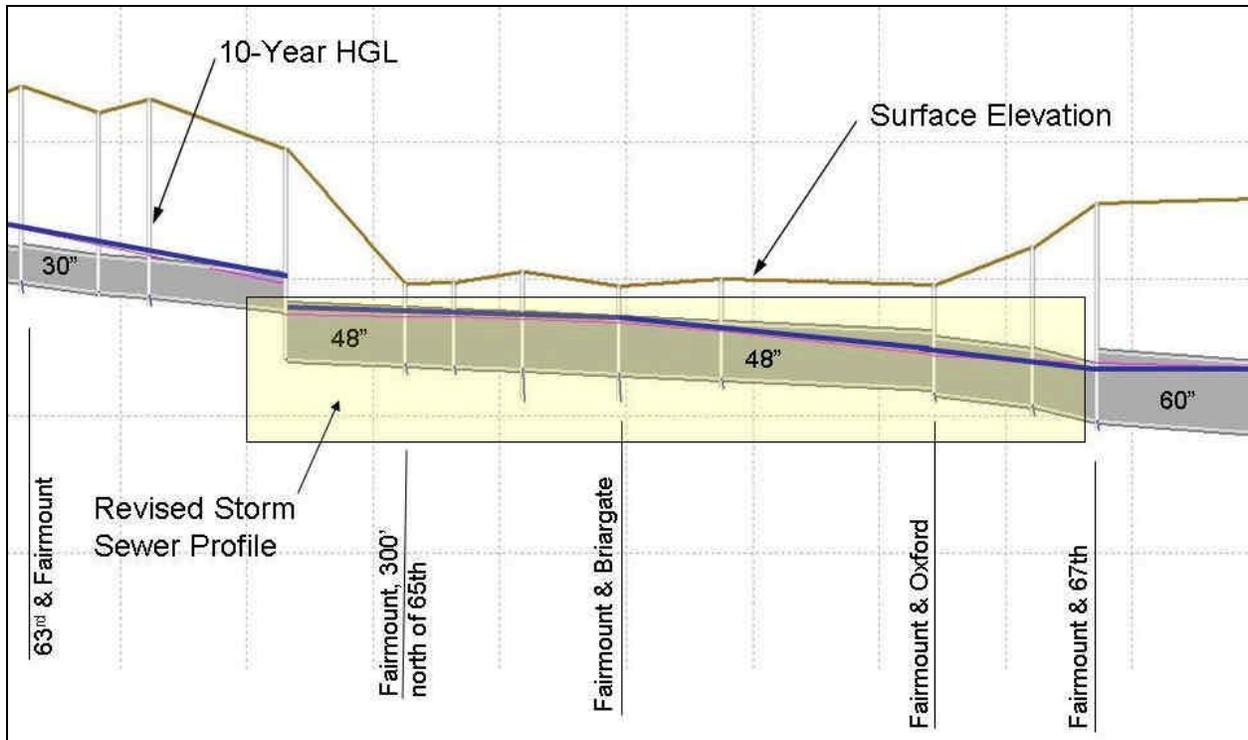
Figure 614-5  
10-Year HGL, Revised Storm Sewer Profile & Downstream Relief Sewer

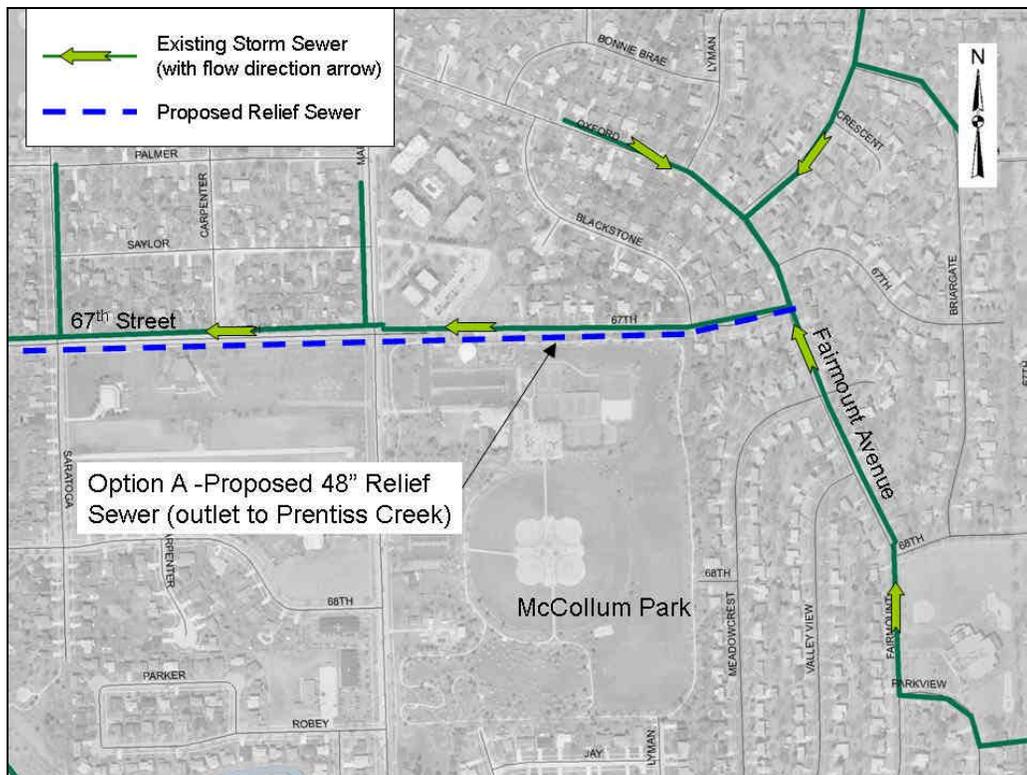
Construction of the relief sewer would require over 4,000 LF of 48-inch storm sewer along 67<sup>th</sup> Street, according to this study (a detailed study would be required prior to final design). This would also increase the 10-year peak flow rate released to Prentiss Creek by approximately 43 cfs, from 253 cfs to 297 cfs, an increase of 17%. Figure 614-6 shows the location of this relief sewer.

Figure 614-6  
Option A – Construction of Relief Sewer

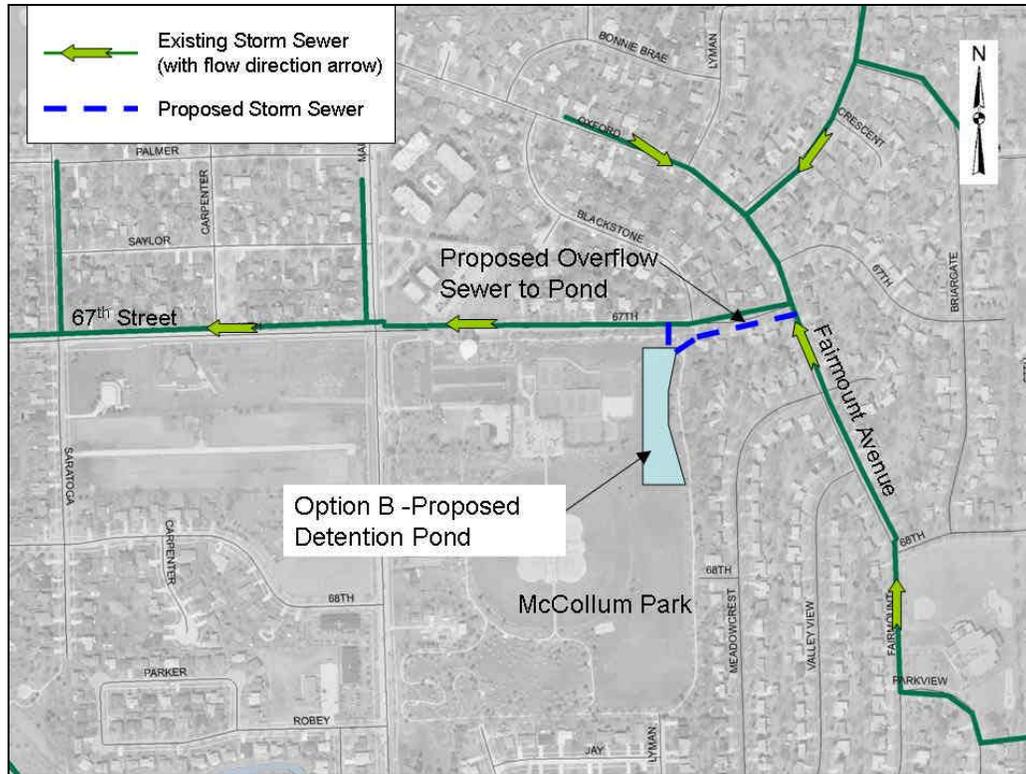
Figure 614-7  
Option B – Construction of Detention Pond

To avoid the disruptive construction along 67<sup>th</sup> Street and to minimize the increase in discharge to Prentiss Creek, a detention facility should be constructed in McCollum Park (Option B). There is already a depressional area in the northeast corner of the park; this area could be increased to act as overflow for the 60-inch trunk storm sewer along 67<sup>th</sup> Street. Figure 614-7 illustrates the proposed location for a detention facility. Alternatively, underground storage could be constructed at this site if space becomes an issue.

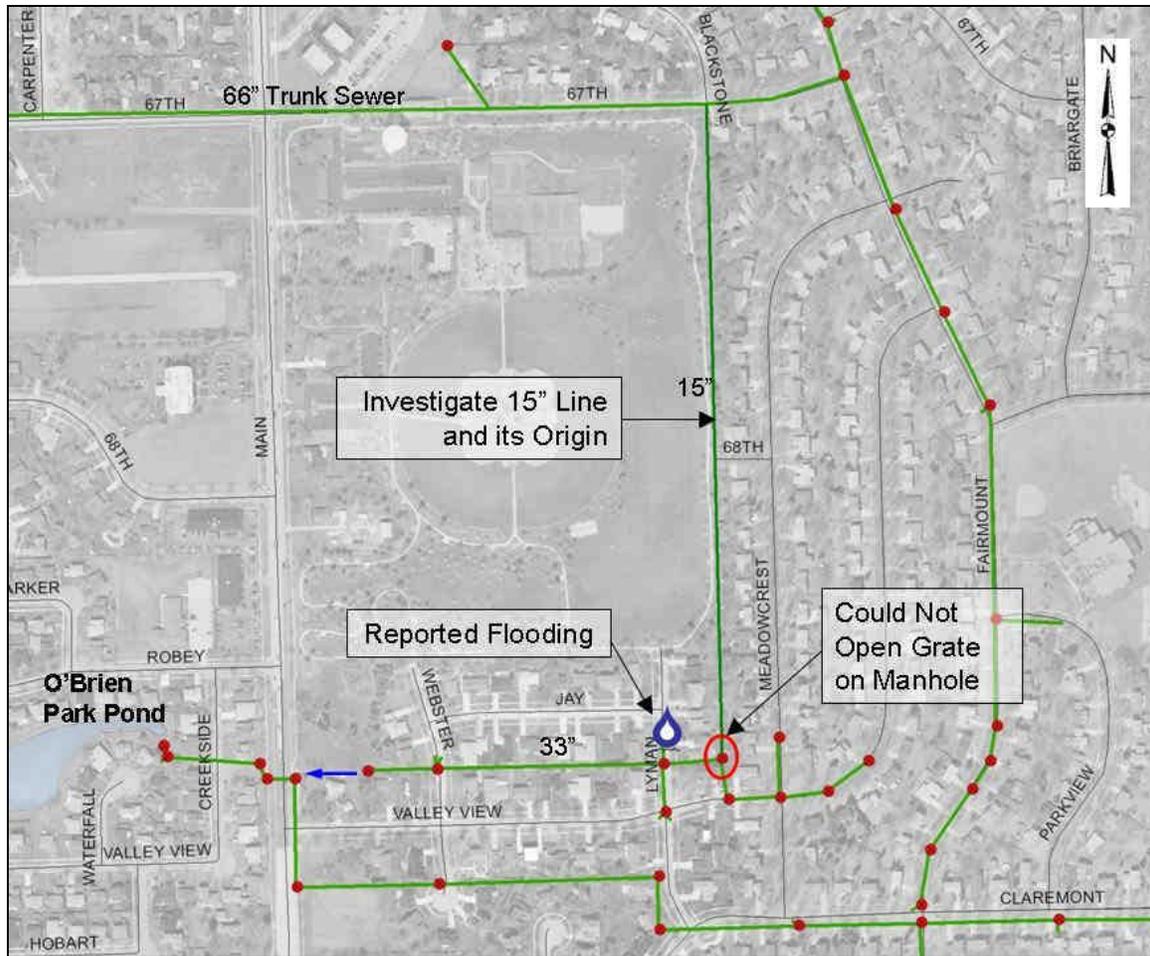
Water may be backing up from the 15-inch storm sewer running northerly between Lyman and Meadowcrest; this sewer ultimately flows to the 60-inch trunk sewer along 67<sup>th</sup> Street. This sewer may backflow when the 66-inch sewer is at or above capacity, causing a backup in the Valley View system. Determination of the hydraulics of this sewer will require further investigation. Figure 616-3 illustrates the storm sewer in this area.

Figure 616-3  
Storm Sewer System, Vicinity of Valley View Drive
