# VILLAGE OF DOWNERS GROVE

## POLICE STATION

ASSET CODE: PS0825

FACILITY CONDITION ASSESSMENT

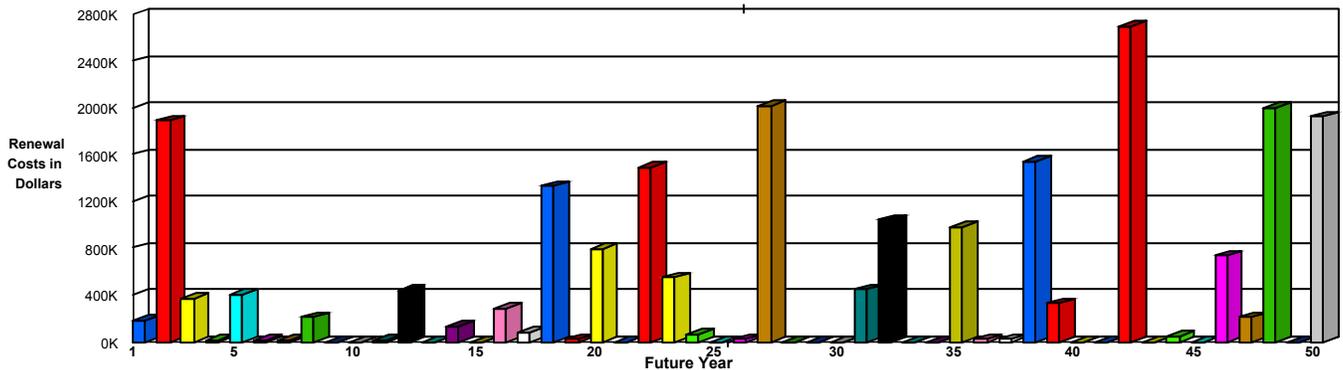
### Life Cycle Model Expenditure Projections

**Average Annual Renewal Cost per SqFt \$7.65**

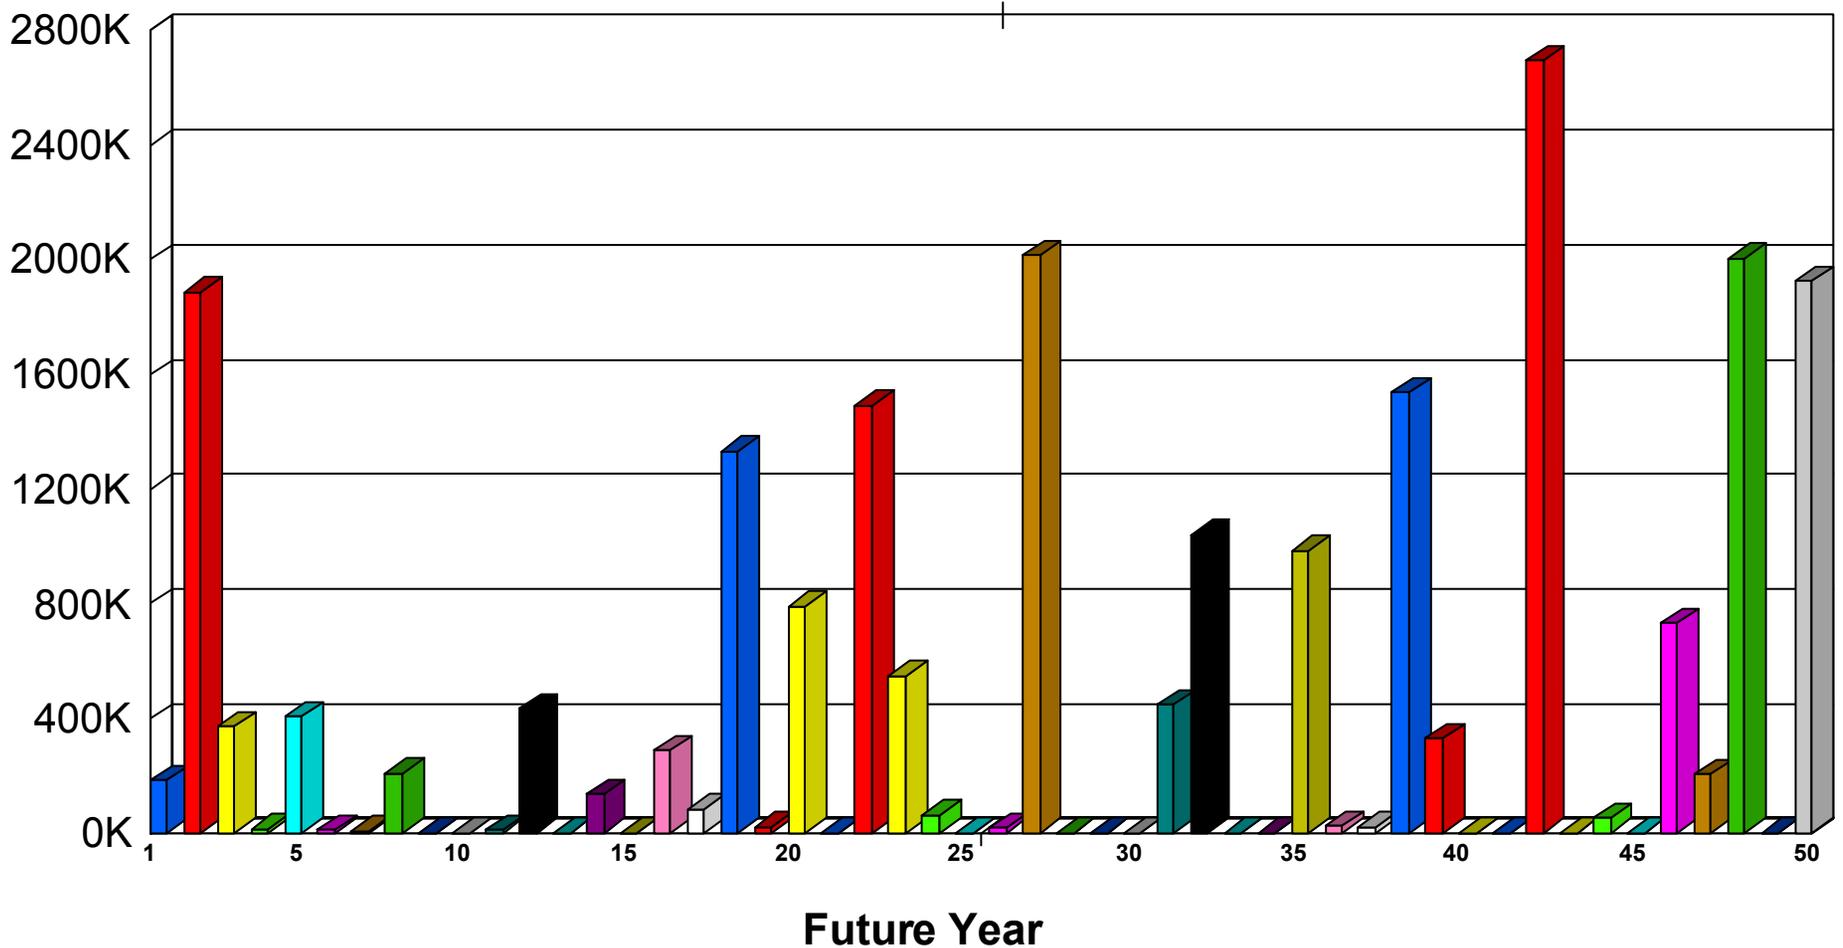
# Life Cycle Model Expenditure Projections

Average Annual Renewal Cost per SqFt \$7.65
