# Project Plan Water System Improvements

Village of  
Downers Grove, Illinois  
April 2015

## Project Plan Water System Improvements

STRAND ASSOCIATES, INC.®  
IDFPR No. 184-001273  
1170 South Houbolt Road  
Joliet, IL 60431  
www.strand.com  
April 2015

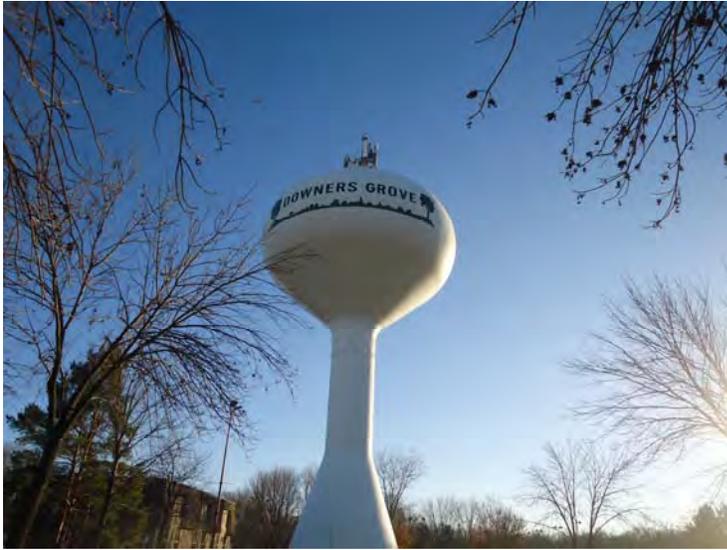
1. The exterior coating is in good condition with no significant coating deterioration found.

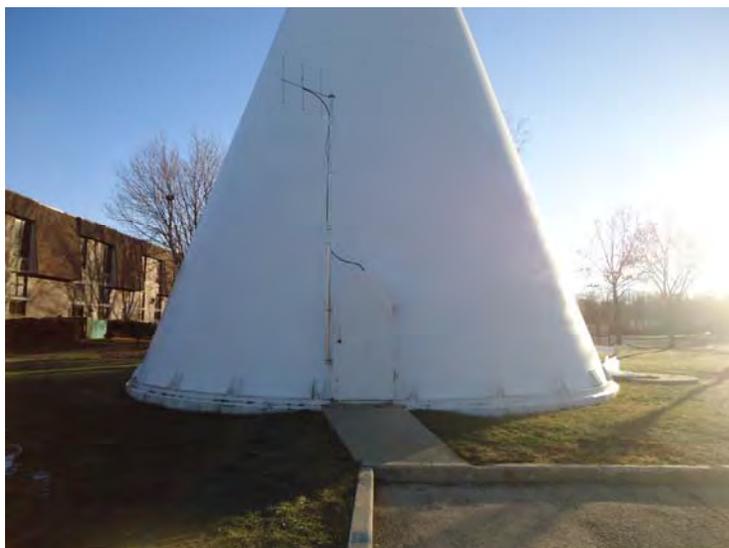
3. The coating on the base cone exterior is in good condition.

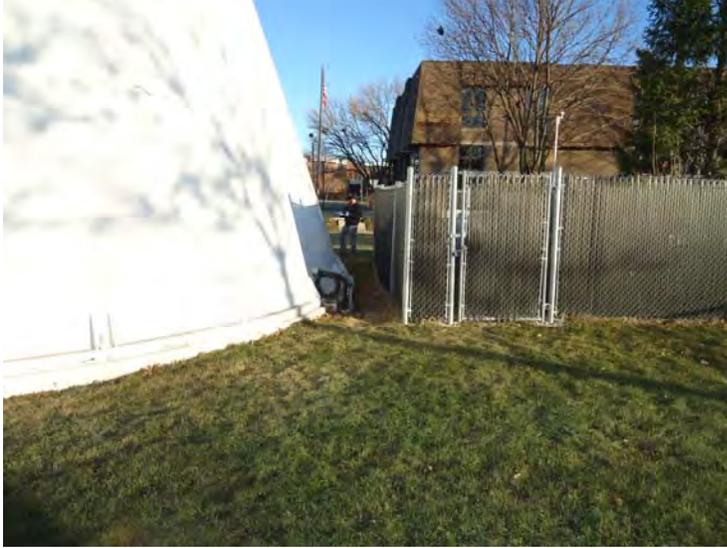
4. An antenna site next to the tank is close to the foundation.

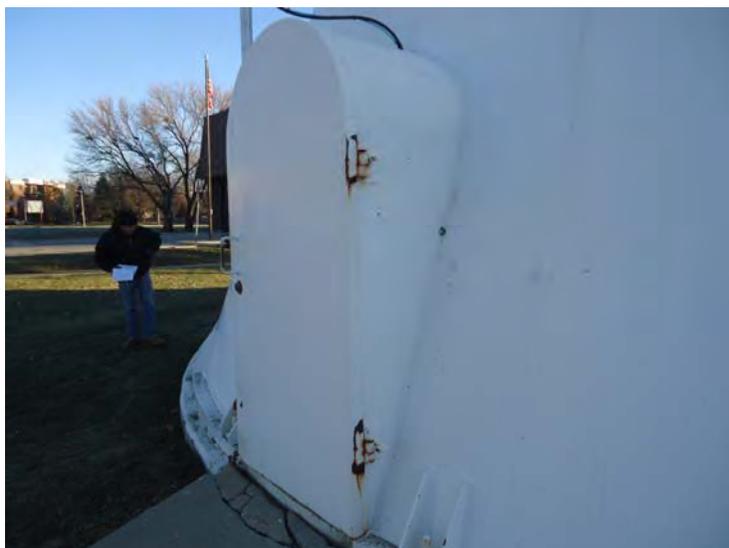
6. The base cone door is in good condition and operated properly during the inspection.

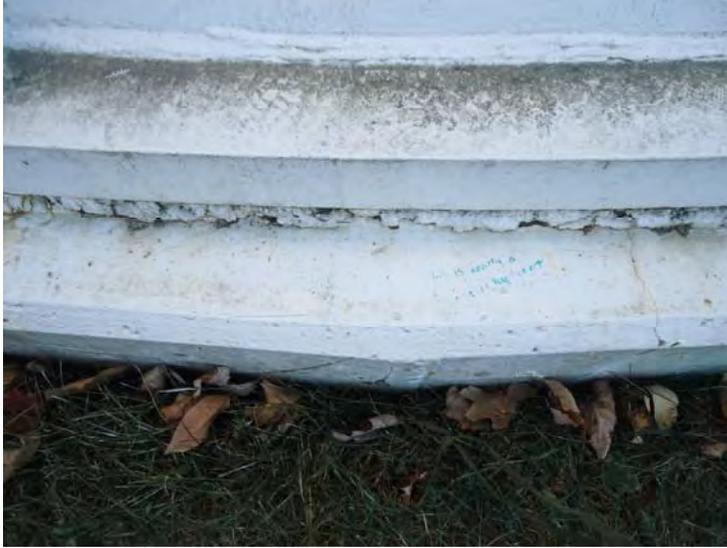
7. The foundation grout is in poor condition with one foot missing.

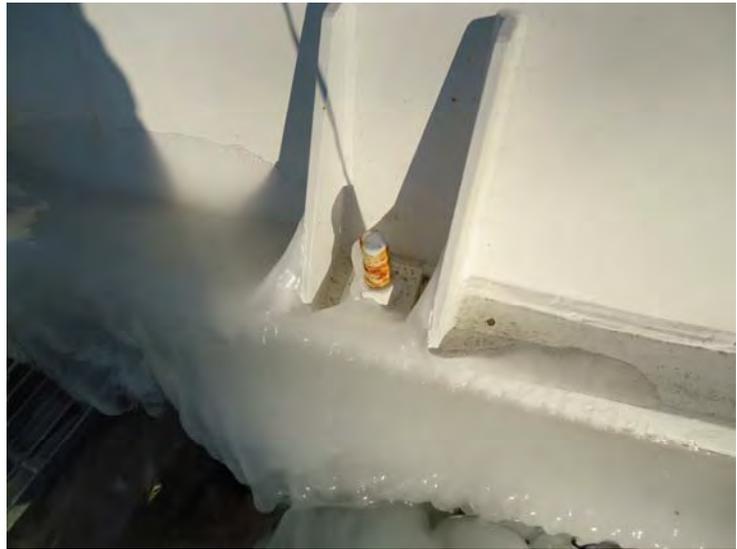
8. The anchor bolts and chairs are in good condition. The coating is in fair condition.

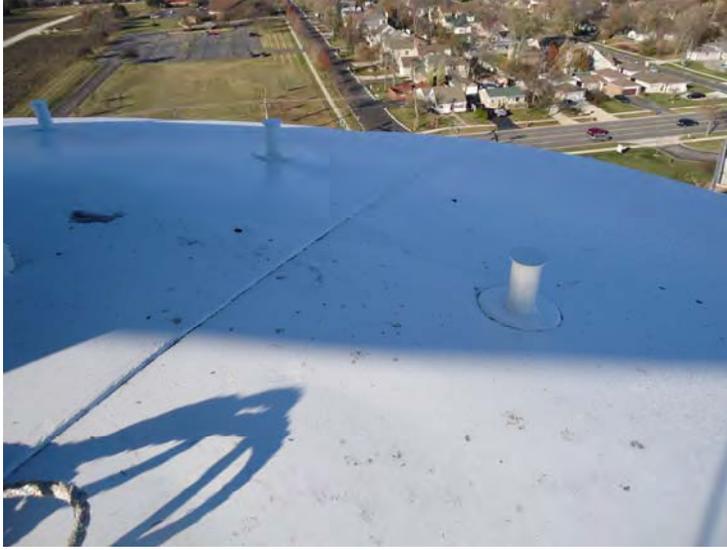
10. The exterior roof coating is in poor condition. Extensive topcoat delamination was found.

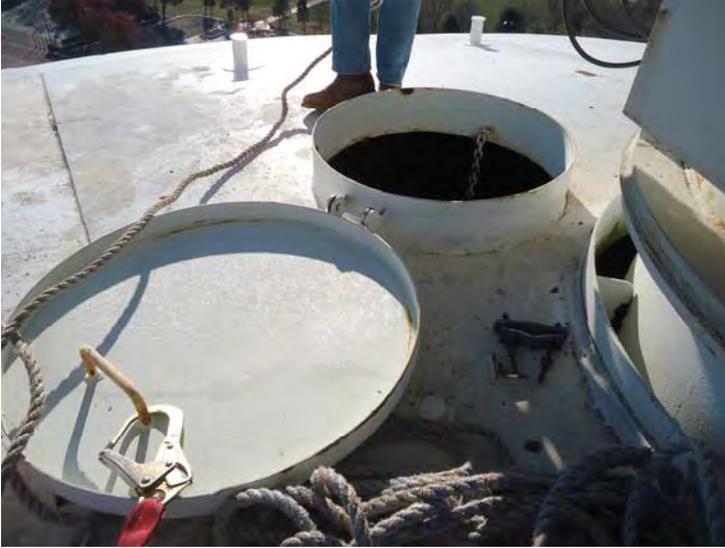
13. The roof hatch into the wet interior is in good condition.

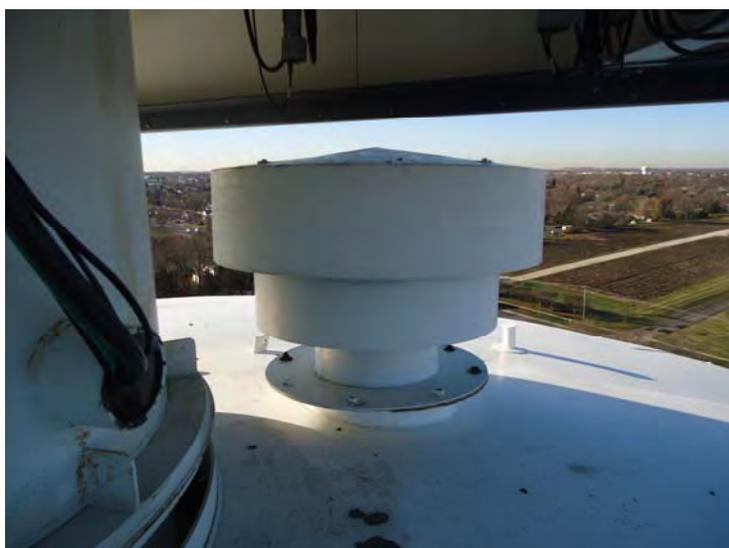
15. The screened pressure vacuum vent is in good condition.

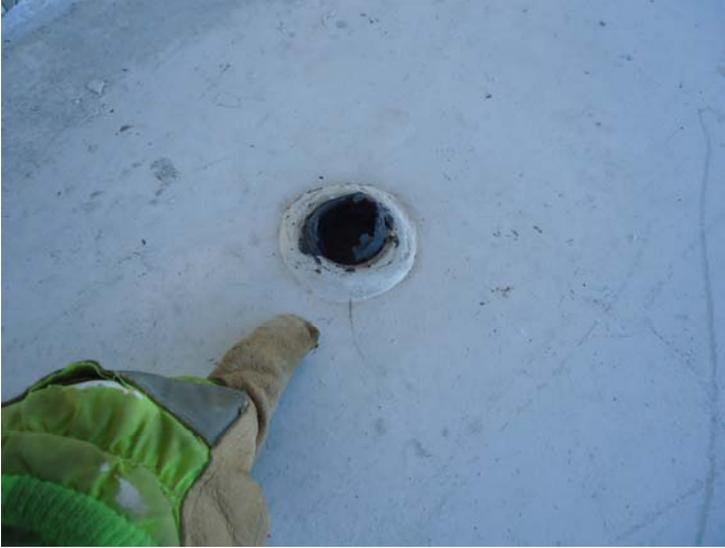
16. The roof couplings are not properly plugged.

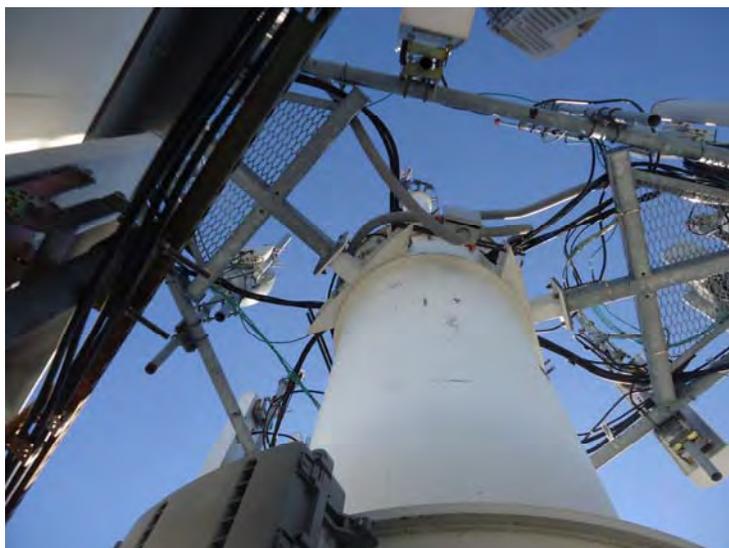
18. The pod is in good condition.  
The coating is in fair condition.

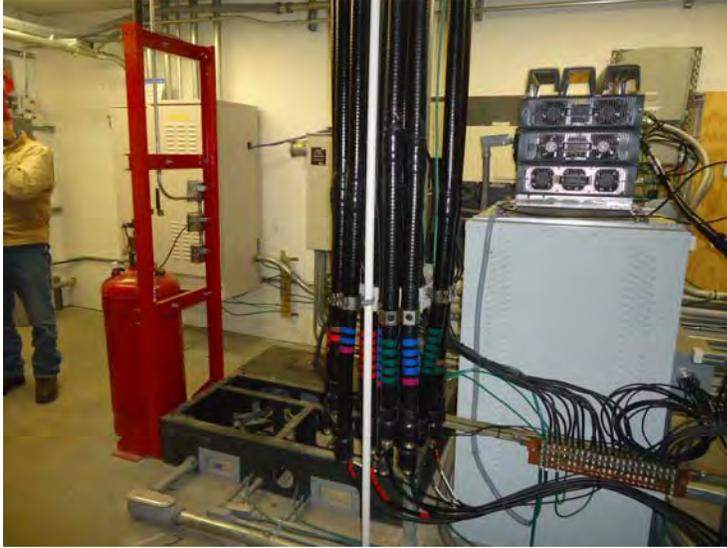
19. The base cone is completely filled with electronic components.

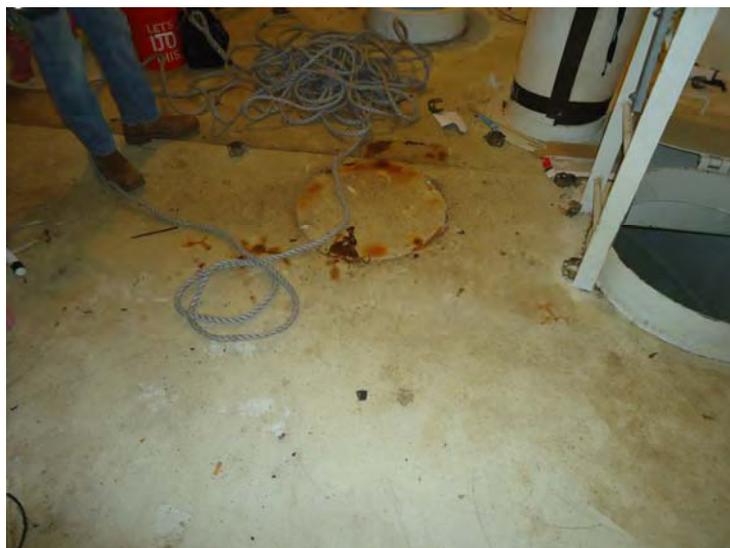
21. Coating on the top of the bottom platform is in fair condition.

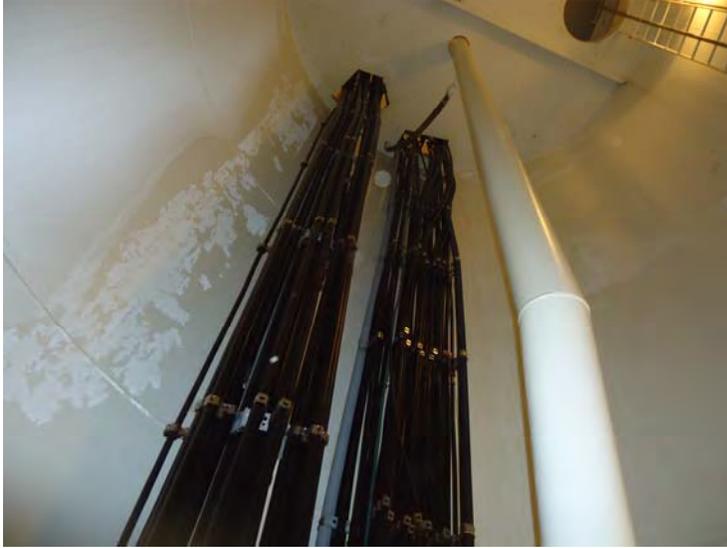
22. Cables are well routed through the stem.

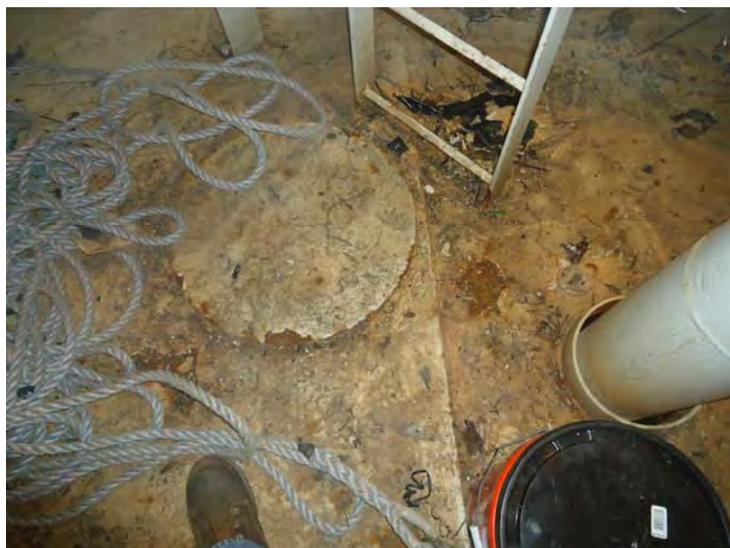
24. The coating on the top of the top platform is in fair condition.

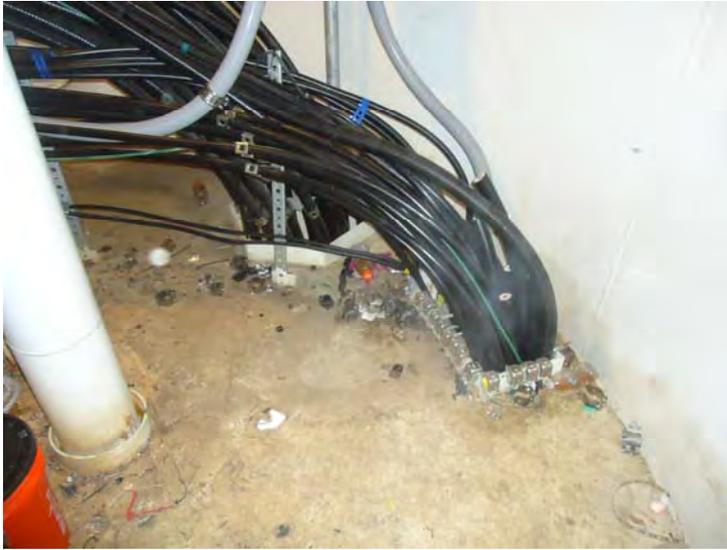
25. Cables routed above the top platform interfere with movement.

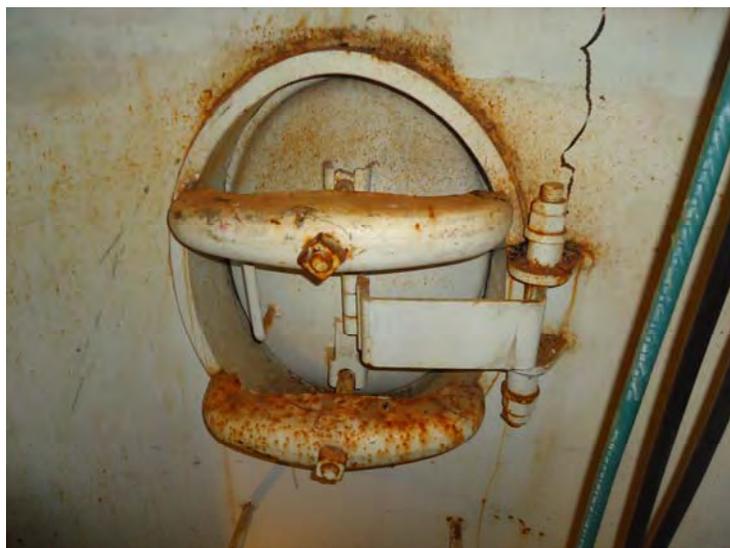
27. The manway into the wet interior is in good condition. The coating is in poor condition.

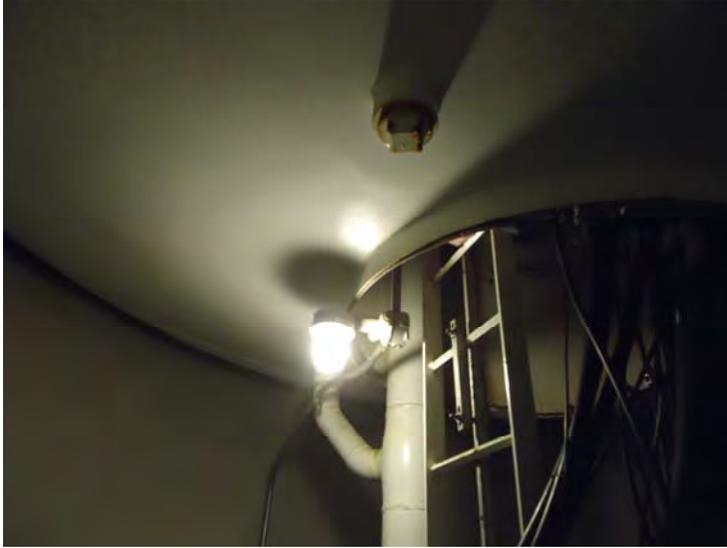
28. The bowl coating is in good condition.

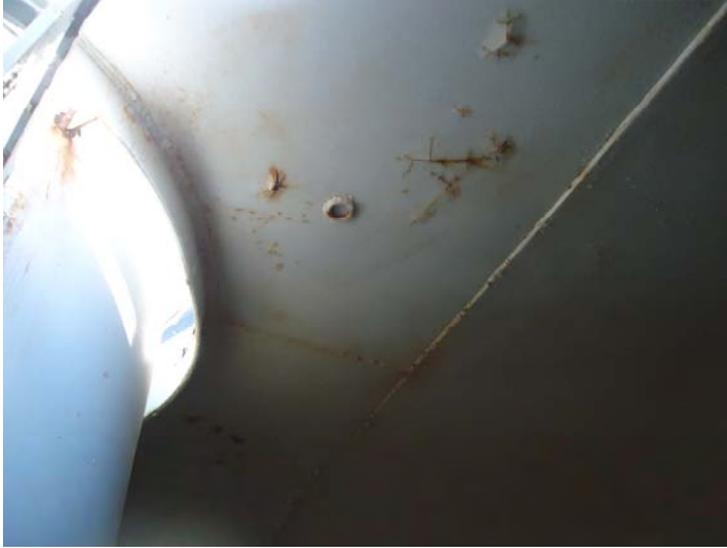
31. The wet interior roof coating is in good condition.

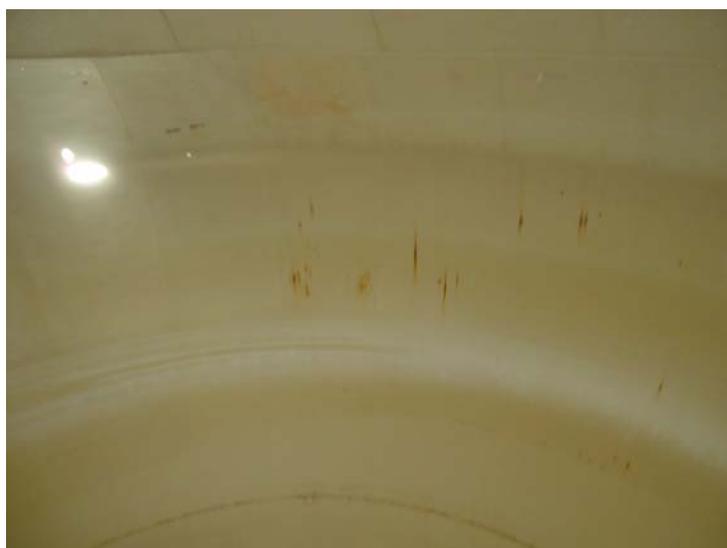
33. Multiple spot coating failures on the wet interior sidewalls were found. The areas are rusting.

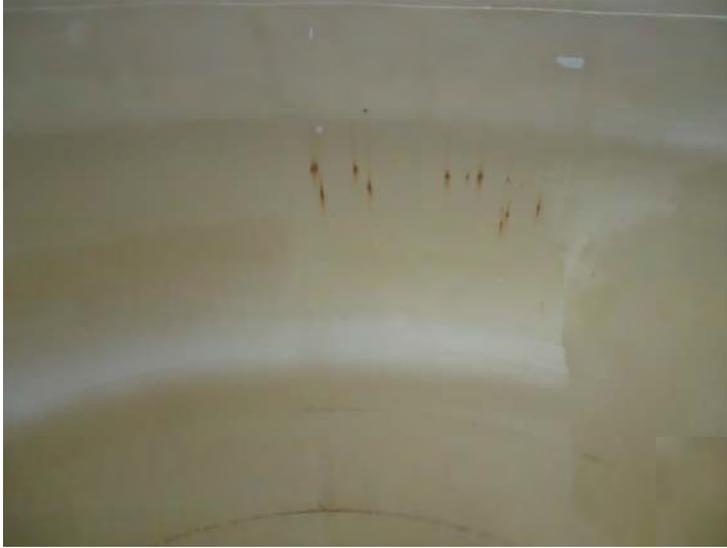
34. Spot coating failures on the wet interior sidewalls are rusting.

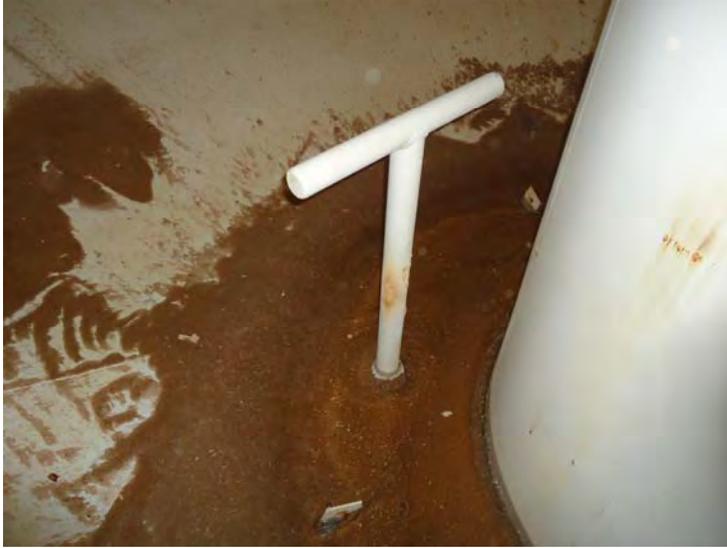
37. The mud at the bottom of the tank was frozen at the time of the inspection. The mud valve operates from the wet interior.

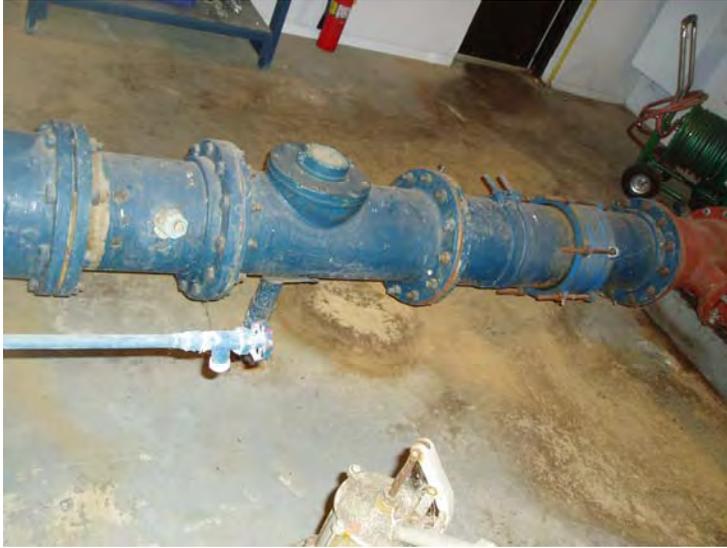
2. The piping located in the building is in good condition. The piping coating is in poor condition. There is delamination, rust bleed through, and spot coating breaks to the substrate with rust undercutting.

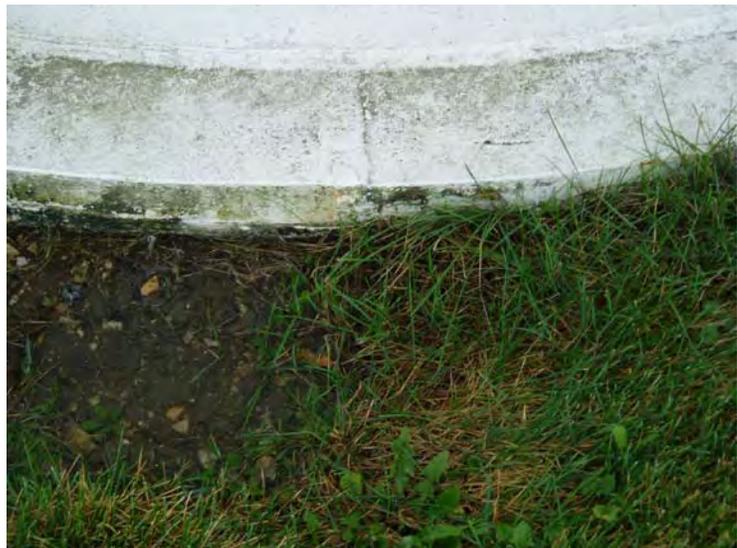
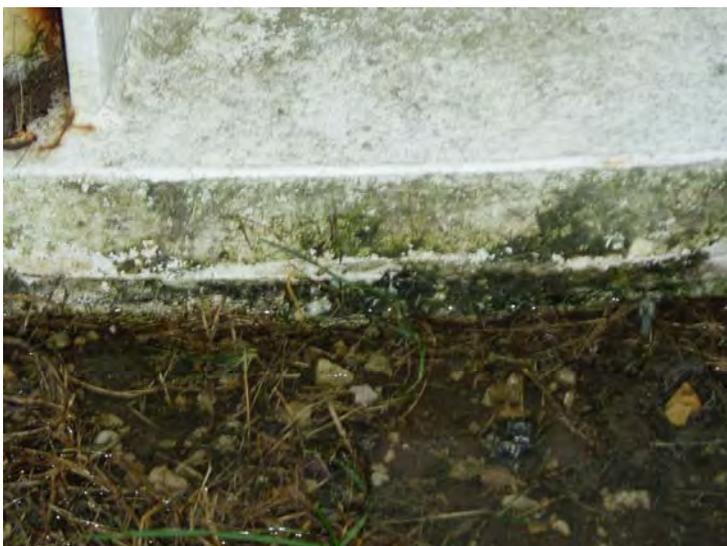
3. The riser foundation is buried and is not accessible for inspection.

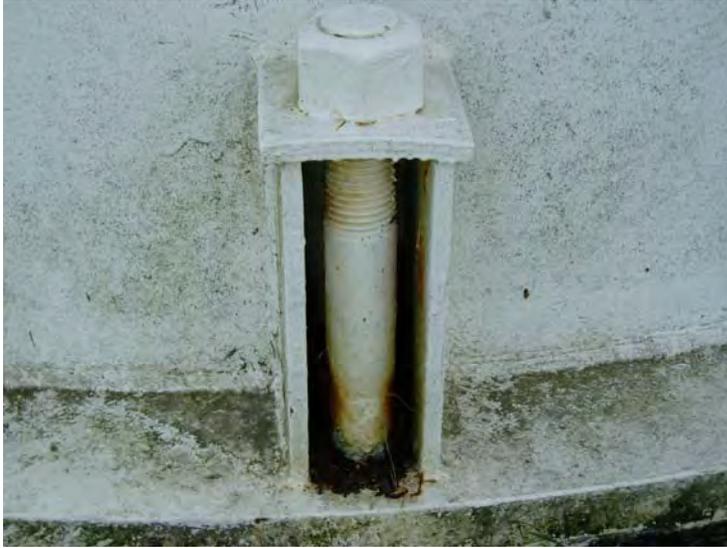
4. The riser grout is in good condition with no significant deterioration.

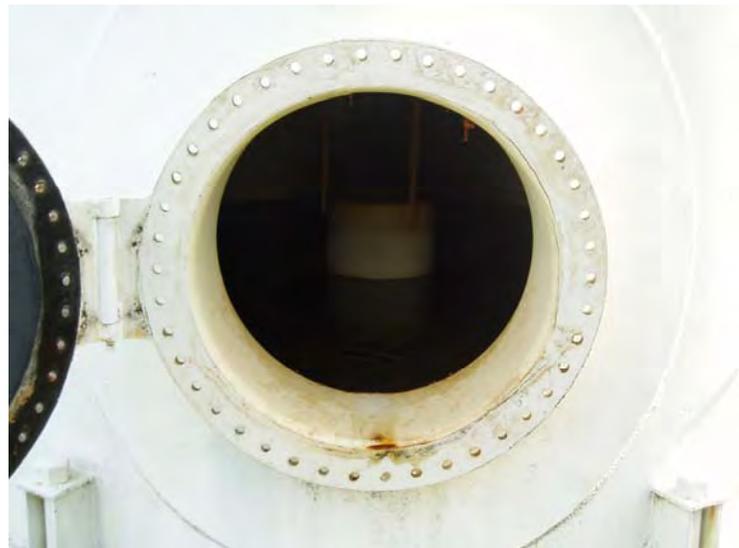
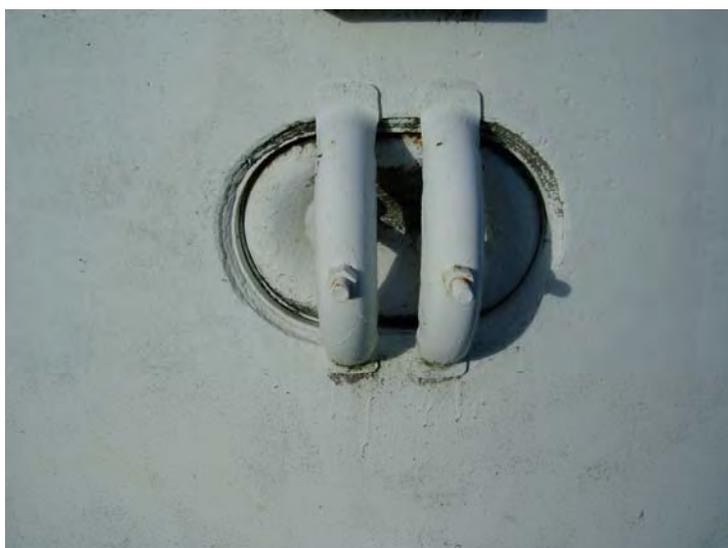
6. The bolted riser manway is in good condition. The manway is hinged and the gasket showed no signs of leaking. The coating is in poor condition.

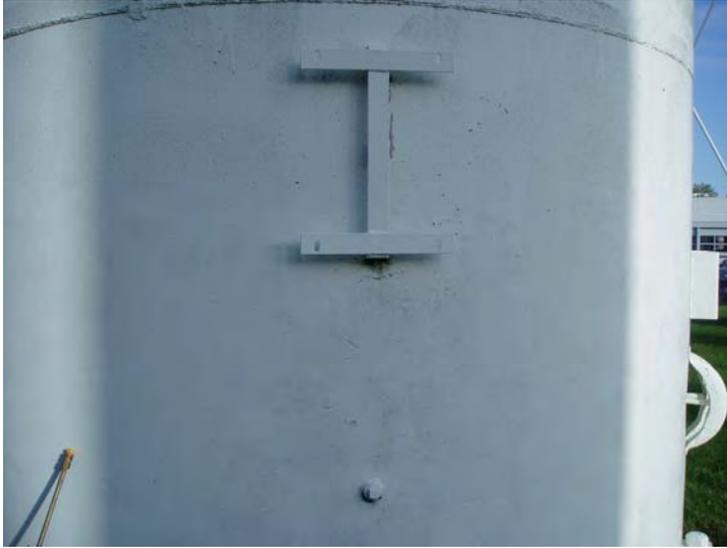
7. The second riser manway is in good condition. The manway is not hinged and the gasket showed no signs of leaking. The coating is in poor condition.

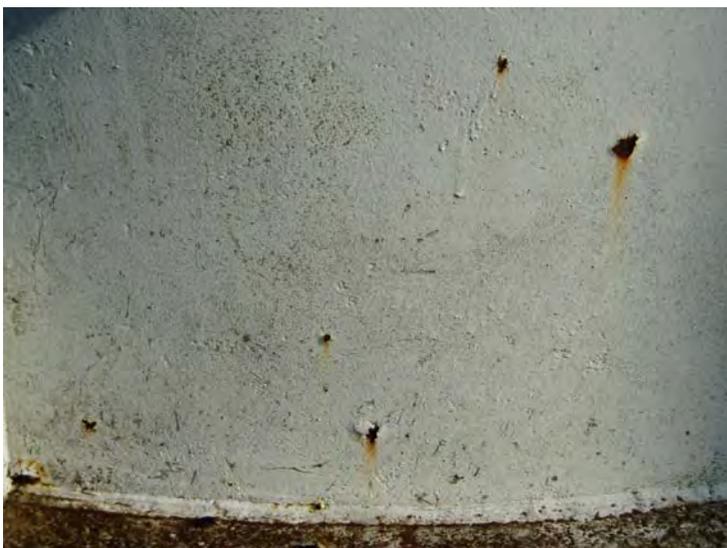
9. The exterior riser coating is in poor condition. The coating is chalking, fading, and eroding.

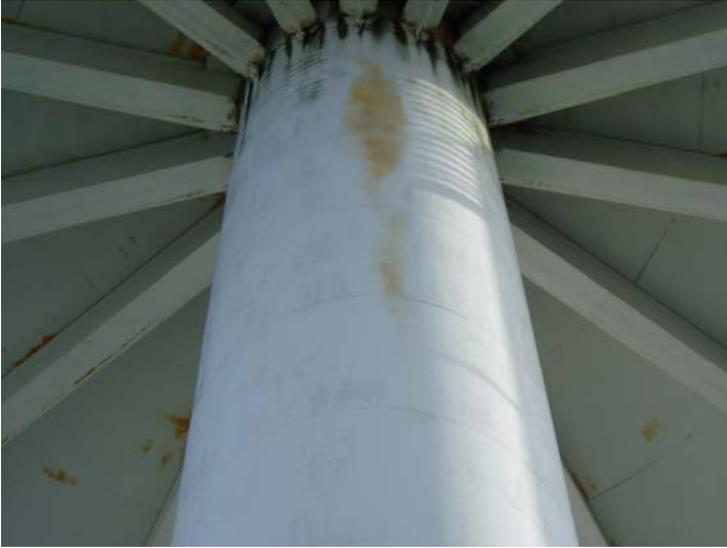
10. There are spot coating breaks to the substrate with rust undercutting.

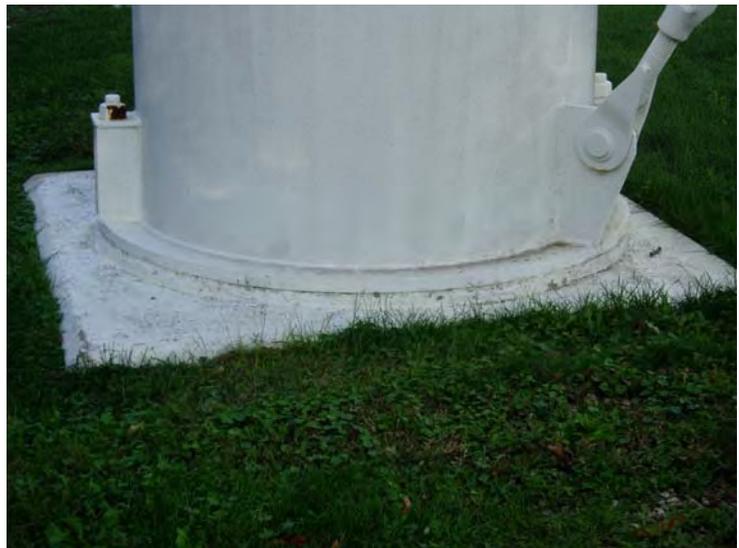
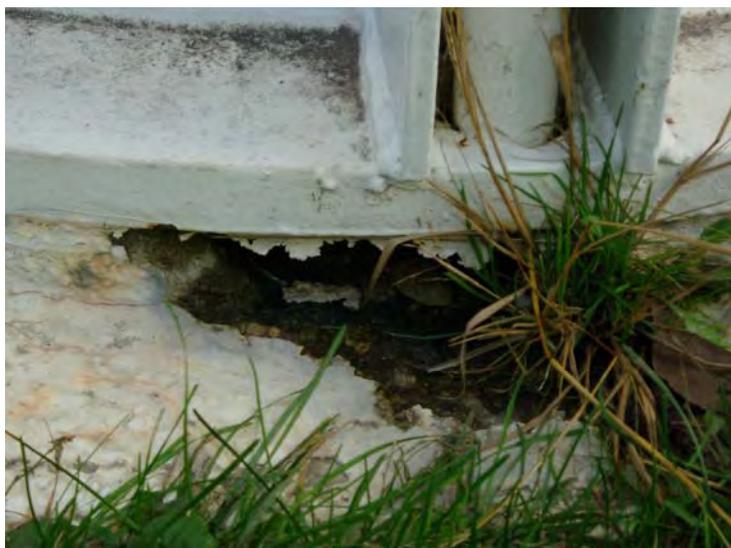
12. The leg foundations are in good condition with minor chips and cracks.

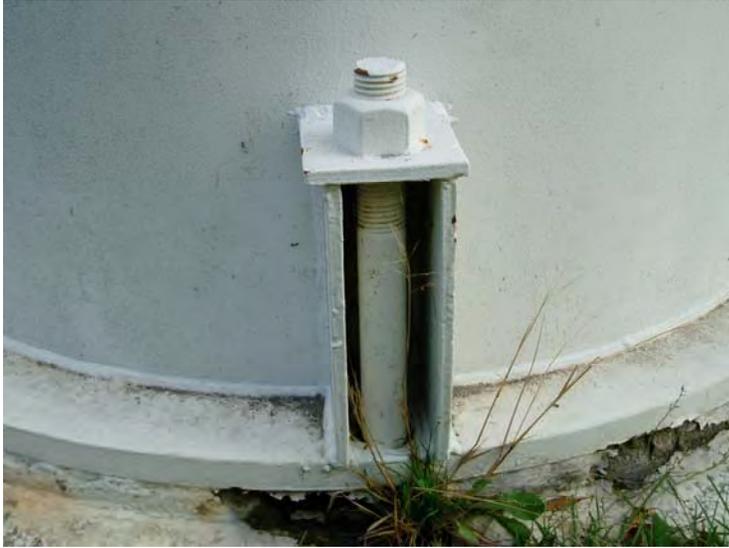
13. The leg grout is in good condition overall with a few areas of grout missing.

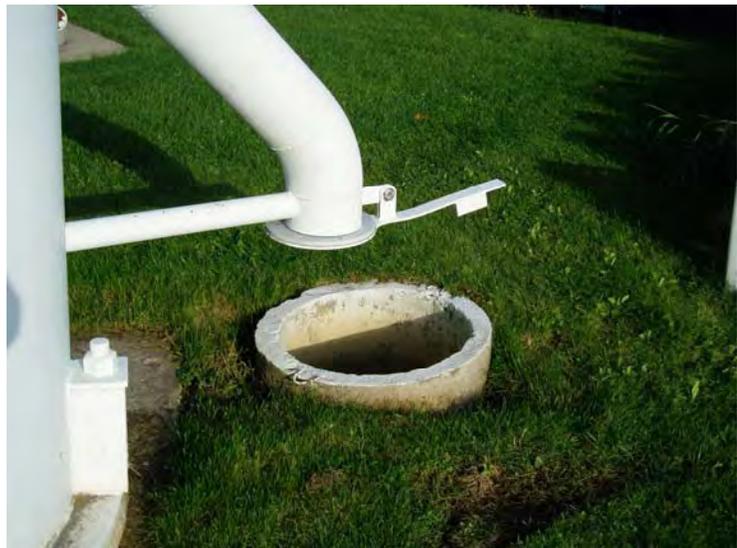
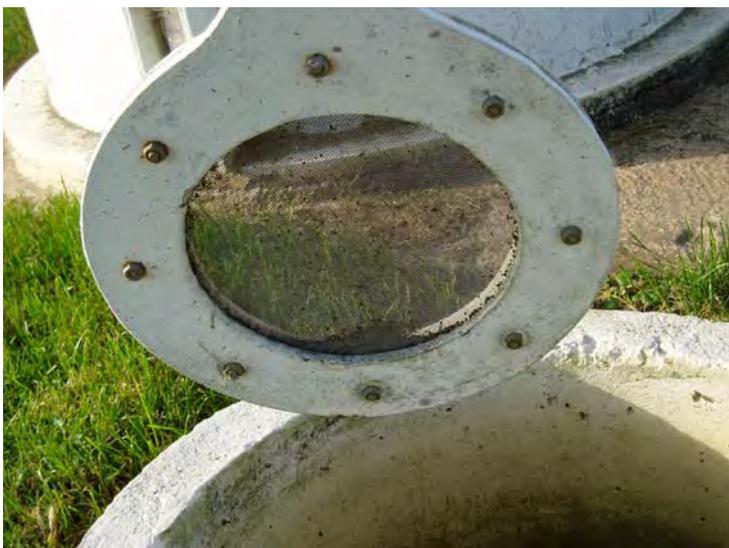
15. The overflow pipe discharges to a storm drain with the required air gap. The overflow pipe and storm drain are in good condition. The coating is in poor condition.

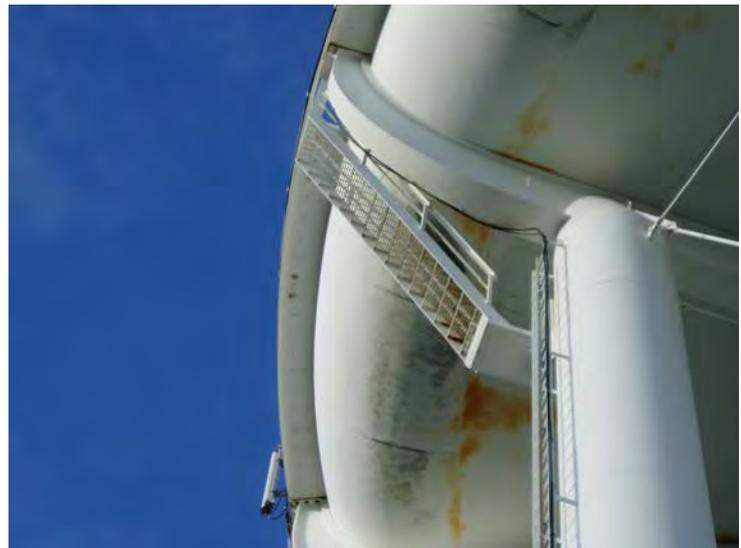
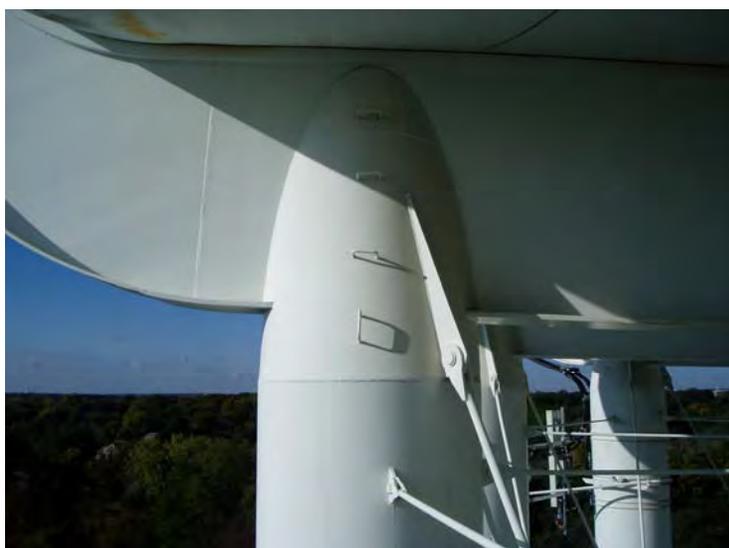
18. There is a step off platform with stairs leading from the top of the leg ladder to the balcony. The step off platform and stairs are in good condition. The coating is in fair condition.

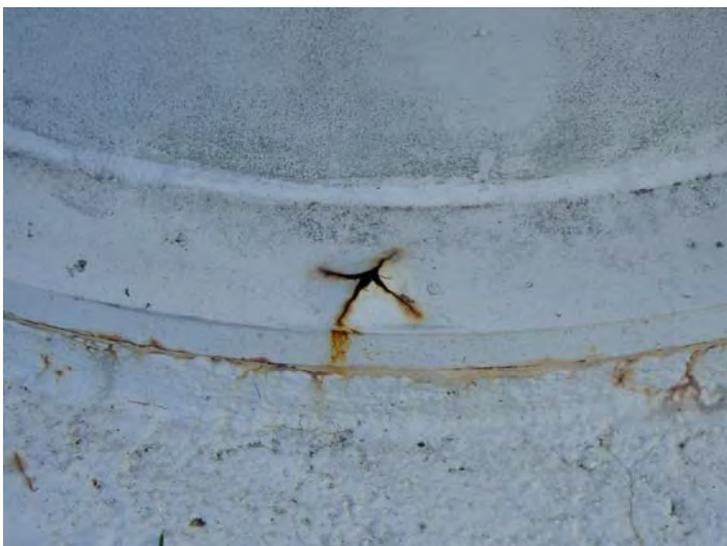
21. The exterior leg coating is in poor condition. The coating is chalking, fading, and eroding. There is rust bleed through.

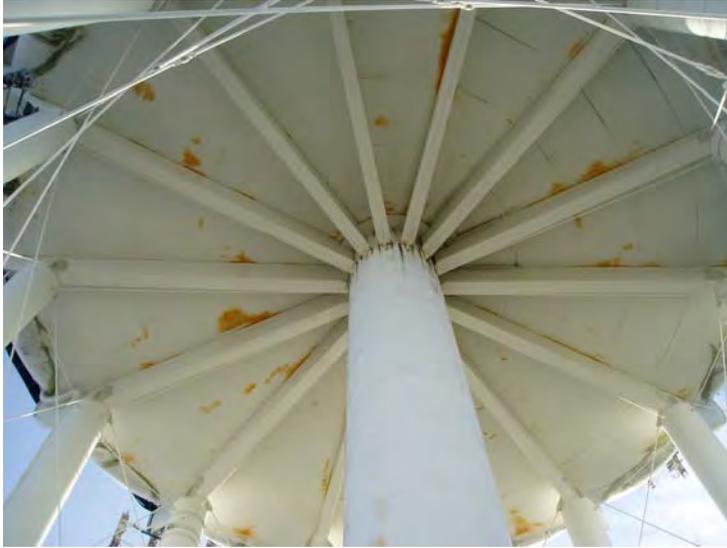
22. There are spot coating breaks to the substrate with rust undercutting.

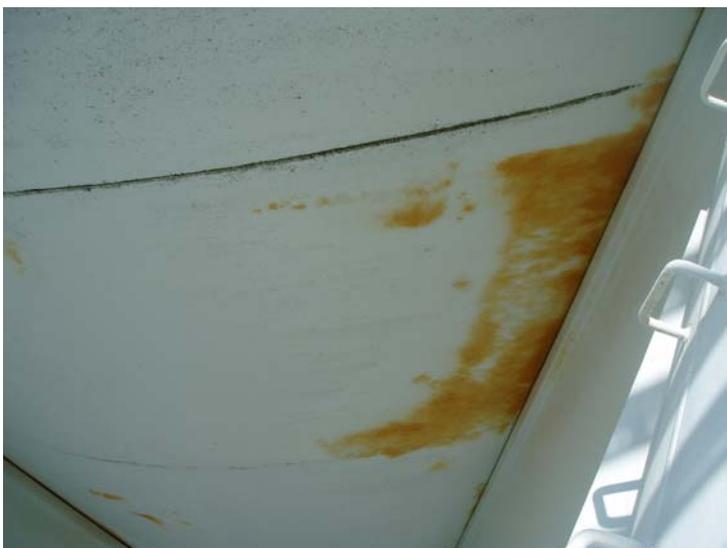
24. There are spot coating breaks to the substrate with rust undercutting.

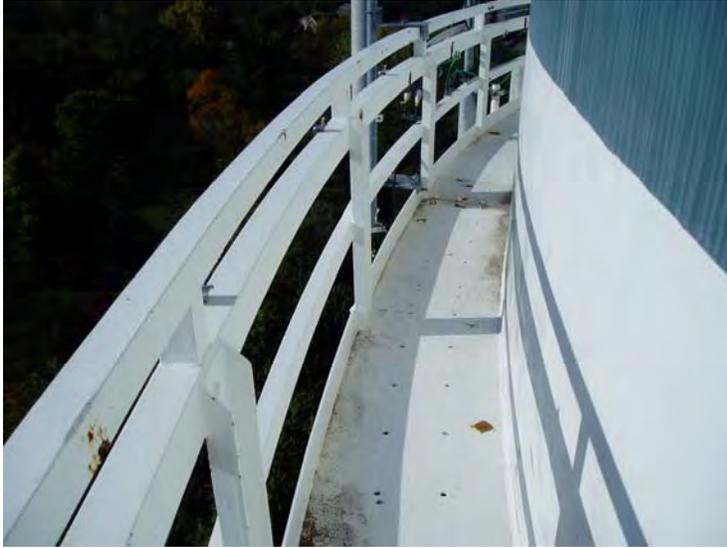
25. There is rust bleed through.

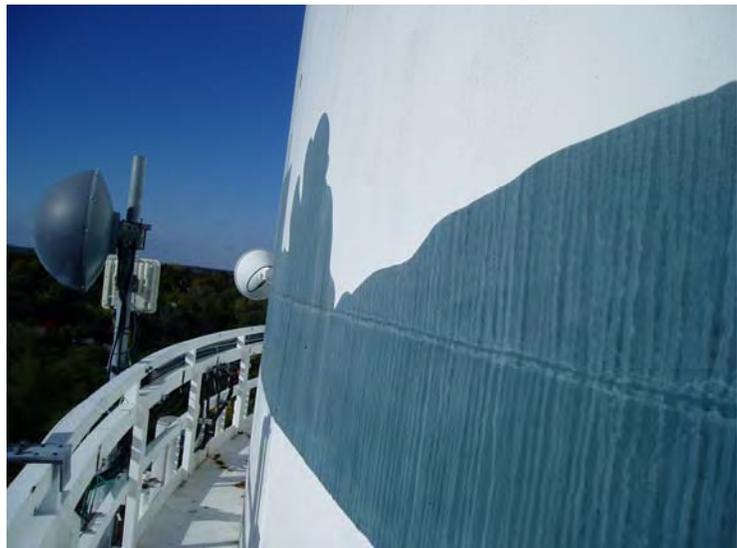
27. The antennas attached to the balcony handrail appear to be in good condition.

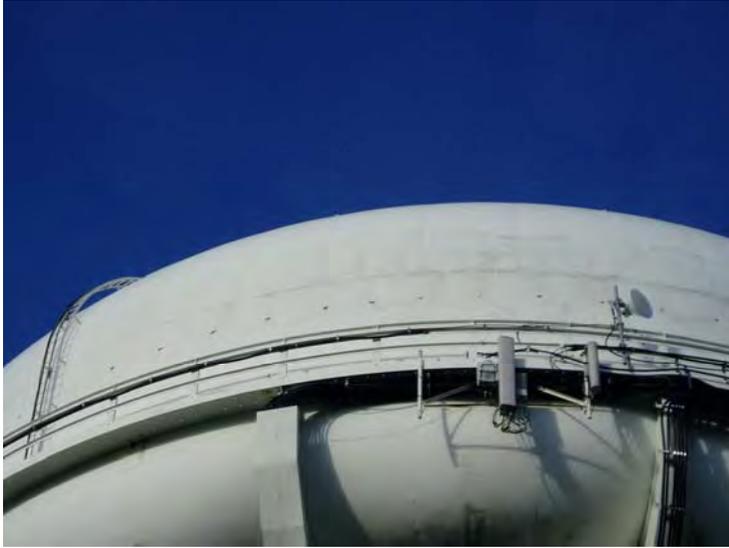
28. The sidewall ladder contains a rail-type fall prevention device. The ladder and fall prevention device are in good condition. The coating is in fair condition.

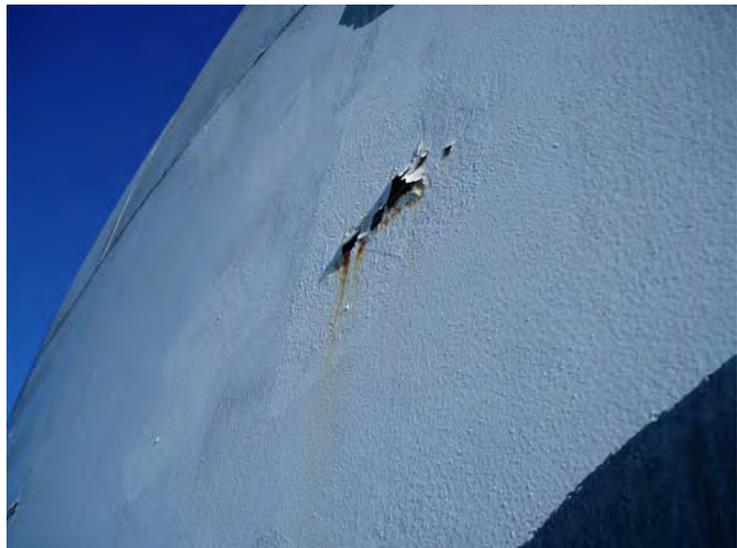
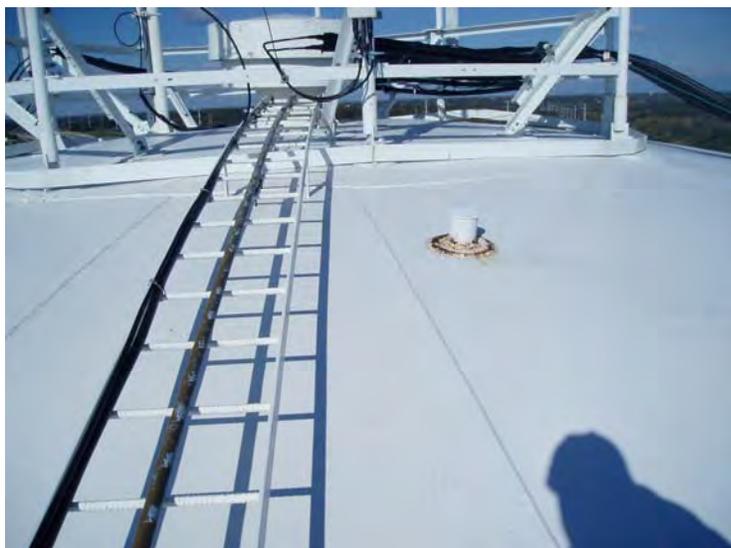
30. There are spot coating breaks to the substrate with rust undercutting.

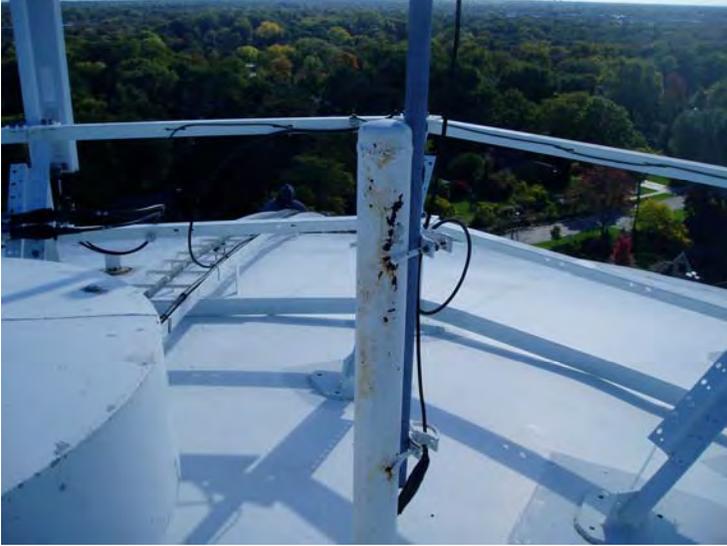
31. The roof ladder contains a rail-type fall prevention device. The ladder is in good condition. The fall prevention device is in fair condition. Some sections of the fall prevention device are misaligned. The coating is in poor condition.

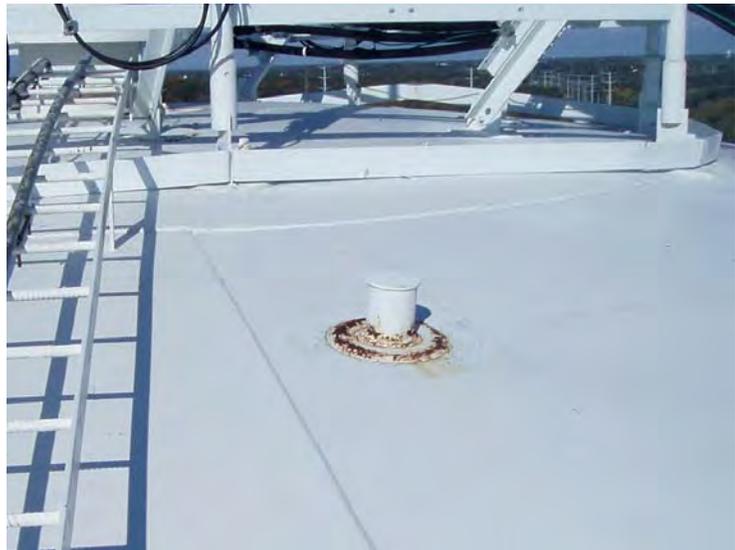
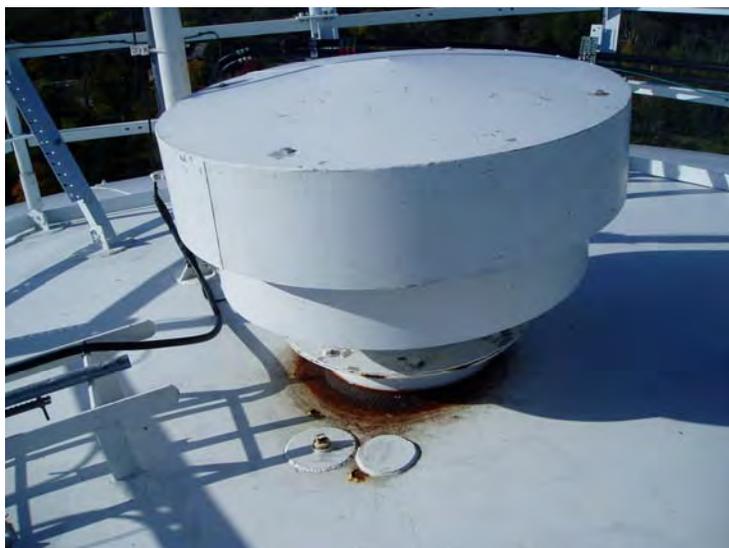
33. There are rigging posts located outside of the roof handrail. The posts are in good condition. The coating is in poor condition.

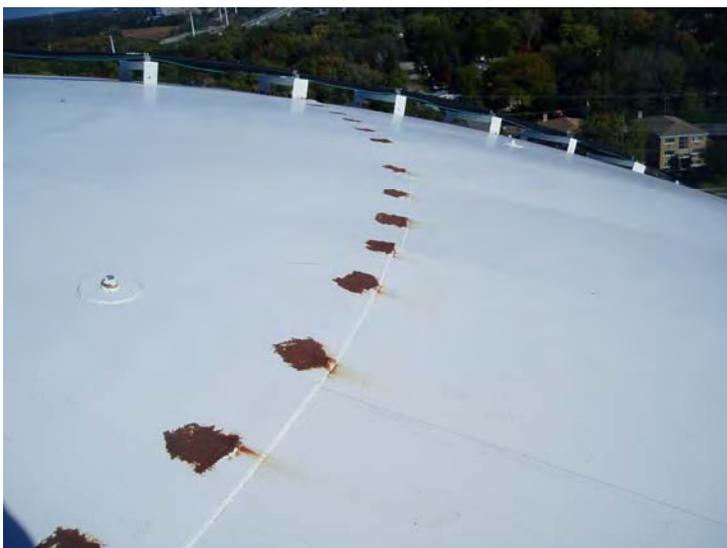
36. The exterior roof coating is in poor condition. The coating is chalking, fading, and eroding.

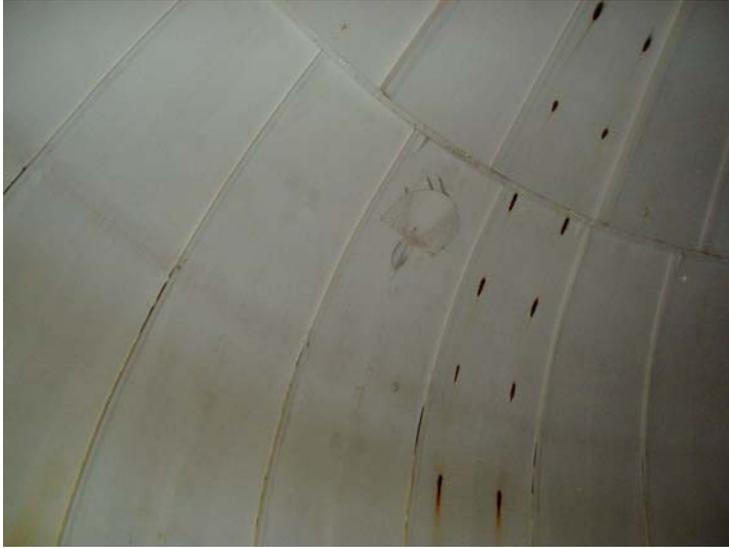
37. There is delamination and spot coating breaks to the substrate with rust undercutting.

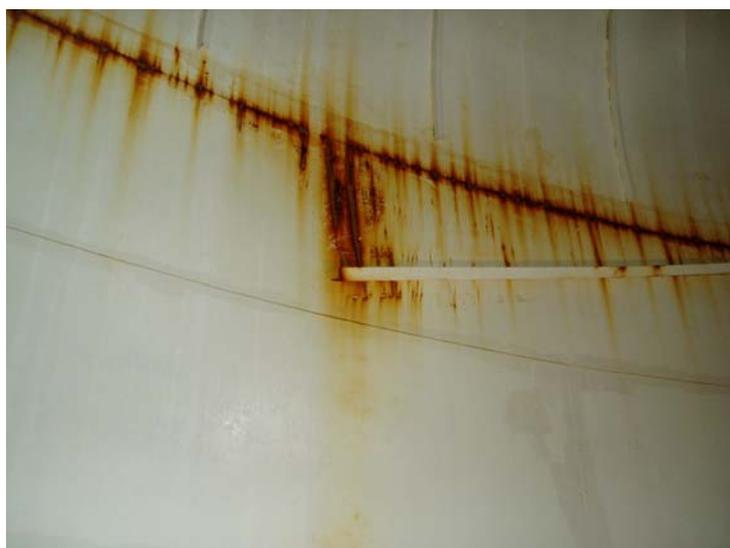
39. The wet interior roof coating is in fair condition overall. There is rust bleed through and weld burns.

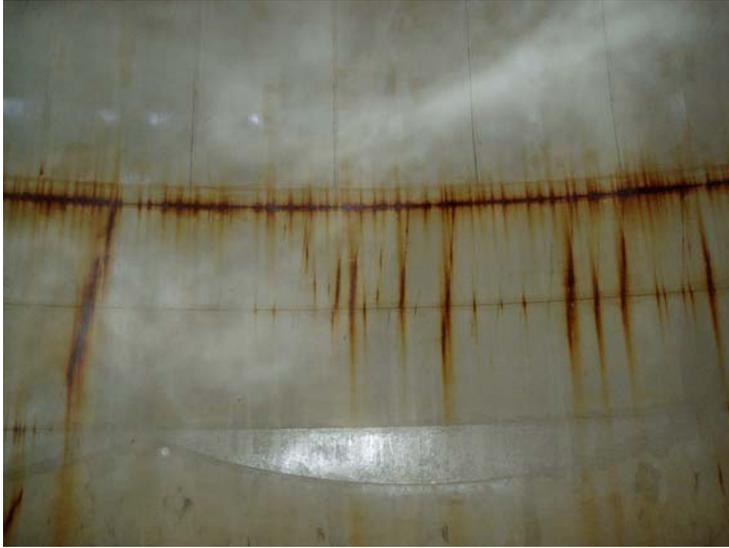
Comments: **Sections of the sidewall beam have been torn loose and are scraping the sidewall and bowl coating**

40. The wet interior sidewall beam is in poor condition. Sections of the beam are torn loose and scratching the sidewall and bowl coating. The beam coating is in fair condition.
