# Project Plan Water System Improvements

Village of  
Downers Grove, Illinois  
April 2015

## Project Plan Water System Improvements

STRAND ASSOCIATES, INC.®  
IDFPR No. 184-001273  
1170 South Houbolt Road  
Joliet, IL 60431  
www.strand.com  
April 2015

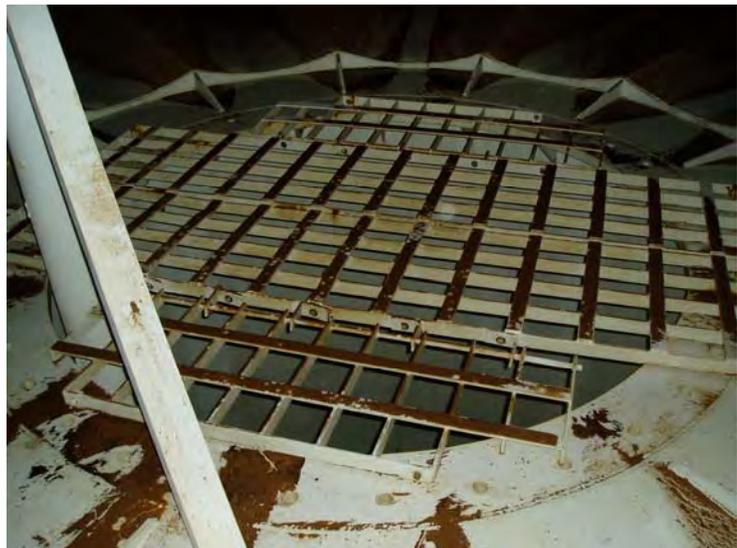
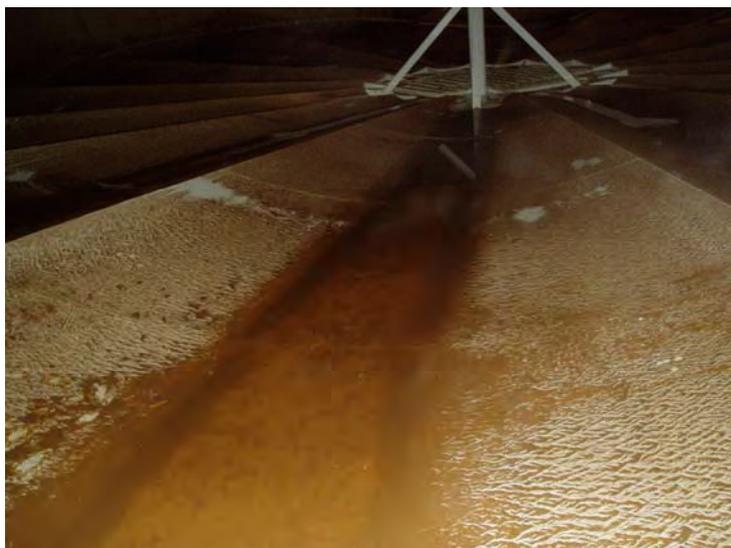
42. The grate over the top of the riser is in good condition. The coating is in fair condition.

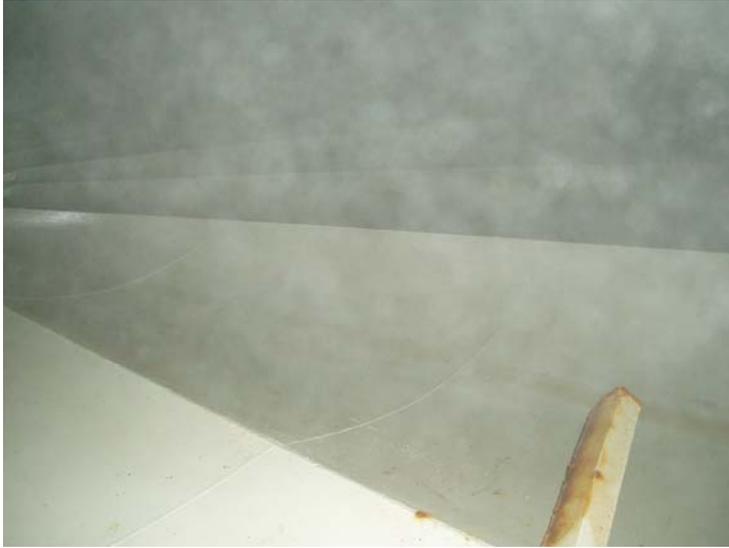
43. There was approximately 1/4-inch of mud sediment that was removed from the wet interior.

9. Retape/Reband the loose insulation on the fill pipe. Cost would be incidental to interior repainting.
10. Install a mud valve in the wet interior to aid with removal of sediment and draining of the tank. The estimated cost is \$4,500.
11. Install a rubber condensate platform with a 2-inch drain line to the overflow with check valve, this will ensure no future water damage to the existing fire house below. The estimated cost is \$15,000.

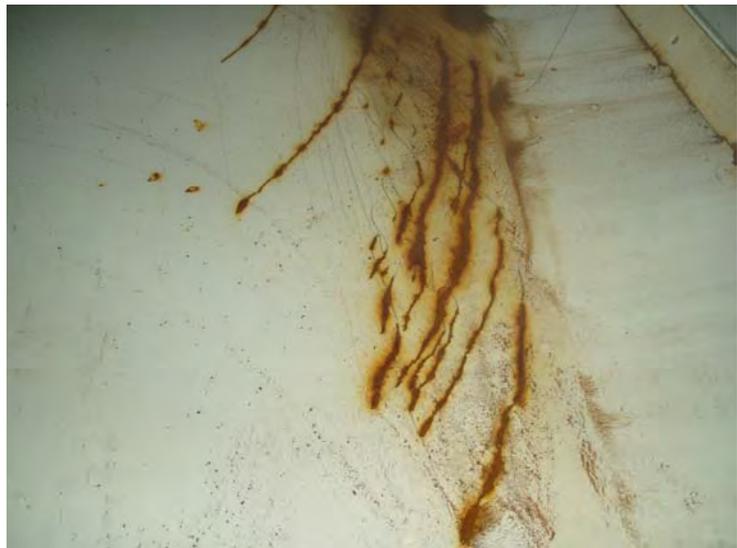
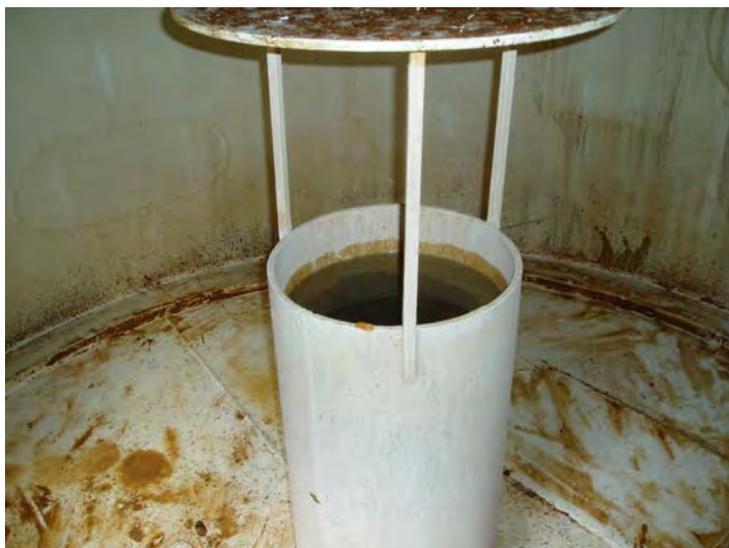
45. There are spot coating breaks to the substrate and scratches to the substrate. The coating is covered with light mineral staining.

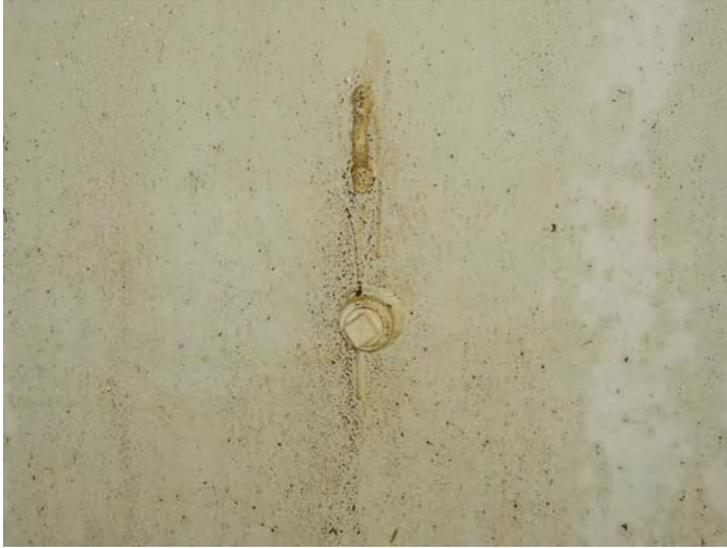
46. The fill pipe has a deflector plate. The fill pipe and deflector plate are in good condition. The coating is in fair condition.

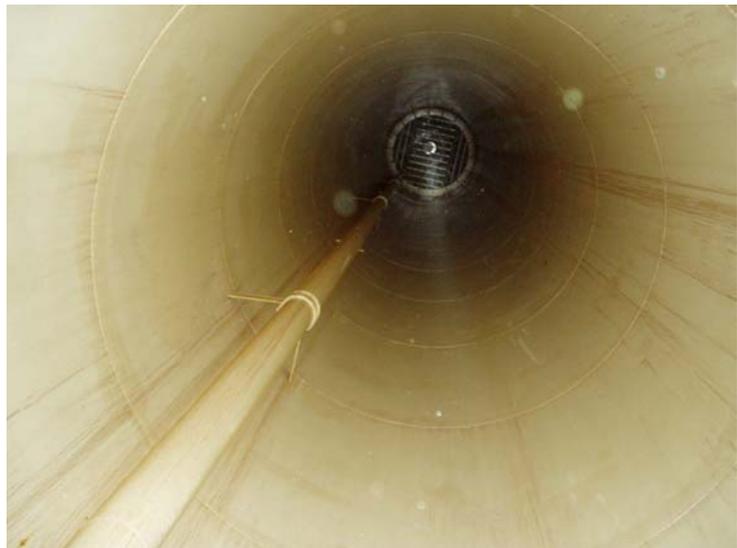
48. The wet interior riser coating is in fair condition.

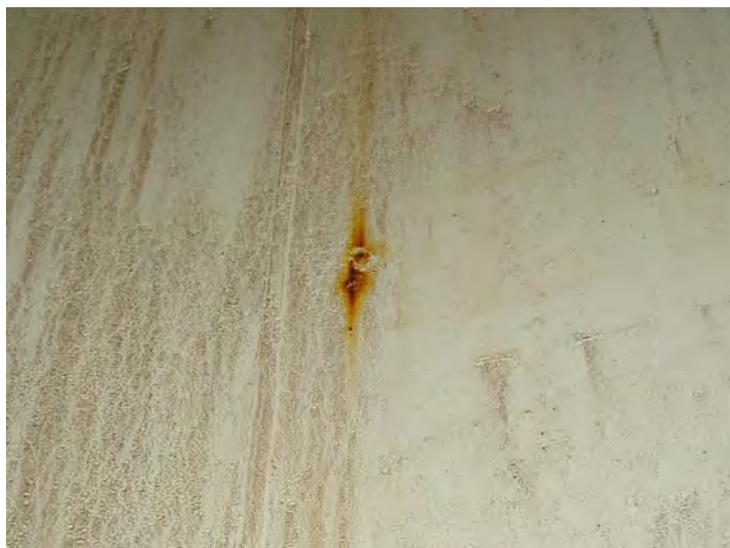
49. There are spot coating breaks to the substrate. The coating is covered with light mineral staining.

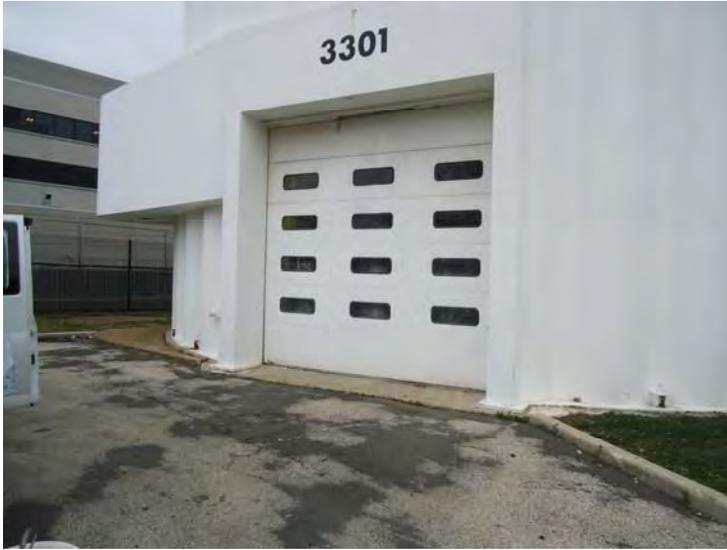
2. The roll up door for access into the base of the tank is in good condition.

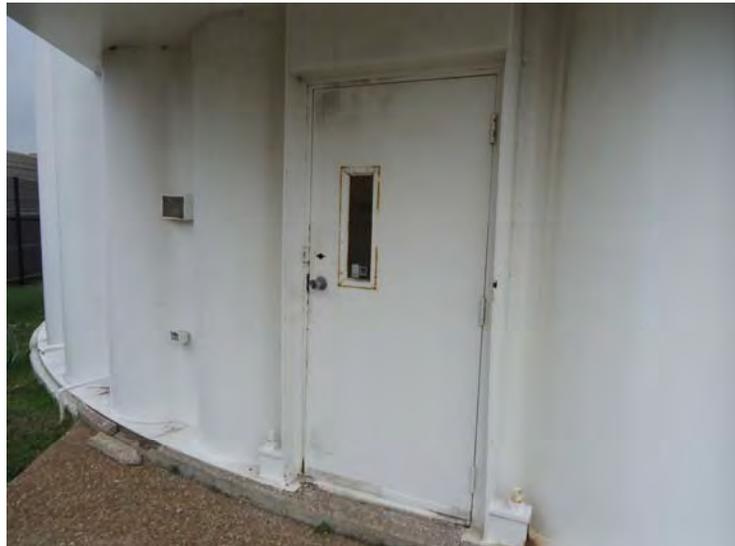
3. The side access door is in good condition and operated properly during the inspection.

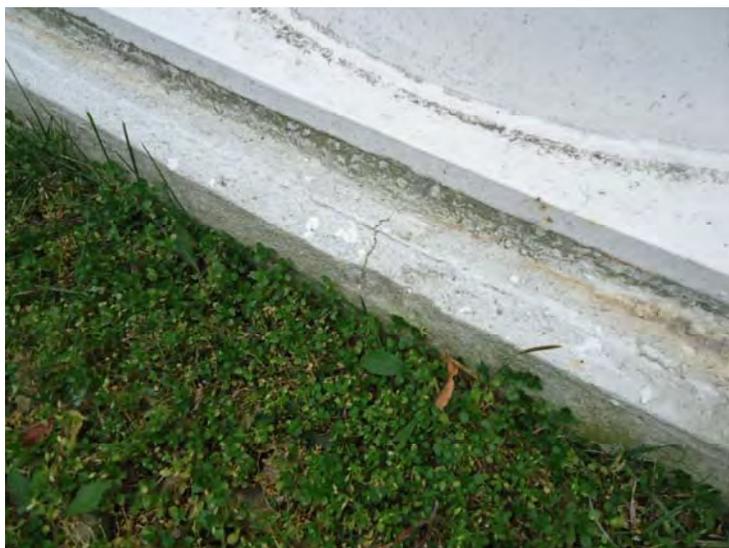
4. The foundation and grout are in good condition.

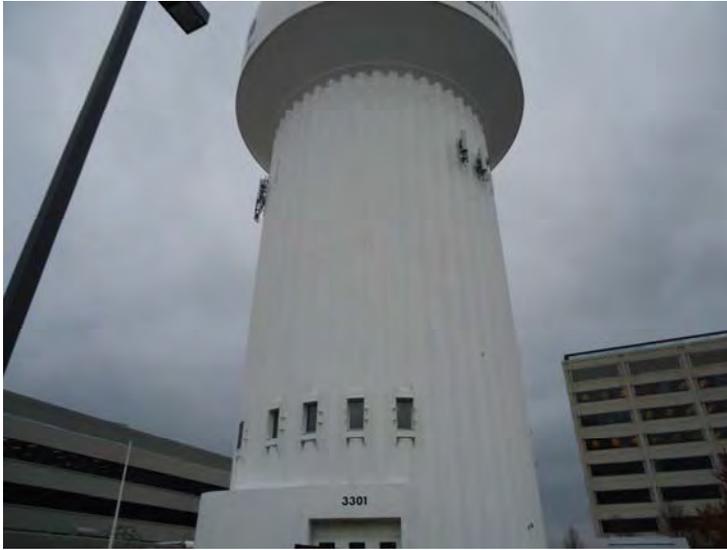
The stem coating is in fair condition. The primary methods of deterioration are spot coating breaks to the substrate, chalking, and fading. The failures noted are minor with only a few breaks noted throughout.

5.The exterior flute coating is in fair condition.

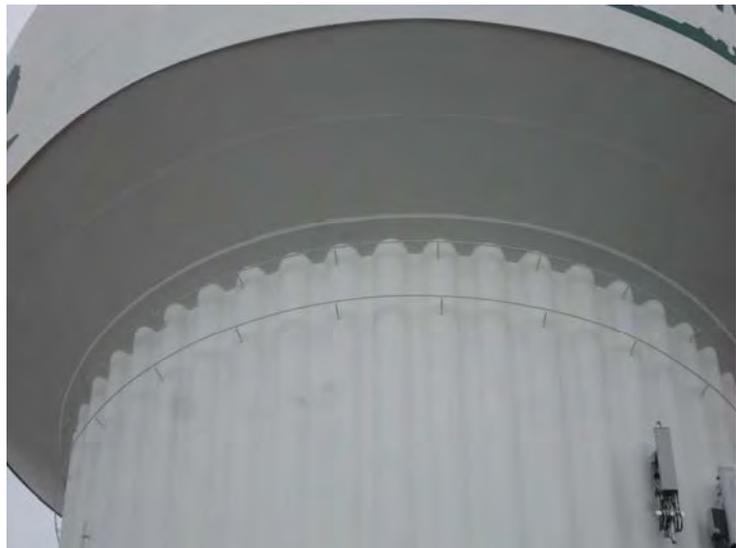
The bowl coating is in fair condition. No coating breaks were found on the bowl. The primary methods of deterioration are chalking and fading.

6.The exterior bowl coating is in fair condition.

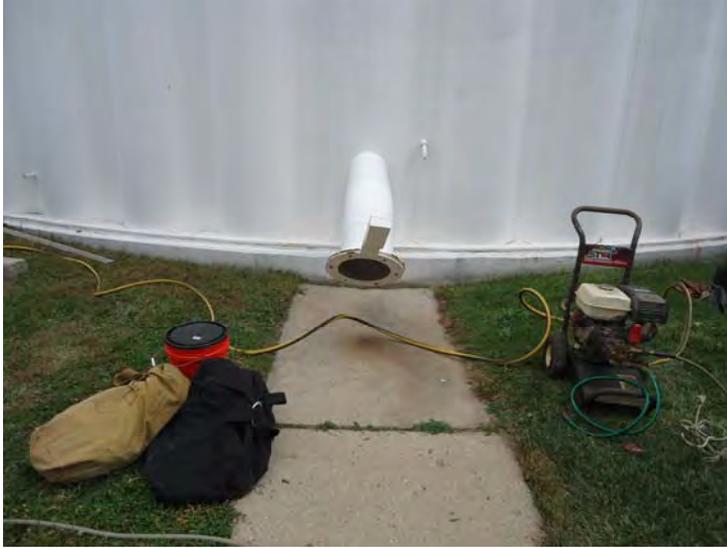
8. The exterior overflow pipe coating is in fair condition.

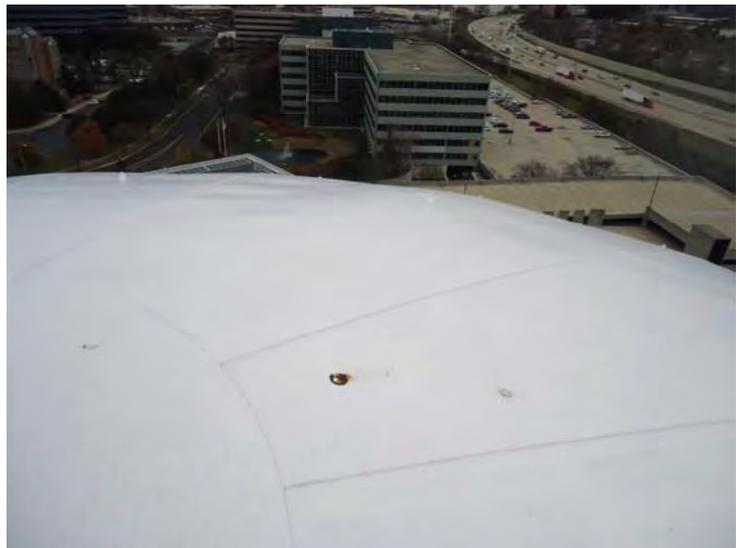
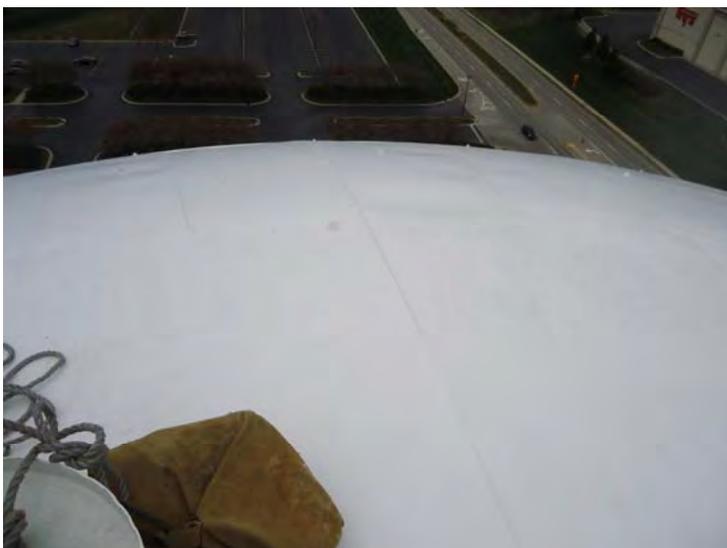
The roof coating is in fair condition. The primary methods of deterioration are spot coating breaks to the substrate, chalking, and fading. The failures noted are minor with only a few breaks noted throughout.

9. The exterior roof coating is in fair condition.

10. Same.

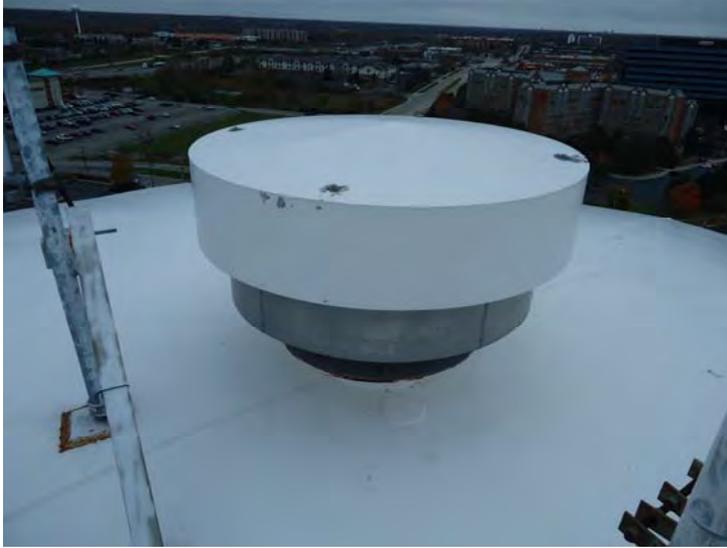
11. The exterior roof vent and screen are in good condition.

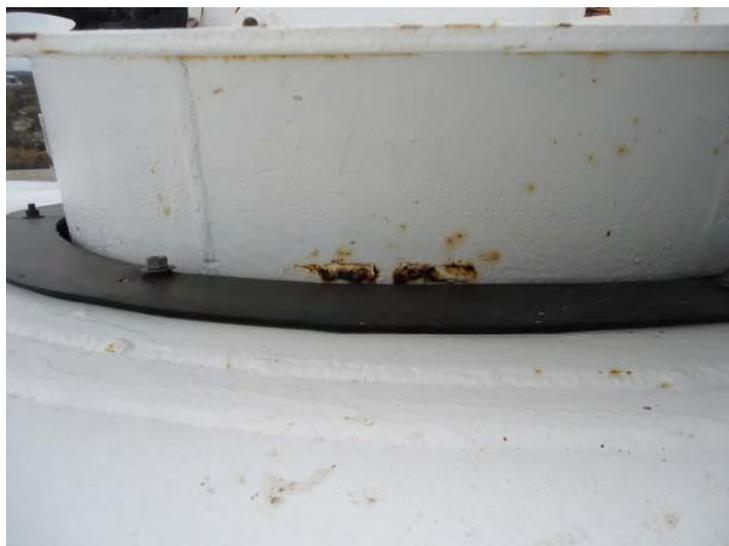
13. The access tube air gap cover does not seal the air gap properly.

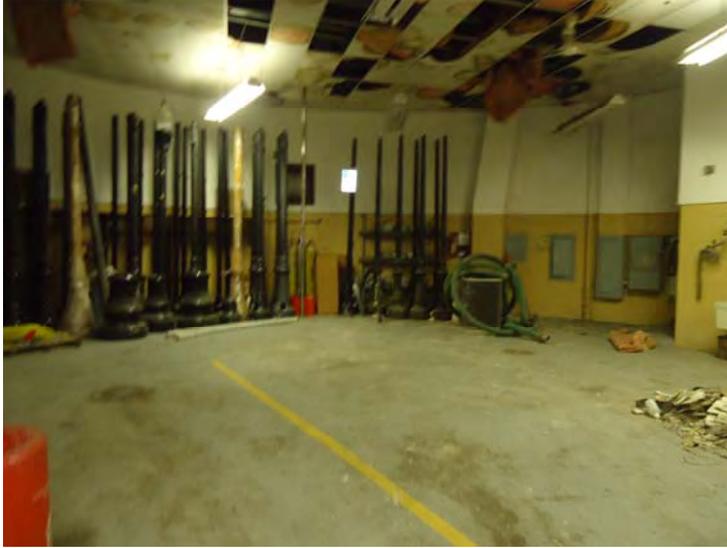
14. The dry interior base of the tank is being used for storage.

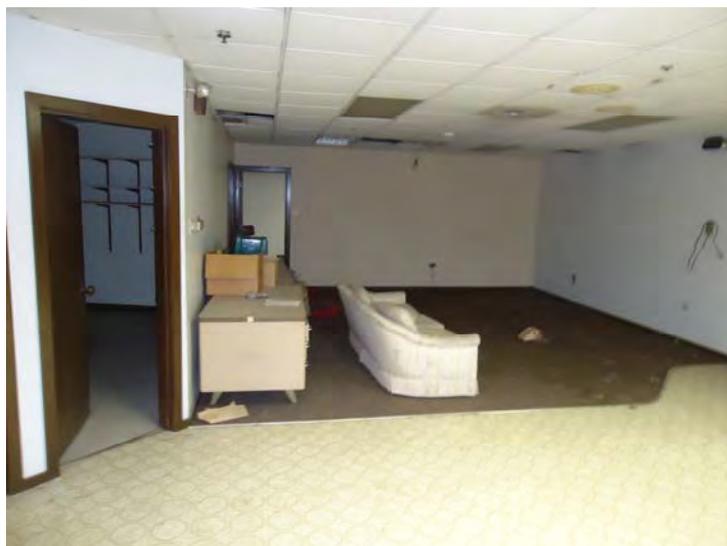
16. The second floor in the dry interior was used for the living quarters for the old firehouse.

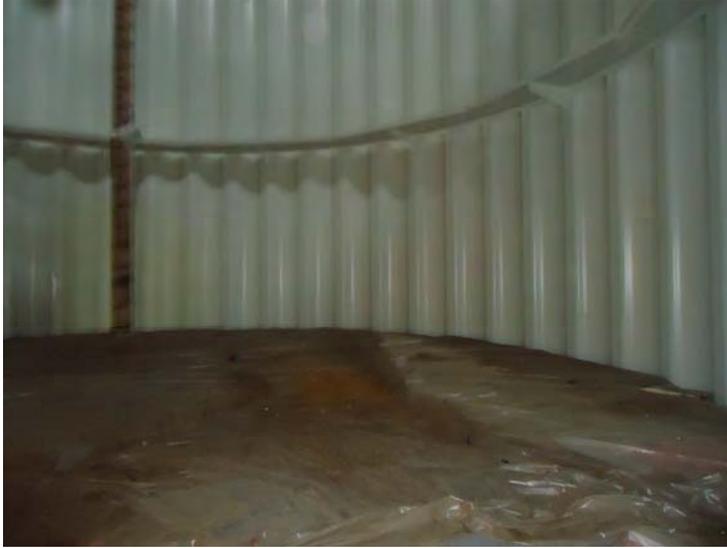
17. The dry interior condensate floor is covered in insulation and plastic.

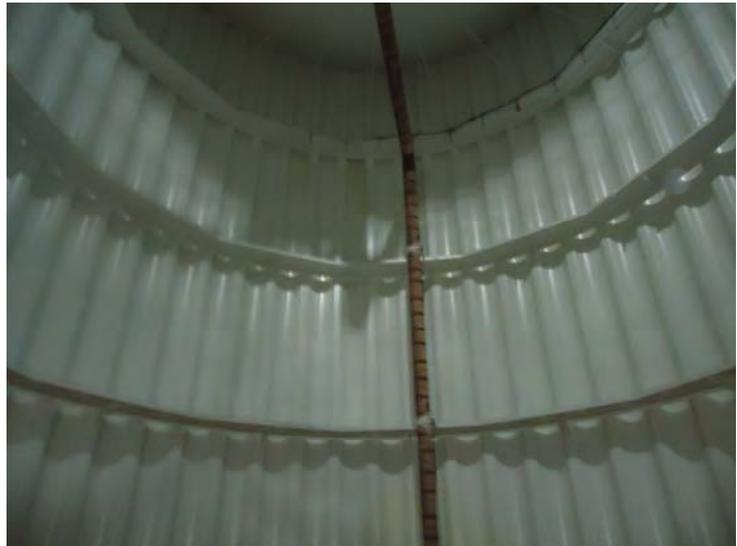
18. The dry interior flute coating is in good condition.

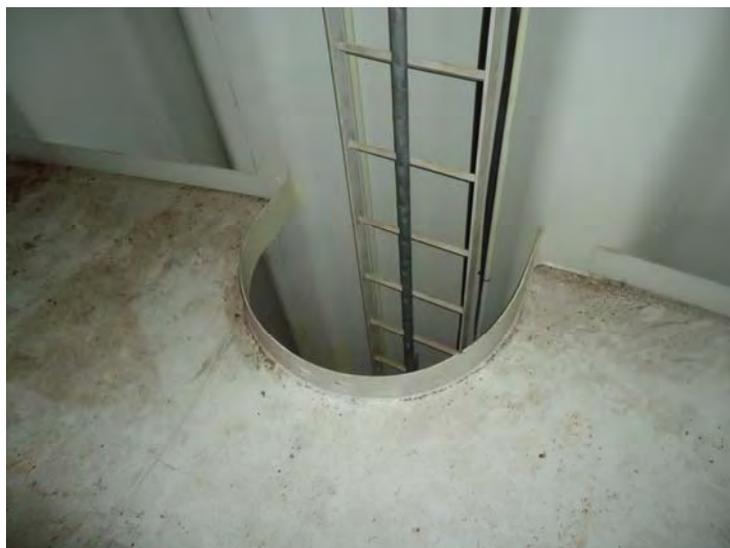
19. The dry interior stiffener platform openings are 24-inch x 32-inch without lids.

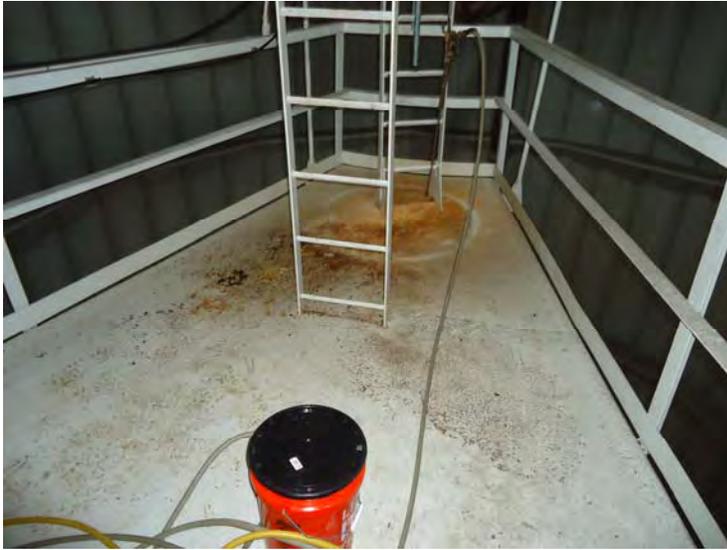
The coating on the tops of the platforms is in good condition. The primary cause of deterioration is spot coating breaks.

20. The dry interior top platform coating is in good condition.

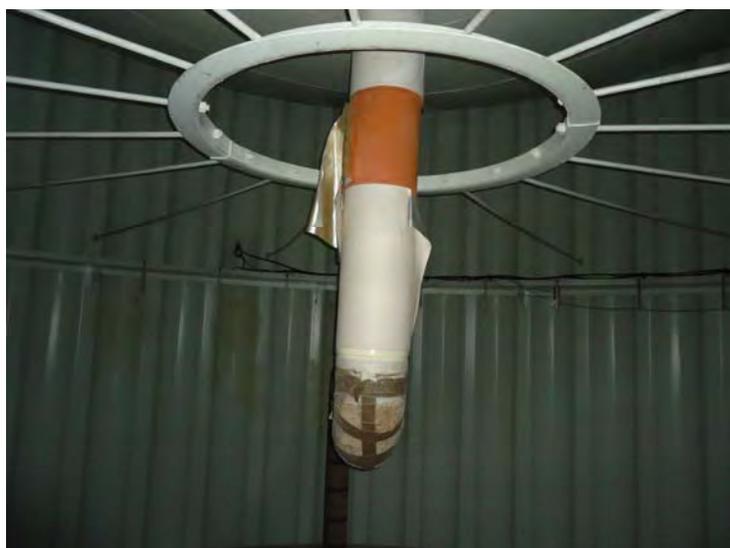
22. The fill pipe insulation and cover is in fair condition, some sections of the cover is falling off.

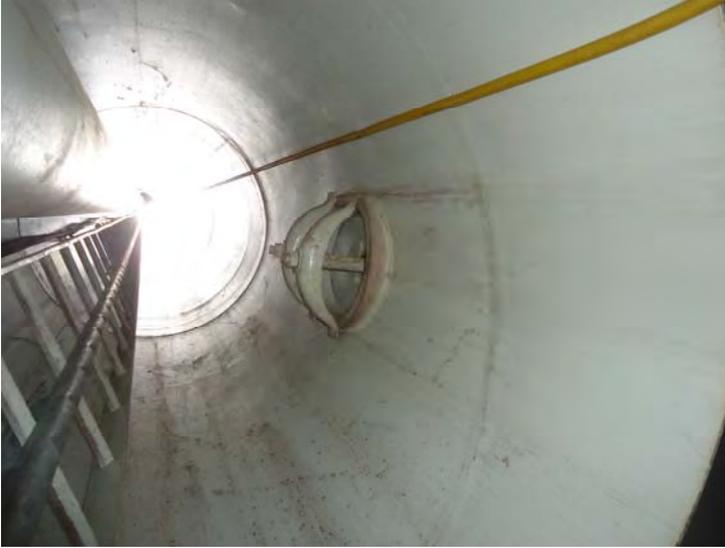
The primary causes of deterioration in the access tube are delamination to primer, spot coating breaks, and rust undercutting.

23. The dry interior access tube coating is in fair condition.

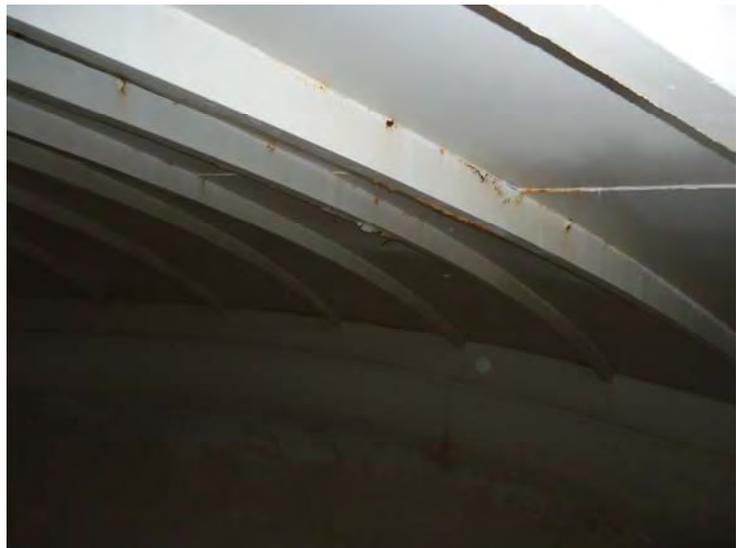
The roof coating is in good condition, with the primary areas of deterioration along the lap seams, the beam edges, and in the crevices. The tank's roof contains caulked lap seams that have started to rust and streak. Staining in the lap seams is not a concern, but should be monitored during future inspections for corrosion growth. Roof beam edge corrosion is typical but should be corrected before structural loss of steel occurs.

24. The wet interior roof coating is in good condition, with minor deterioration.

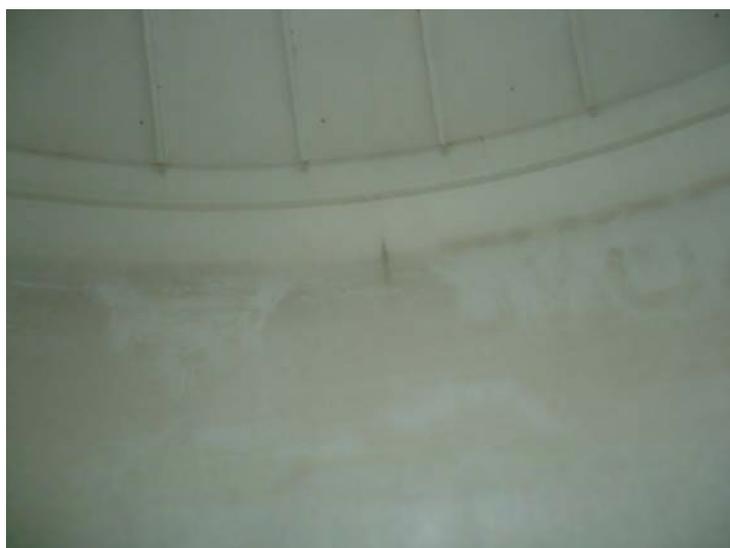
The sidewall coating is in good condition with deterioration in the form of spot coating breaks and delamination. There is not any significant damage at the high water line, which would be the area most affected by ice pressures and ice movement. The coating is still protecting the metal, with the exception of the noted failures.

25. The wet interior sidewall coating is in good condition, with spot coating breaks and delamination.

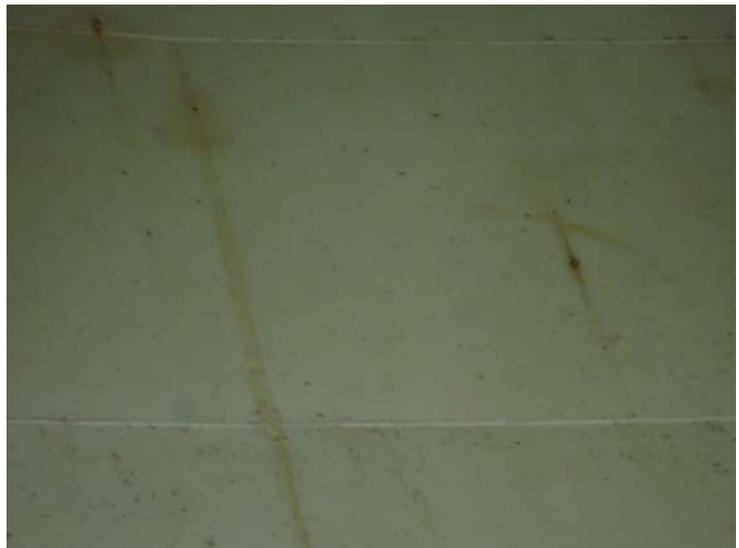
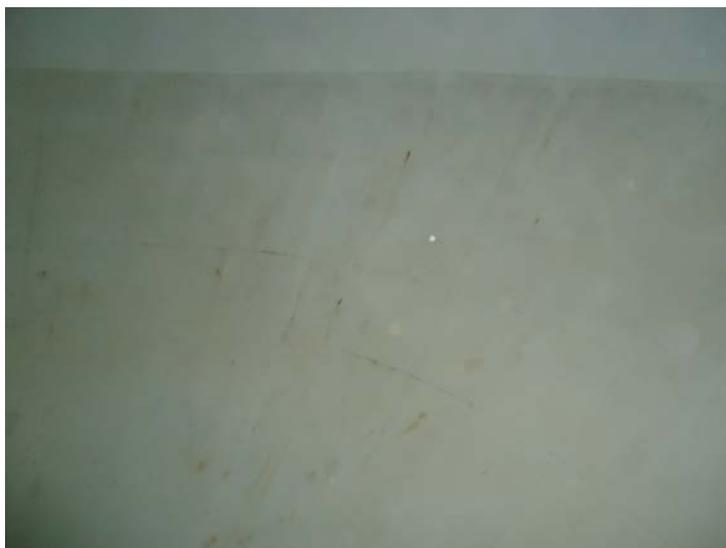
27. The wet interior bowl coating is in good condition, with spot coating breaks

28. Same.

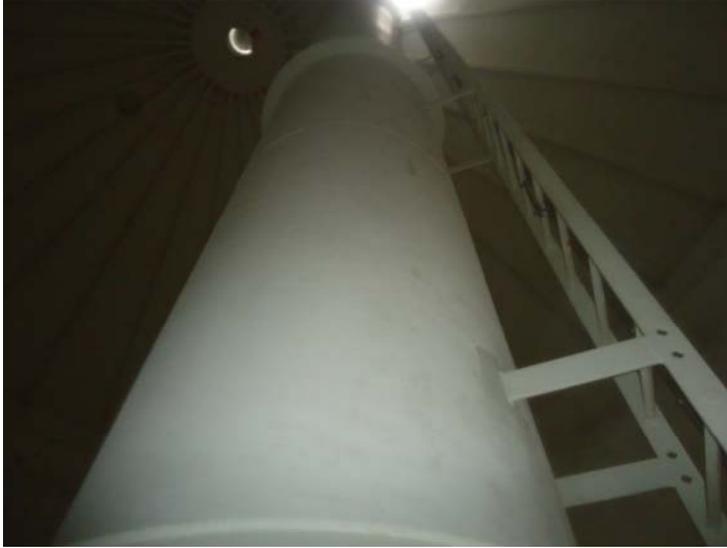
The access tube coating is in fair condition with deterioration in the form of spot coating breaks, delamination, and rust bleed through.. There is damage at the high water line, which would be the area most affected by ice pressures and ice movement. The coating is still protecting the metal, with the exception of the noted failures.

29. The wet interior access tube coating is in fair condition, with spot breaks, rust undercutting, and rust bleed through. There is damage at the high water line from ice.

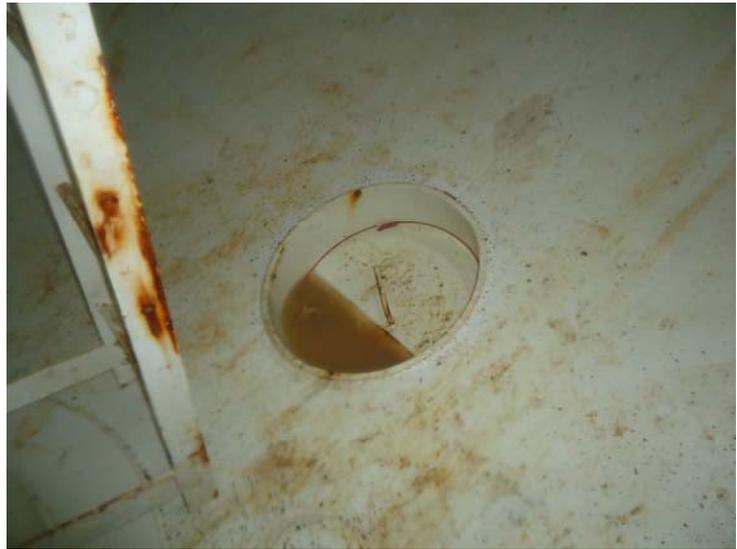
30. The wet interior bowl manway coating is in good condition.

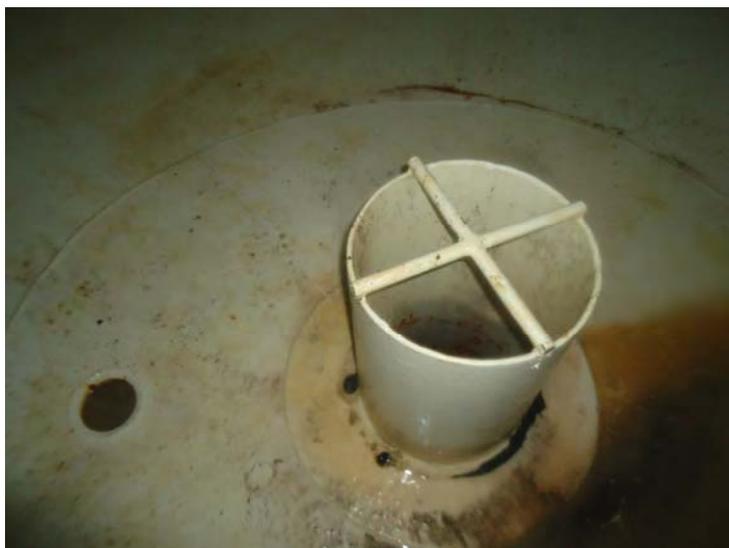
31. The wet interior fill pipe coating is in fair condition.

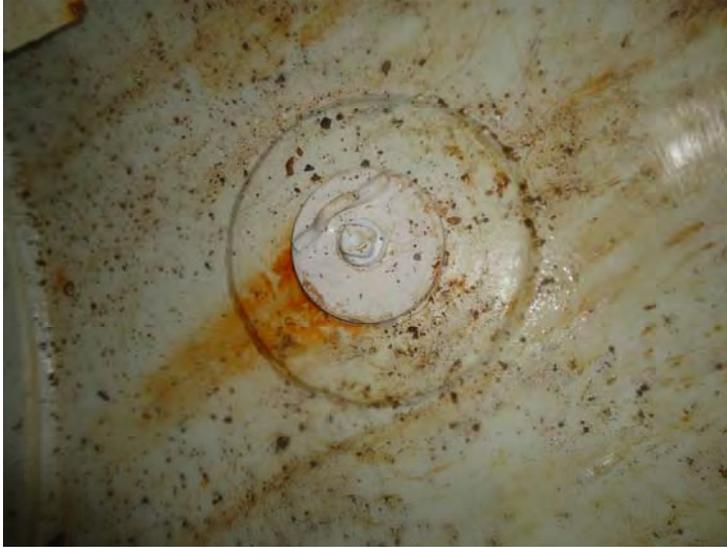
32. The cathodic protection pressure fitting was leaking through the original fitting. The cathodic was removed by Corpro and plugged with a new cap.

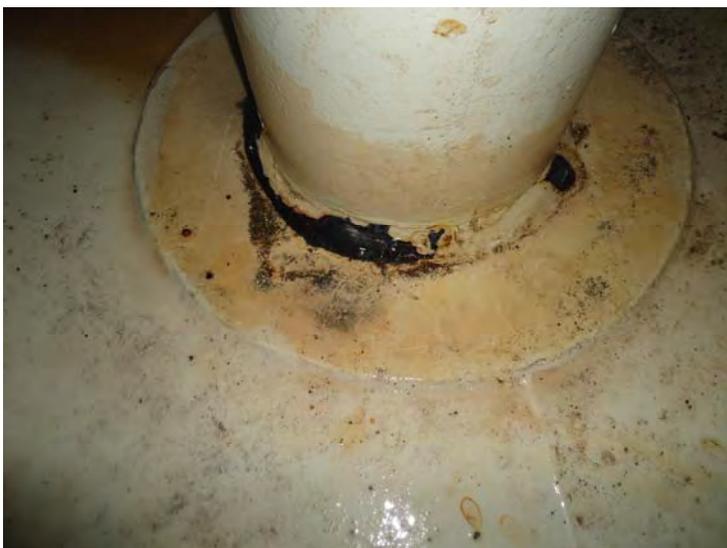
34. The fill pipe has old cathodic deposits around the neck.

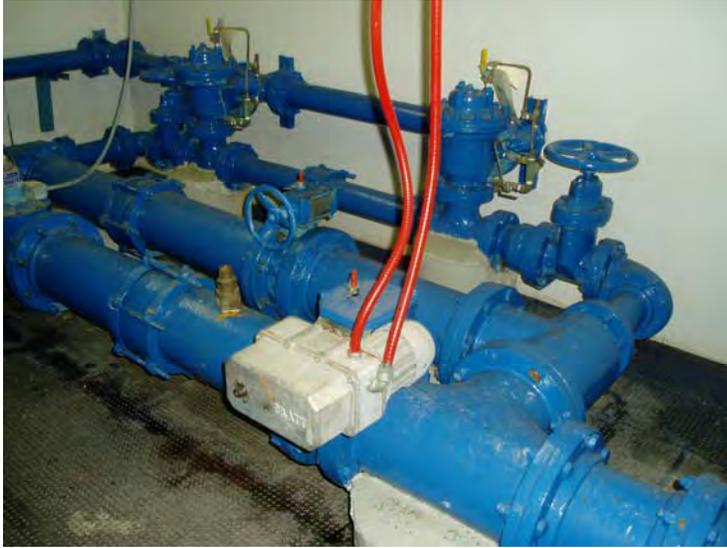
2. The piping located in the pit of the building adjacent to the tank is in good condition. The coating is in fair condition. There is rust bleed through.

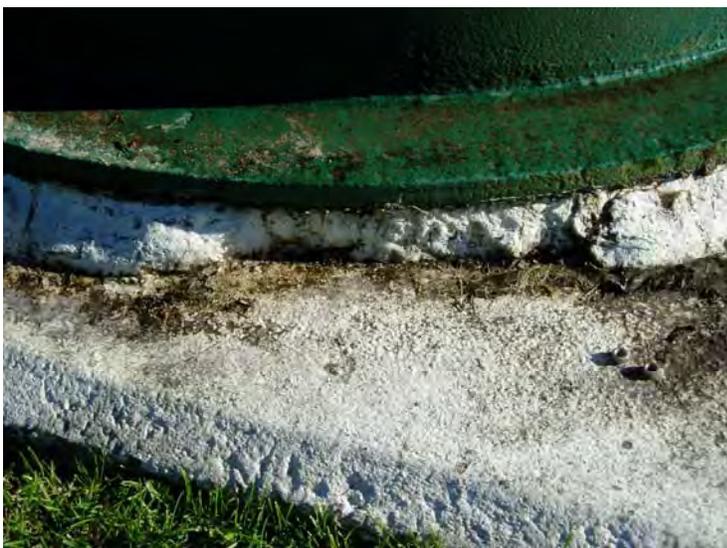
4. The riser foundation grout is in good condition and showed minor amount of deterioration. No grout is missing between the foundation and the base plate.

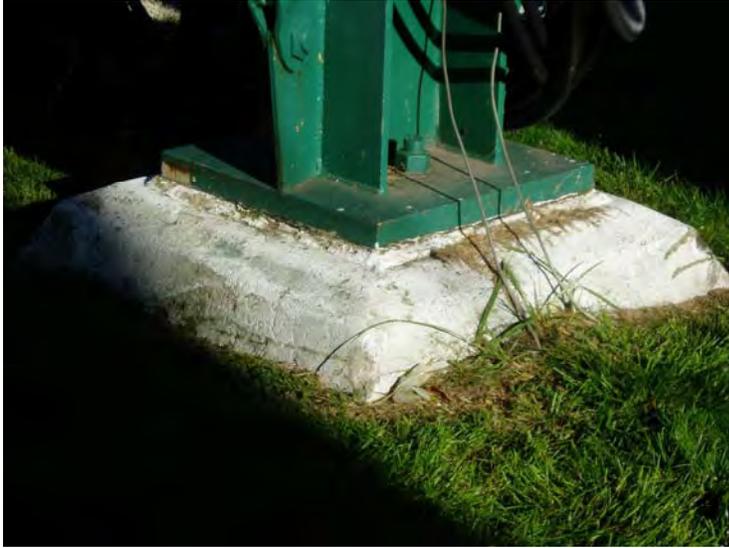
5. The leg foundations are in good condition and showed minor amounts of deterioration including chipping and cracking.

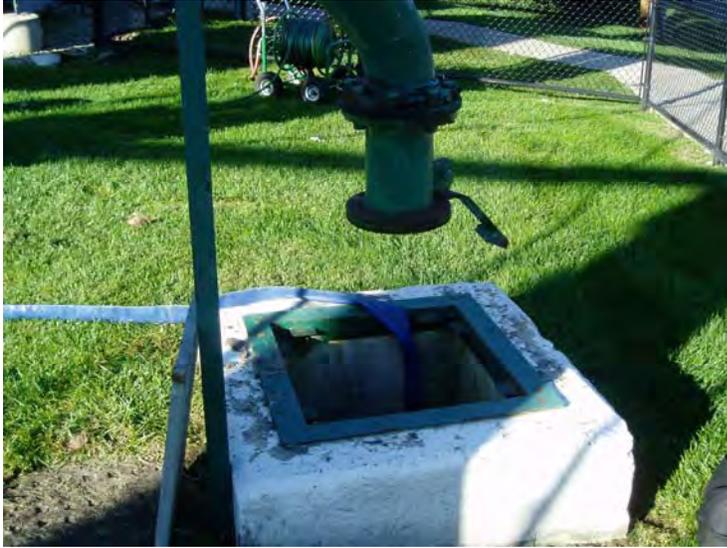
7. The leg anchor bolts are in good condition. The coating is in fair condition.

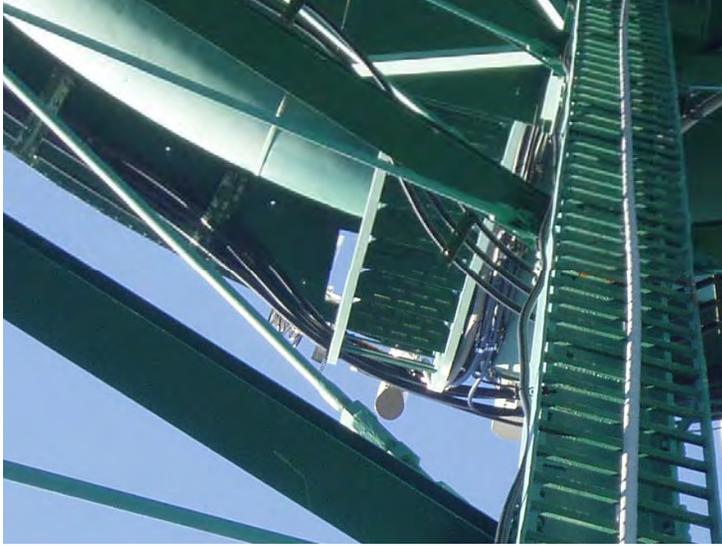
10. The leg ladder contains a rail-type fall prevention device. The ladder and fall prevention device are in good condition. The coating is in fair condition.

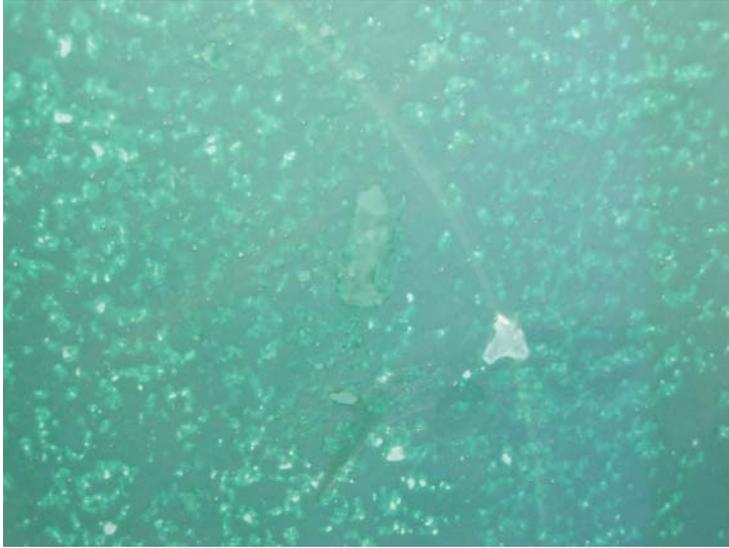
13. The exterior leg coating is in fair condition. The coating is chalking, fading, and eroding.

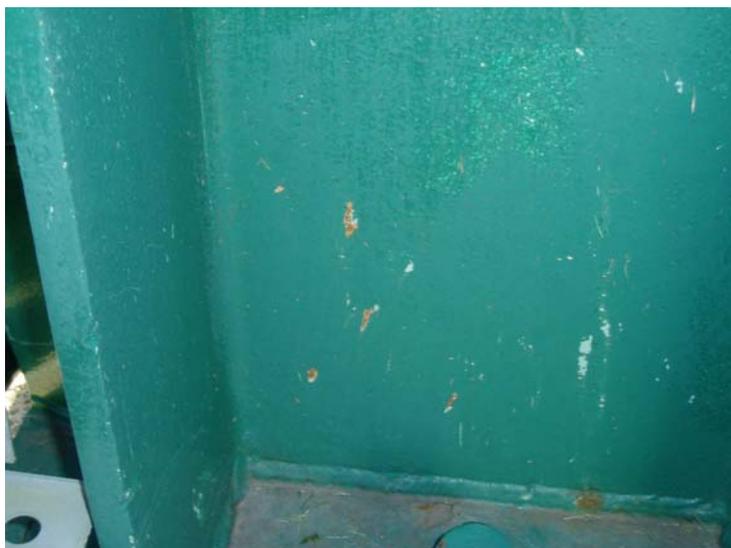
15. Same.

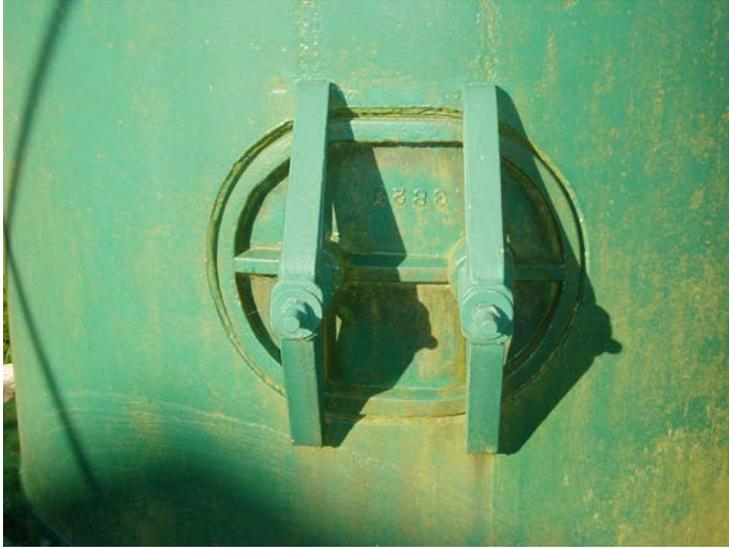
16. There are spot coating breaks to the substrate.

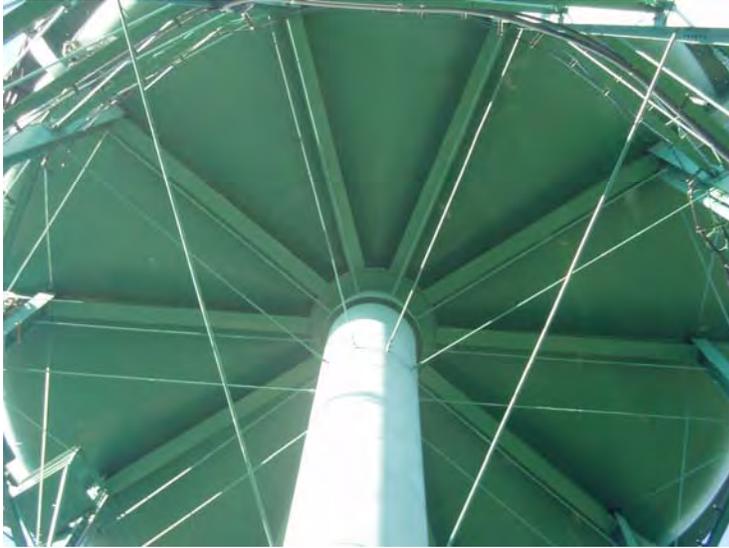
19. The exterior riser coating is in good condition. The coating is chalking and fading. There are minor spot coating breaks to the substrate.

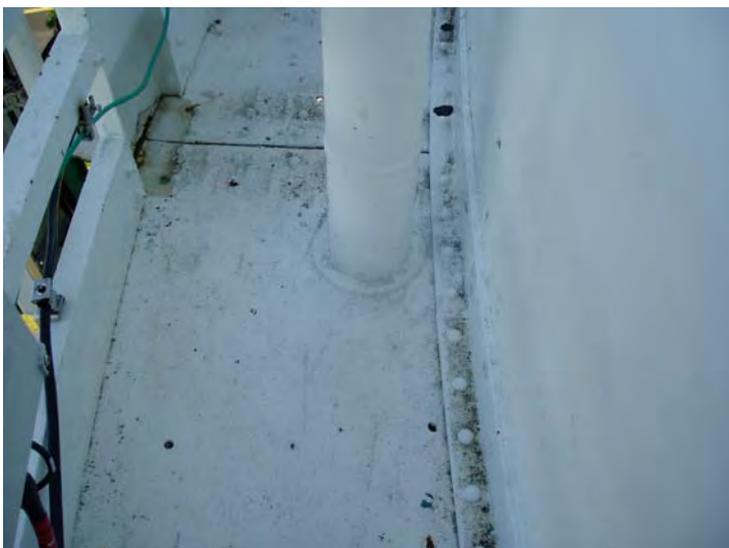
21. There is topcoat delamination.

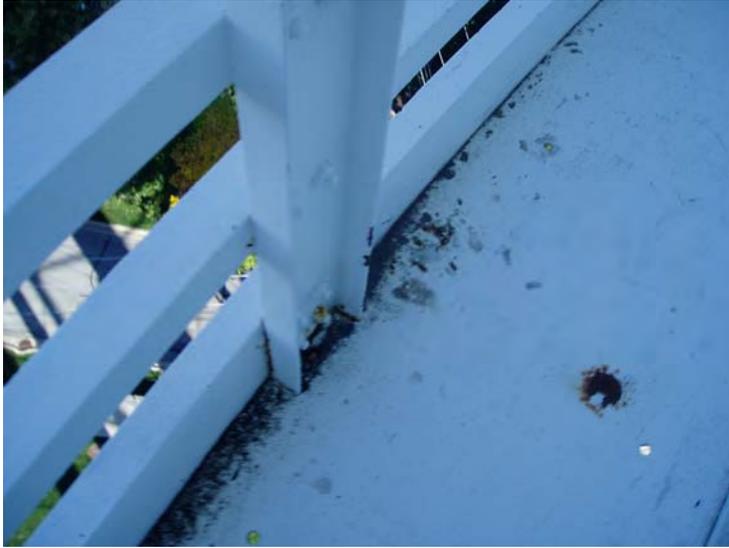
22. The balcony is in good condition with no missing bolts or rivets.

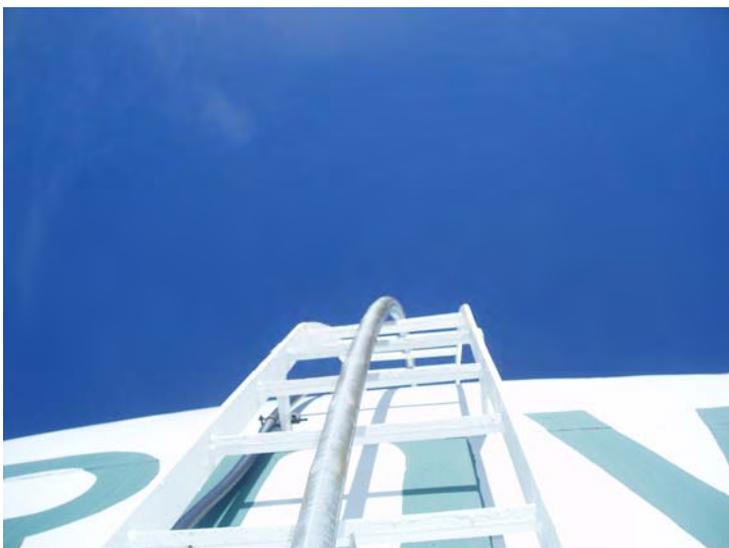
24. The sidewall manway is hinged and the gasket showed no signs of leaking. The manway is in good condition. The coating is in fair condition.

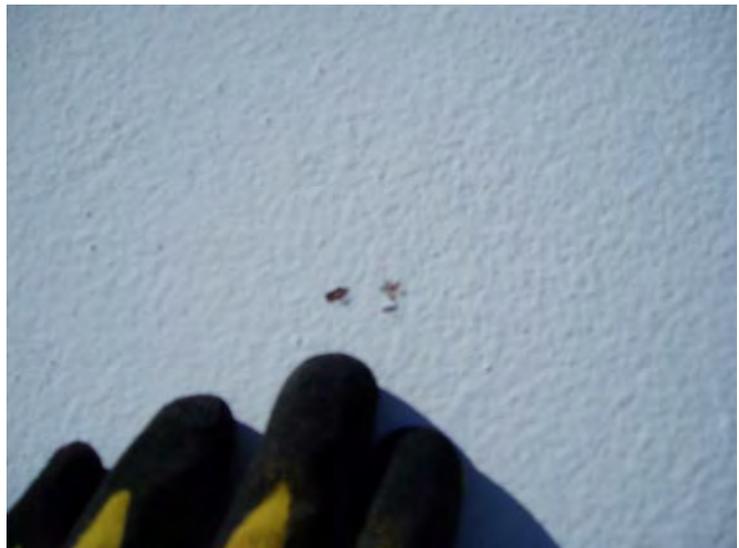
26. The exterior sidewall coating is in fair condition. The coating is chalking, fading, and eroding.

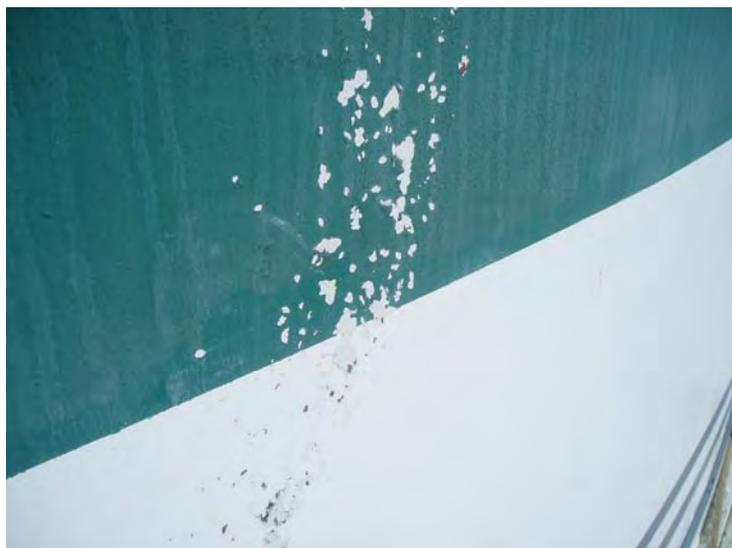
27. There are spot coating breaks to the substrate.

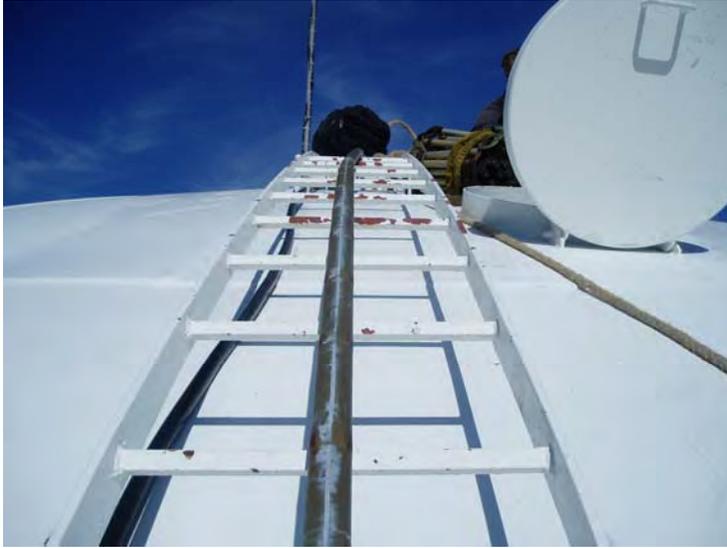
28. There is topcoat delamination.

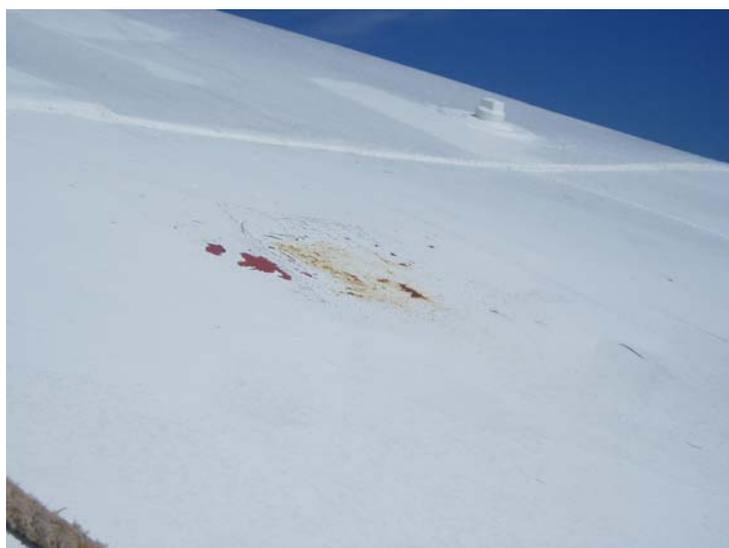
36. There is topcoat delamination.

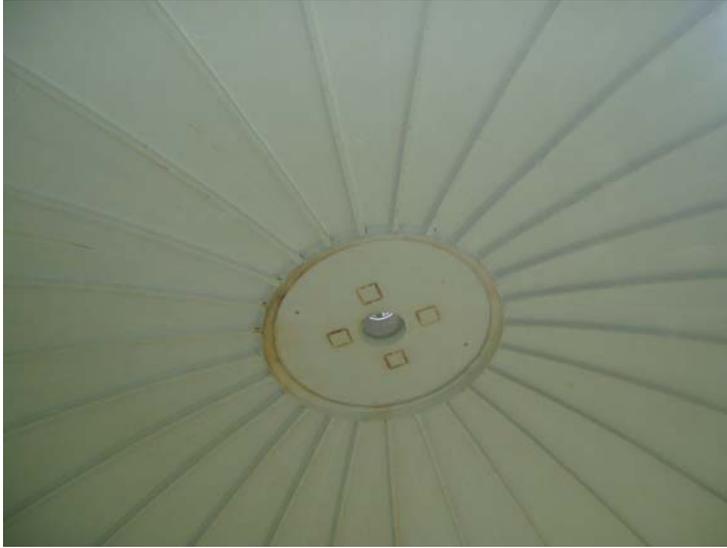
37. There are areas of rust bleed through and spot coating breaks to the substrate with rust undercutting.

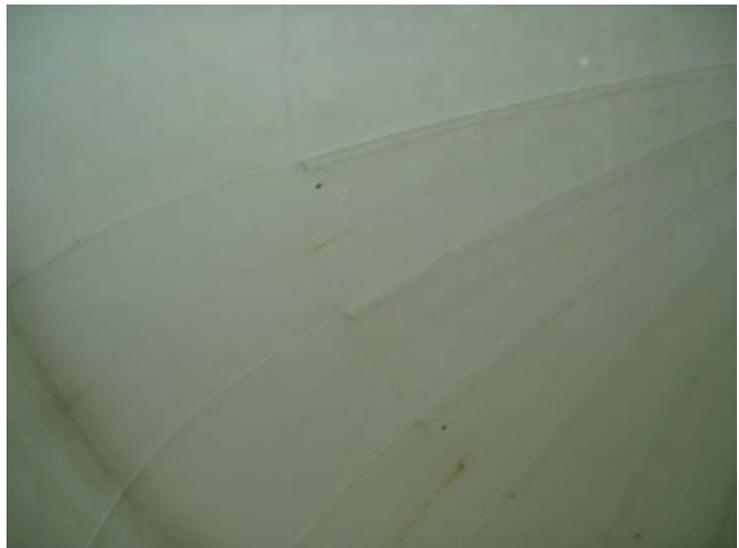
38. The wet interior roof beams are in good condition. The coating is in fair condition. There is edge and crevice corrosion.
