# Project Plan Water System Improvements

Village of  
Downers Grove, Illinois  
April 2015

## Project Plan Water System Improvements

STRAND ASSOCIATES, INC.®  
IDFPR No. 184-001273  
1170 South Houbolt Road  
Joliet, IL 60431  
www.strand.com  
April 2015

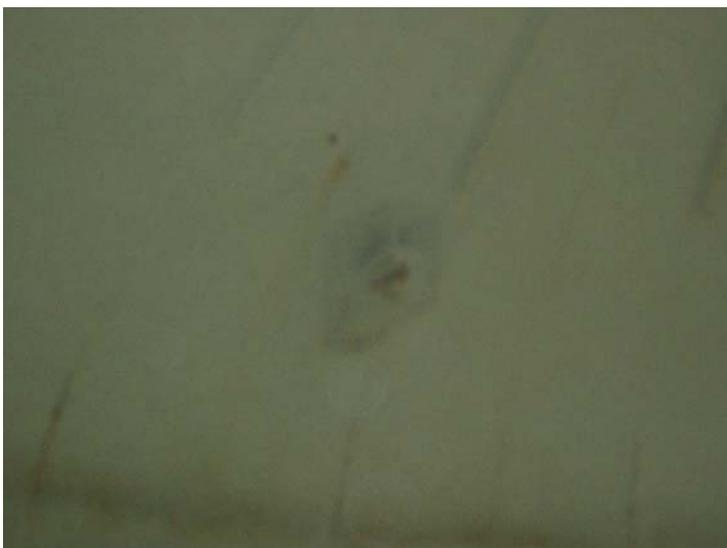
39. The wet interior roof coating is in good condition. There are spot coating breaks to the substrate with rust undercutting.

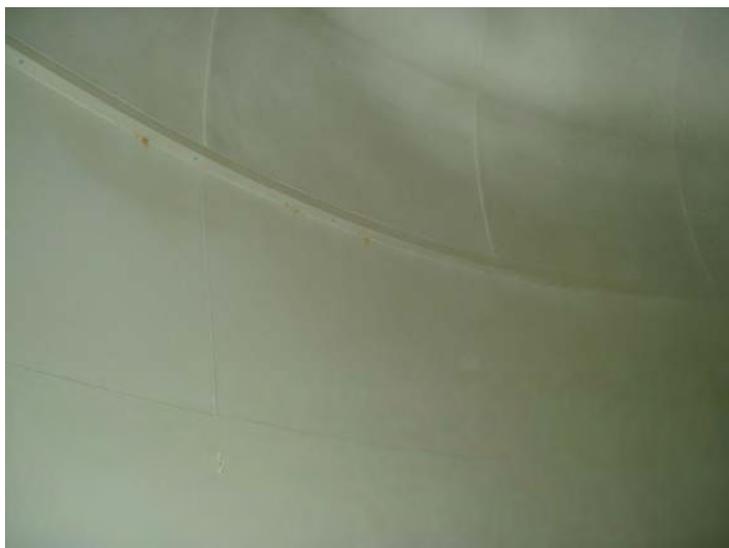
42. The sidewall beam is in good condition. The coating is in fair condition.

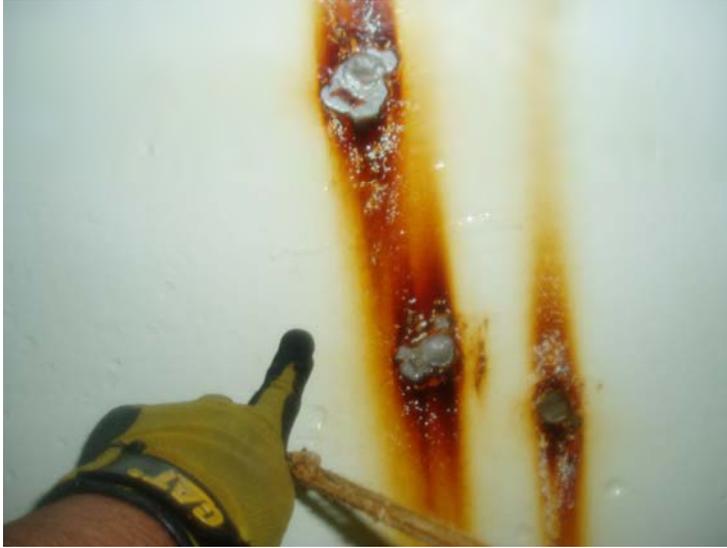
43. The wet interior sidewall coating is in good condition overall.

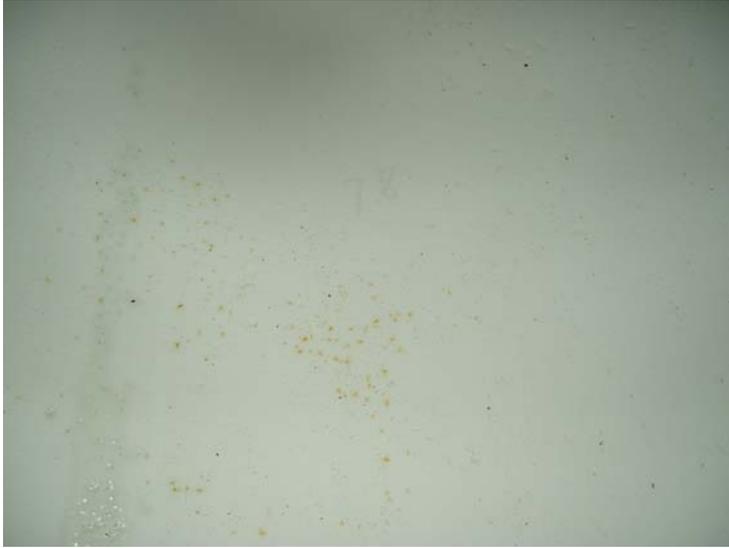
46. Approximately 1/16-inch of mud sediment was flushed from the wet interior.

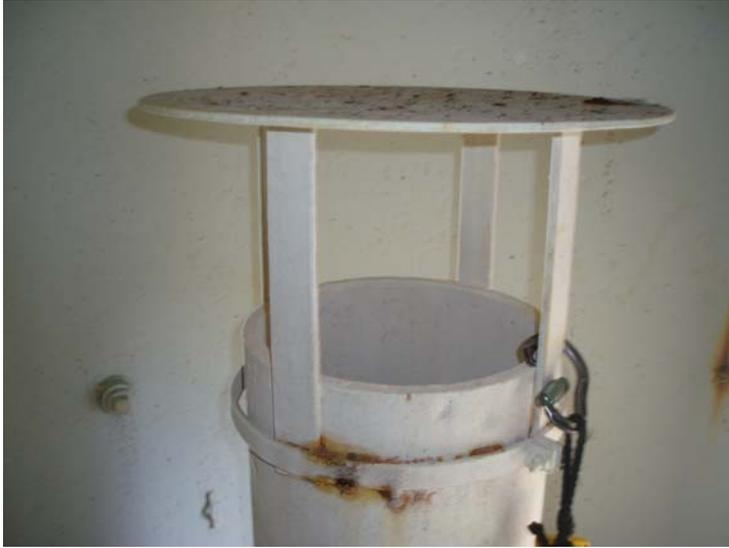
50. The fill pipe has a deflector plate. The fill pipe and deflector plate are in good condition. The coating is in fair condition.

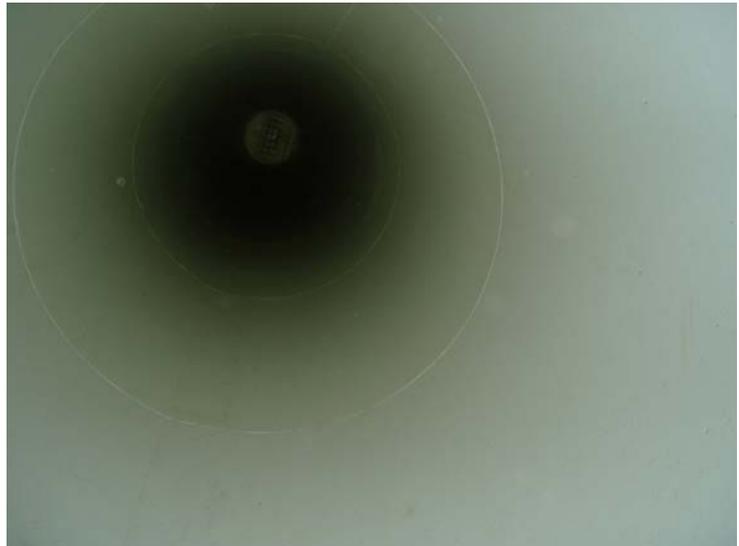
51. The wet interior riser coating is in fair condition.

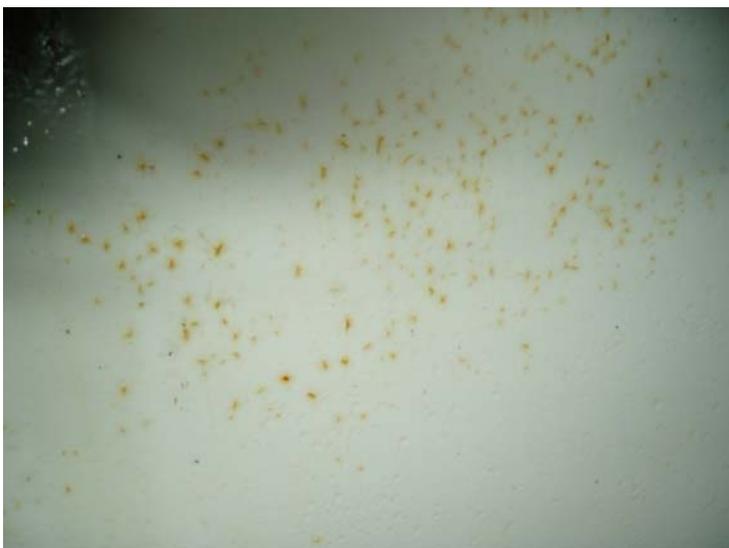
52. There are areas of rust bleed through.

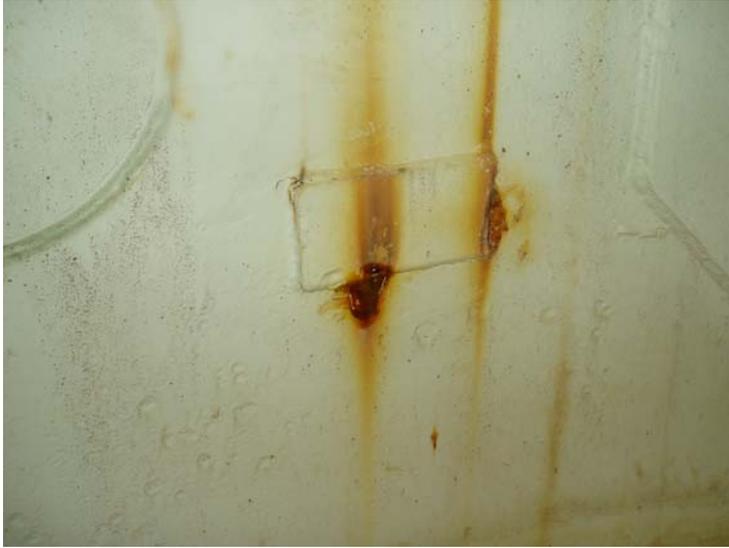
53. There are spot coating breaks to the substrate with rust undercutting.

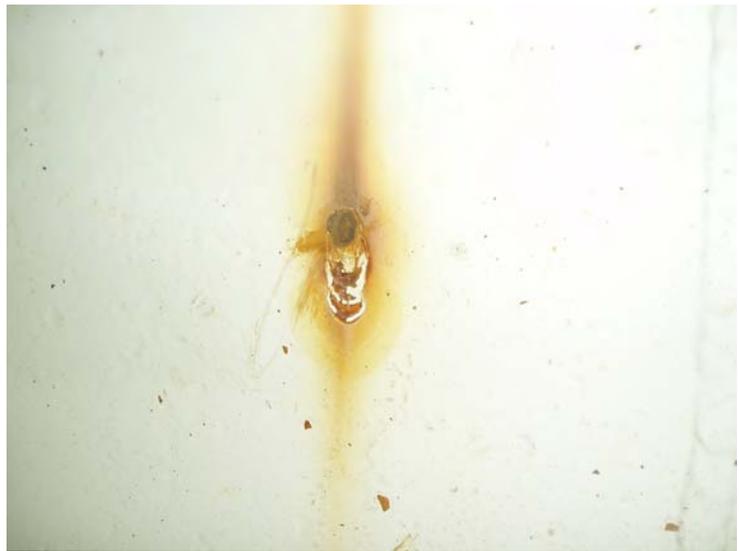
54. Same.

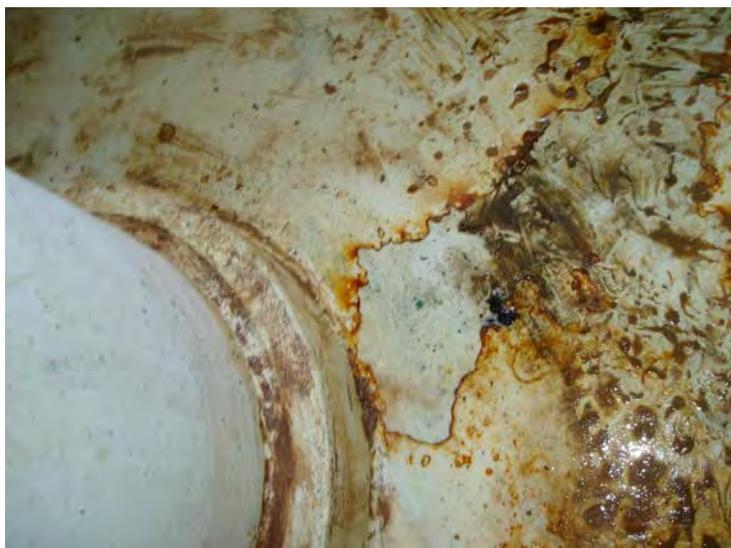
55. There is topcoat delamination.
